Preliminary Report

**Earthquake and Tsunami Damage Assessment in Port Vila**

January 2002

**SOPAC**

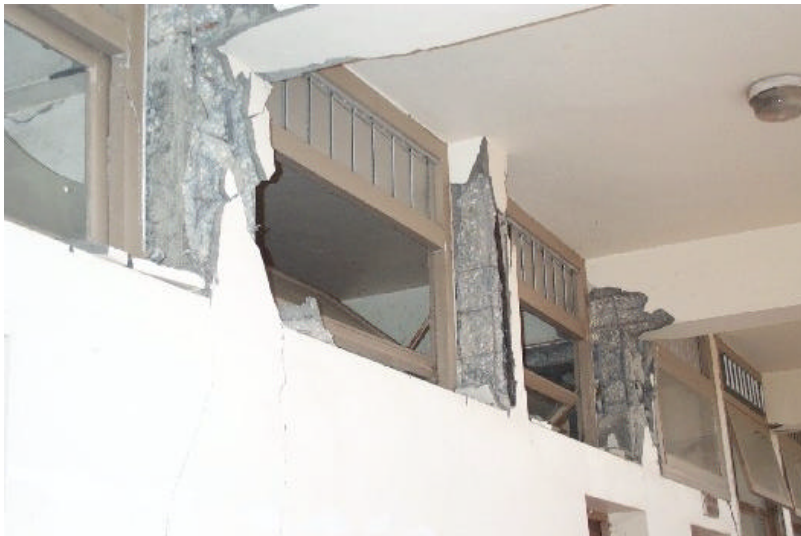
Significant structural damage occurred to the Lycee Bouganville where a 3-storey school classroom building was severely damaged, displaying short-column failure concentrated at the top of the infill walls throughout the entire ground floor level (Figure 4), an adjacent dormitory block suffered similar, significant structural damage, and a 2-storey classroom block reached the stage of incipient failure.

The school buildings are built on a cut and filled slope. Damage consistently increases from upper to lower floors. The pattern of failure suggests that the fixity of the ground-floor infill walls has concentrated stresses and promoted shear failure in the short, lower-floor columns. The design strength of the concrete has been exceeded, possibly due to poor concrete mix characteristics. A retrofitting program should be undertaken without delay for this particular design (where not already condemned) especially in the case where they are used as public school buildings.

**Figure 4: Short columns spalled and failed, ground floor, Lycee Bouganville**

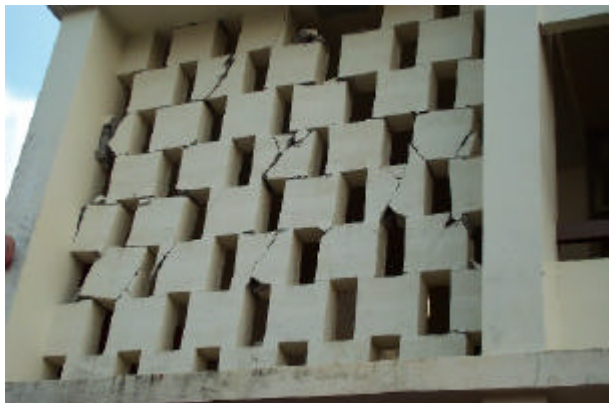
Unreinforced concrete blocks set in a checkerboard pattern in the stairwell spaces of the Lycee buildings (Figure 5) have failed catastrophically, highlighting a dangerous and unnecessary construction practice. The blocks should be removed immediately and replaced by alternative materials.

**Figure 5: Infill blockwork in stairwells sheared and collapsed**

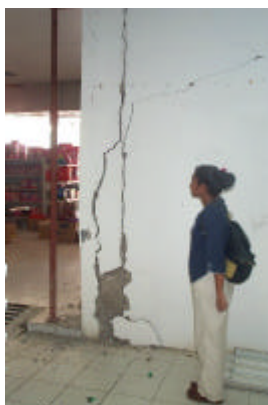
**Figure 6: Damage around ground-floor columns at Au Bon Marche**

The 3-storey Au Bon Marche in No.2 district was badly damaged (Figure 6) through column failure, probably due to inadequate foundation floor beams.

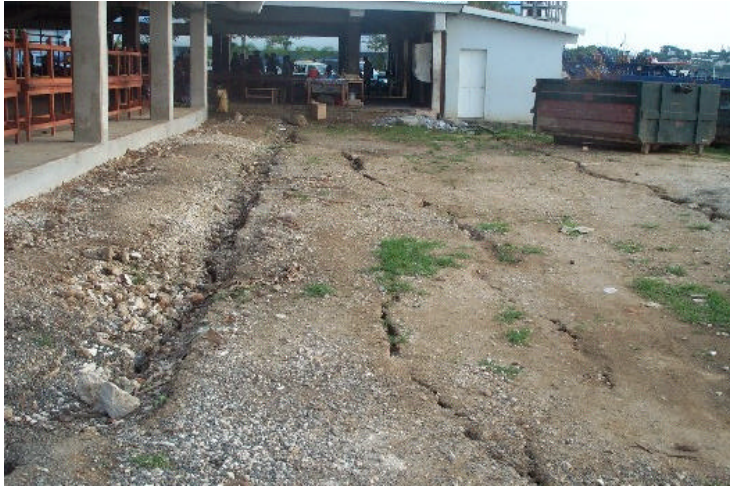
Figure 7: Fissuring in back-fill behind sea wall, north of Market

Movement of the sea wall during the main shock has led to some permanent deformation to seaward and subsidence of the foreshore in reclaimed areas around the Central Business District. The worst affected area runs for some 150 m from the open park area north of the main public Market (Figure 7), southward through the seaward end of the Market building and car park and then through the seaward end of the Sea View Restaurant/Bon Marche in a 25 m-wide zone adjacent to the sea wall.

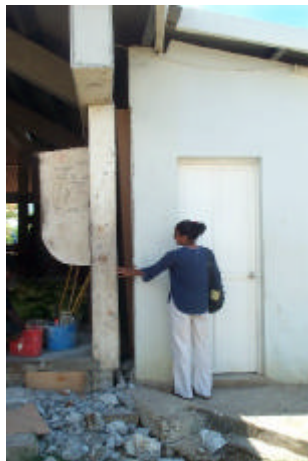
This has led to the subsidence and tilting of the Sea View Restaurant, detaching it away and rotating it to seawards from the main Bon Marche building, and causing significant distress and cracking to structural columns and beams throughout the restaurant. Similarly, the toilet block on the seaward end of the Market (Figure 8) has detached 150 mm away from the main structure. It is likely that both structures are founded directly on fill in an inherently unstable area.

Figure 8: Detached Market toilet block

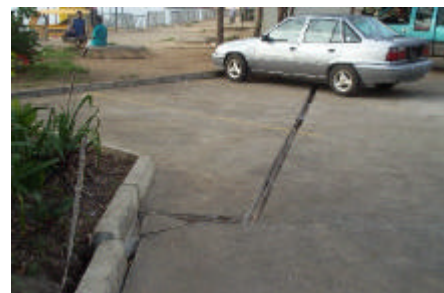
The ground distress also extends into the floor slab up to the first row of columns of the main market where the first (westernmost) slab construction joint has opened up. Between the public Market and the restaurant, the concrete slabs of the car park have also opened up some 50-100 mm on construction joints (Figure 9) due to the same cause.

Figure 9: Car park slabs opened south of Market

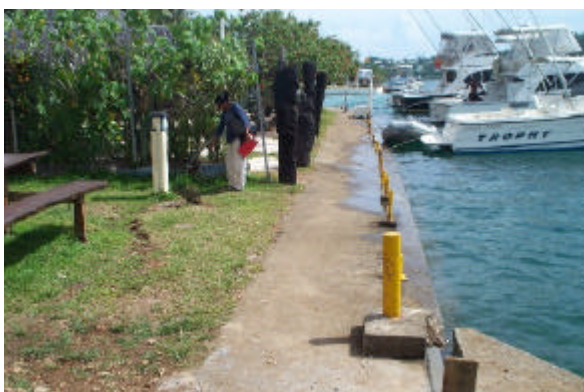
Subsidence and rotation of the sea wall has also occurred further south in the vicinity of the Waterfront Bar (Figure 10). Fissures that opened in filled ground behind the sea wall there reportedly issued water under high pressure.

Figure 10: Ground fissures and tilted sea wall near Waterfront Bar

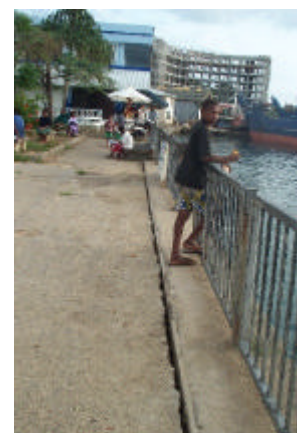
A gap of around 20 mm is present between the concrete sea wall and backfill in much of the reclaimed area around the CBD (Figure 11).

Figure 11: Gap between sea wall and back-fill

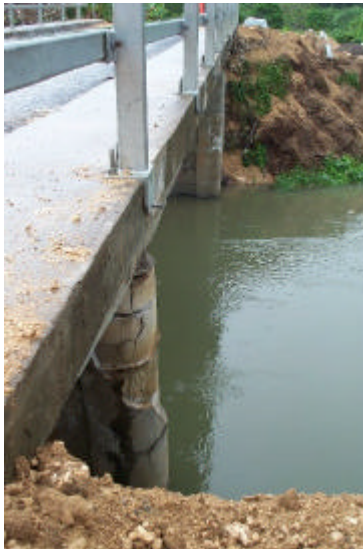
The Teuma Bridge (Figure 12) to the southeast of the city has suffered significant structural damage as a result of the shearing of the eastern pier set/pile cap due to a rotational soil failure in the eastern abutment. The bridge superstructure has shifted eastward and tilted down to the east, causing some tilting of the western pier set as well. Soil failure due to liquefaction is also apparent in the western approach.

Figure 12: Damaged Teuma Bridge

The PWD has plans in hand to drive new piles, re-establish the level of the superstructure and repair the piers.

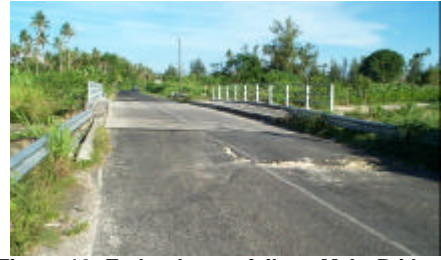
Figure 13: Embankment failure, Mele Bridge

Both the Mele (Figure 13) and Prima Bridges to the northwest of Port Vila have been affected by failure of their approach embankments and abutments due to liquefaction in the underlying alluvial soils (Figure 14), although the main bridge structure in both cases is considered by the PWD to be sound.

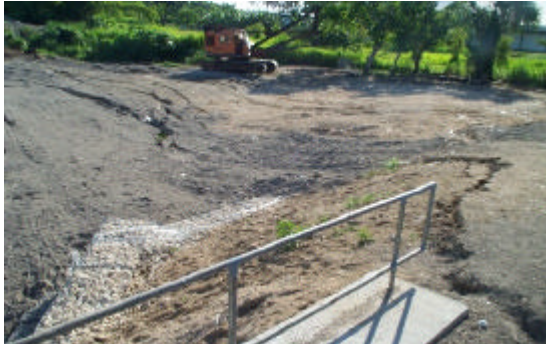
Figure 14: Slumping due to liquefaction, Prima Bridge

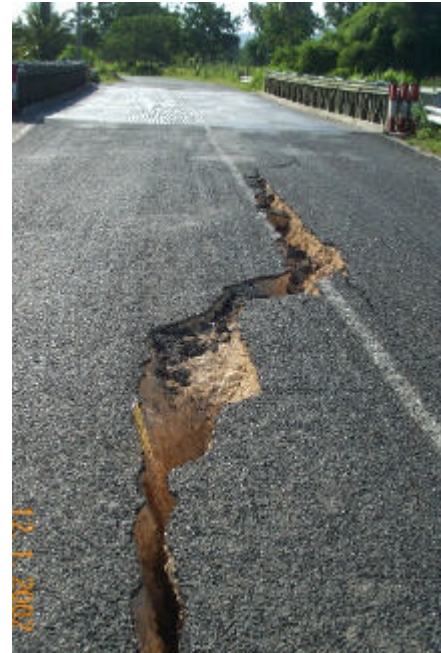
Fissures in the roadway and underlying embankment fill (Figure 15) opened up to 500 mm wide with depths in excess of a metre in places.

Figure 15: Embankment failure, Prima Bridge

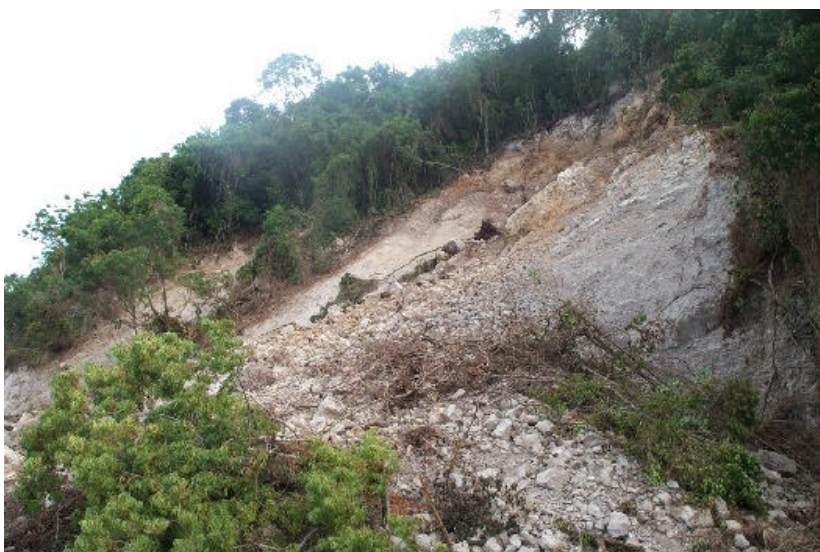
Port Vila Harbour (Figure 16). The geology of Port Vila is characterised by a thick series of weak volcanic tuffs capped by a cemented limestone some tens of metres thick. The slope failures in the wharf road were principally in the weaker tuffs although undercutting of the top of the cliff has brought down significant blocks of limestone as well (Figure 17). Failures in the tuff have been variously initiated on wide shear zones, areas where the layering dips out of the cliff face, and also within fossil gullies containing weak colluvial material.

Figure 16: Massive slope failure in tuff above Wharf access road

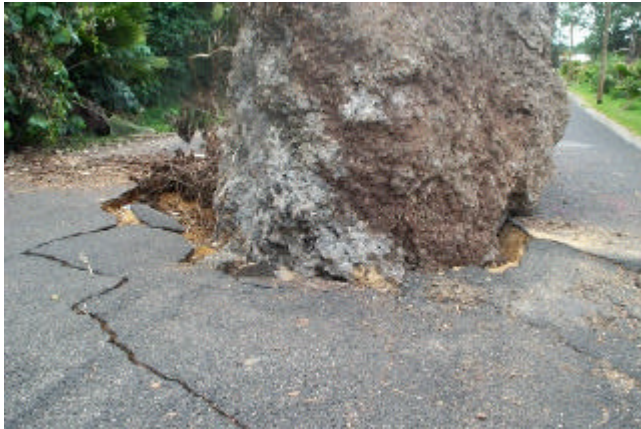
**Figure 17: Toppled limestone boulder puncturing road surface**

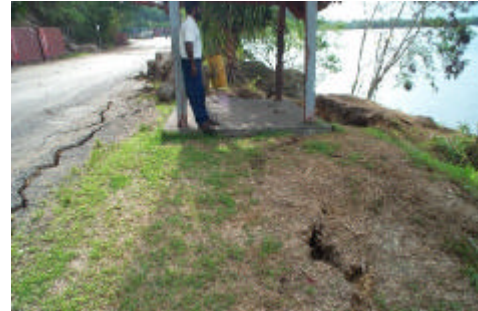
The fill in the roadway to the wharf has fissured and failed in numerous places (Figure 18). The security of the wharf access road is a key issue requiring further geotechnical investigation and remedial work.

**Figure 18: Road embankment collapse, Wharf road**

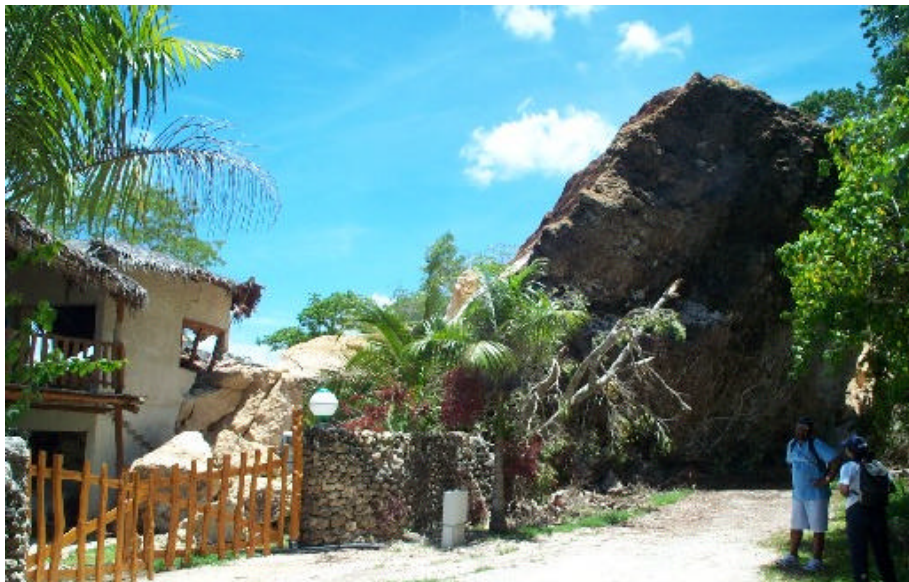
Significantly, the one catastrophic slope failure that did occur in the west of the peninsula (Figure 19) was in the area between Pango and

**Figure 19: Toppling failure from the cliff face behind Pango Resort**

Watarua-Paradise Cove where prior erosion of the tuff had undercut the overlying limestone. Shortly after the major shock, a section of the cantilevered limestone, including one house-sized block of limestone of about  $75 \text{ m}^3$ , toppled from the 10 m high cliff line to partially demolish a modern concrete bungalow used as a reception area for the Pango Resort.

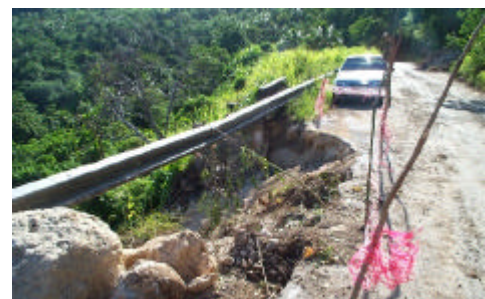
**Figure 20: Road embankment collapse, Klem's Hill**
