# Monitoring Traffic Safety

Longer and heavier vehicles

Datum	July 2011
Status	Final

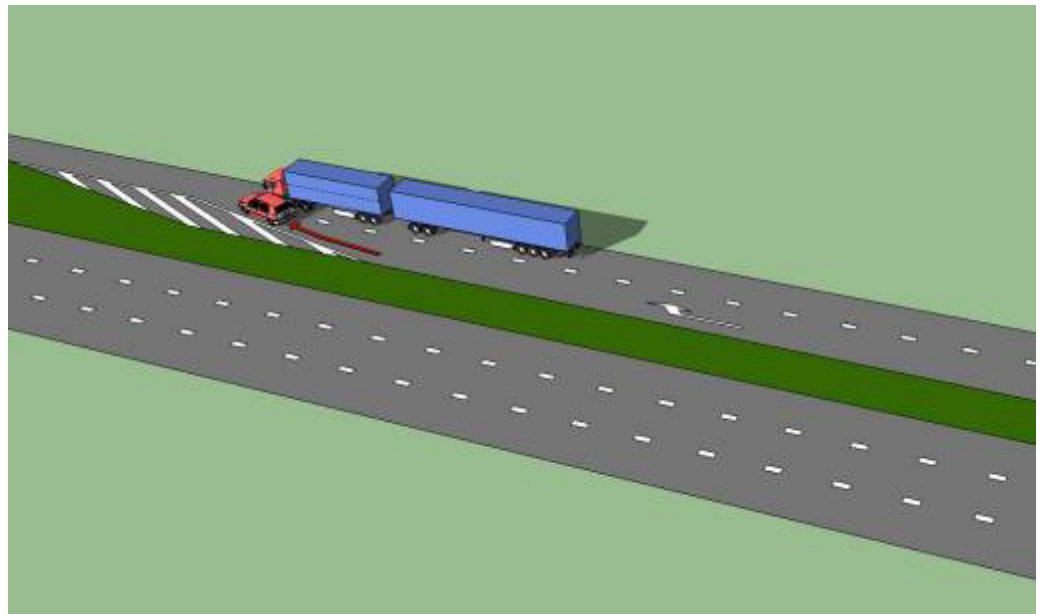
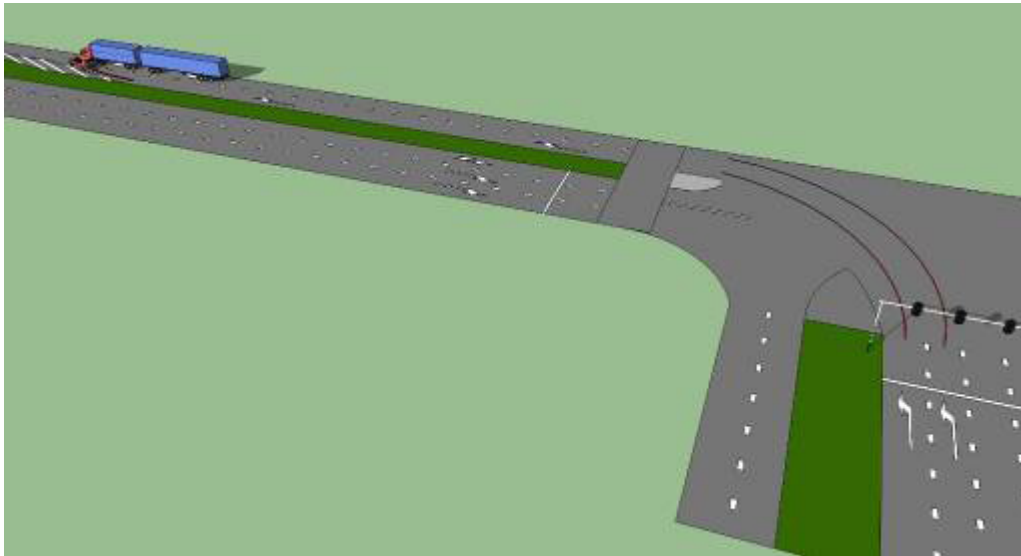
A passenger vehicle was driving in the outside lane with the intention to overtake the LHV driving in the inside lane. When the car changed lanes to merge across into the through lane in front of the LHV, the vehicles collided sideways, resulting in material damage only. The LHV was hit at the front left side. The passenger car failed to stop at the scene of the accident.

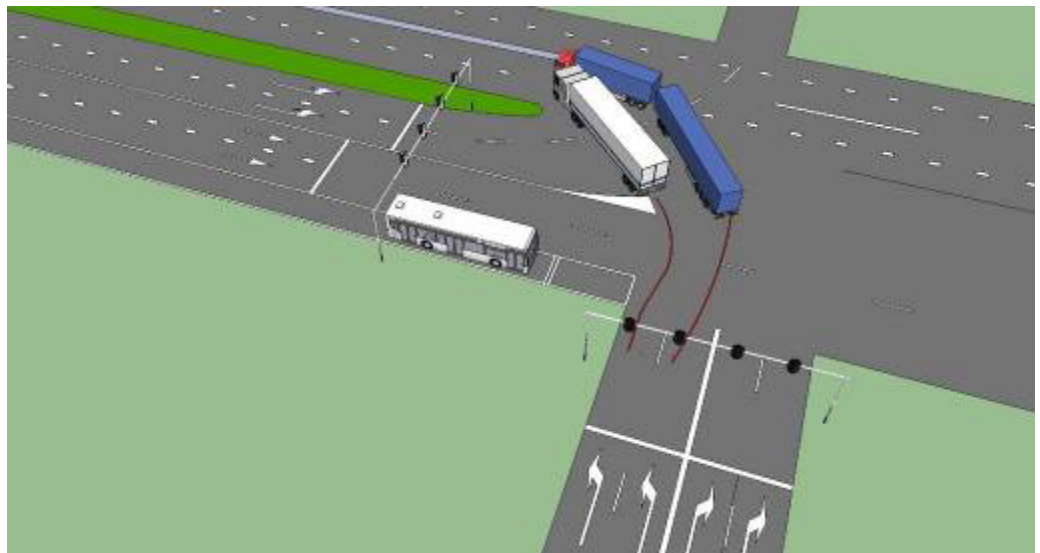
Adjacent to each other in the two left-turn lanes there was a regular truck on the outside lane and an LHV in the inside lane. As both approached the intersection, the regular truck negotiated the turn too widely, causing a side collision resulting in material damage only.

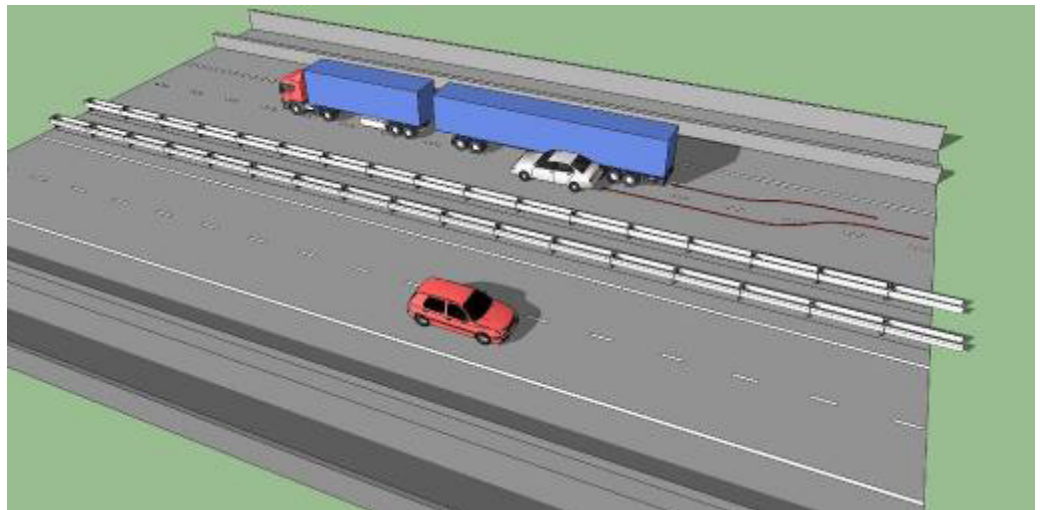
A passenger vehicle was in the process of overtaking an LHV combination when the LHV swerved. This led to a side collision resulting in material damage only.

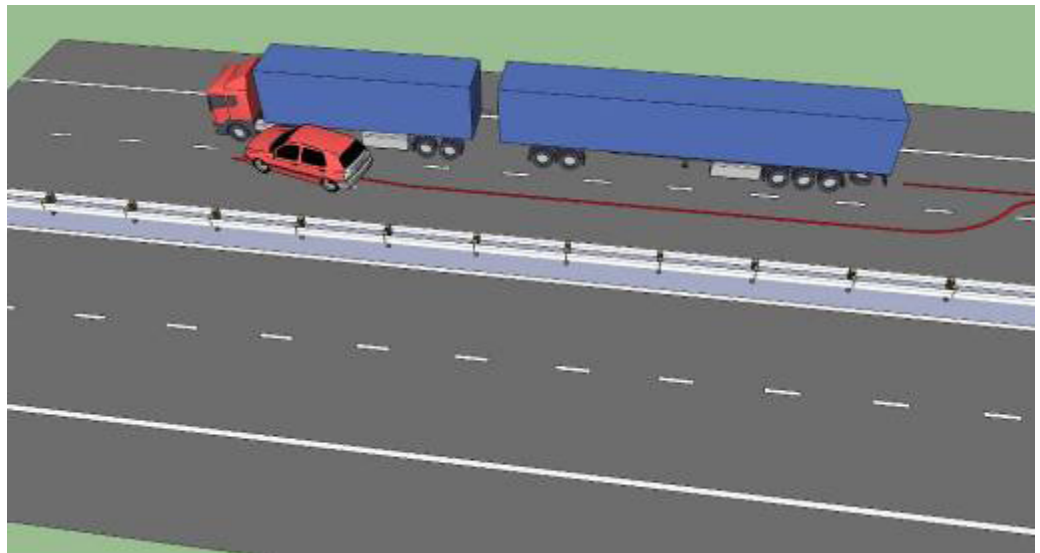
A passenger vehicle was in the process of overtaking the LHV, when the driver steered sideways too early, causing a side collision and resulting in material damage only. The LHV was hit on its left side. The driver of the passenger vehicle failed to stop at the scene of the accident.

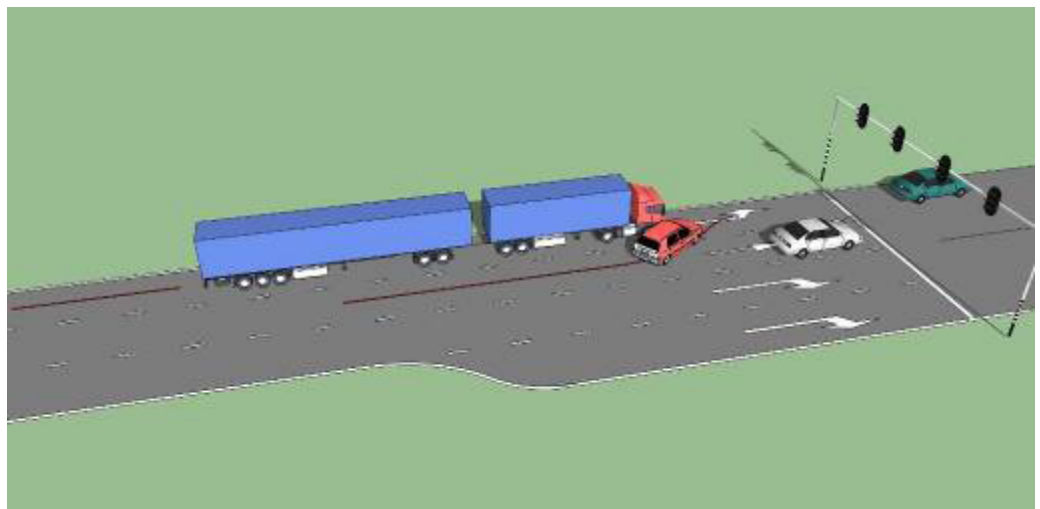
The LHV involved had pulled up in the lane designated for traffic turning left for the A10 northbound. The passenger vehicle involved had pulled up in the through lane. The traffic lights for both these lanes changed to green simultaneously. As traffic started moving, both the LHV and the passenger vehicle accelerated. At that point the driver of the passenger vehicle decided he wanted to turn left for the A10 northbound and changed lanes right in front of the LHV. The space to do so had become available as the car in front of the LHV had accelerated more swiftly than the LHV. Although the driver of the passenger vehicle presumed that the driver of the LHV had noticed him, he was in fact positioned in the LHV's blind spot. This led to a side collision resulting in material damage only.

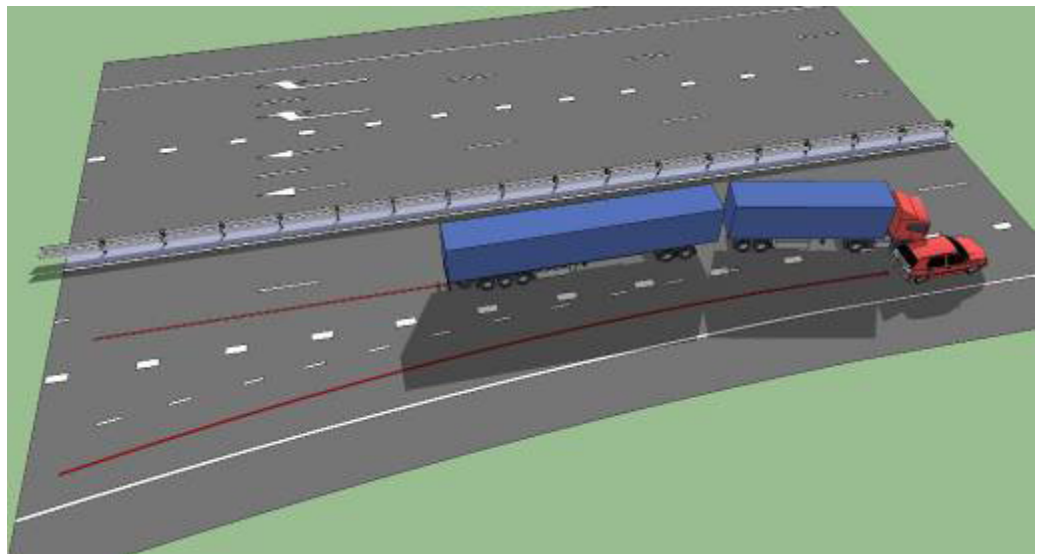
The passenger vehicle was coming from the A50 and driving on the inside lane. The LHV came from the A28 from the direction of Amersfoort and switched to the right lane to continue on the weaving lane towards the exit, Zwolle south. The LHV driver failed to see the passenger vehicle driving on his right because it was driving in the LHV's blind spot. This caused a collision with material damage only.

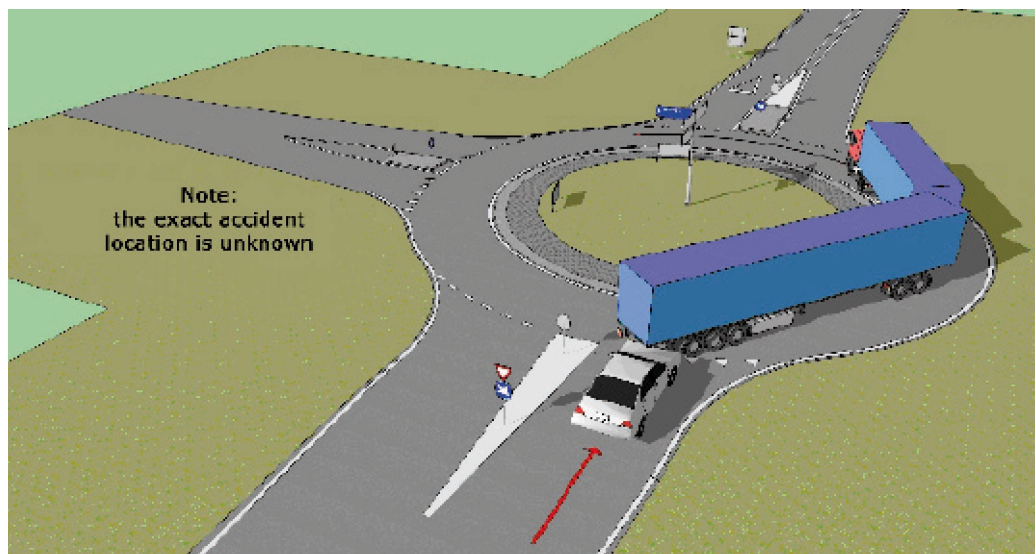
The LHV approached the roundabout and as it did, felt a knock. The driver declared to the police that he wasn't aware he had been hit, and had continued on his way. He later noticed damage to his trailer which had clearly been caused by another vehicle. According to the accident record, there was material damage only; the damage corresponded with a side collision with another – passenger – vehicle.

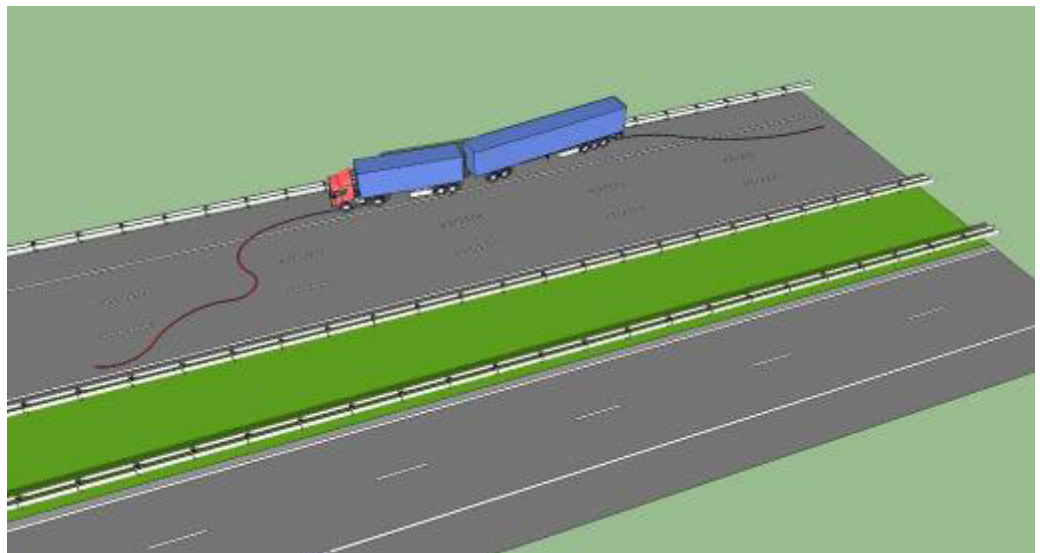
The driver of the LHV lost control of his vehicle. This led to the trailer hitting the guard rail, causing the LHV to skid and the trailer to overturn. This single-vehicle accident resulted in material damage only.

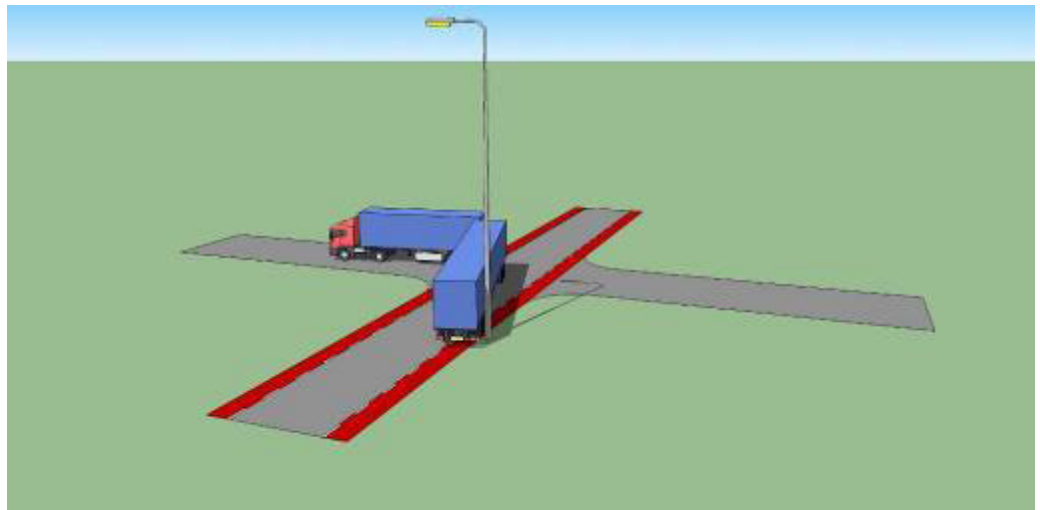
As the LHV made a left turn at the intersection, the far corner of its trailer swerved out into a lamp post. This collision resulted in material damage only.

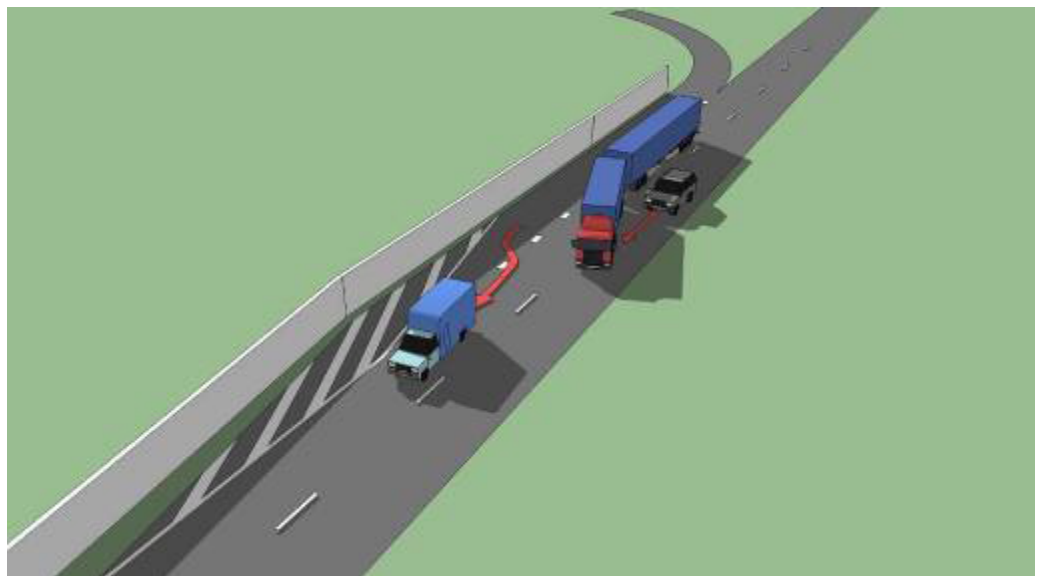
To give merging traffic sufficient space the LHV, which was travelling on the inside lane on the A17, changed to the outside lane. The driver of the LHV failed to notice a delivery van on the outside lane. This resulted in a side collision whereby the delivery van was badly damaged. The accident resulted in material damage only.

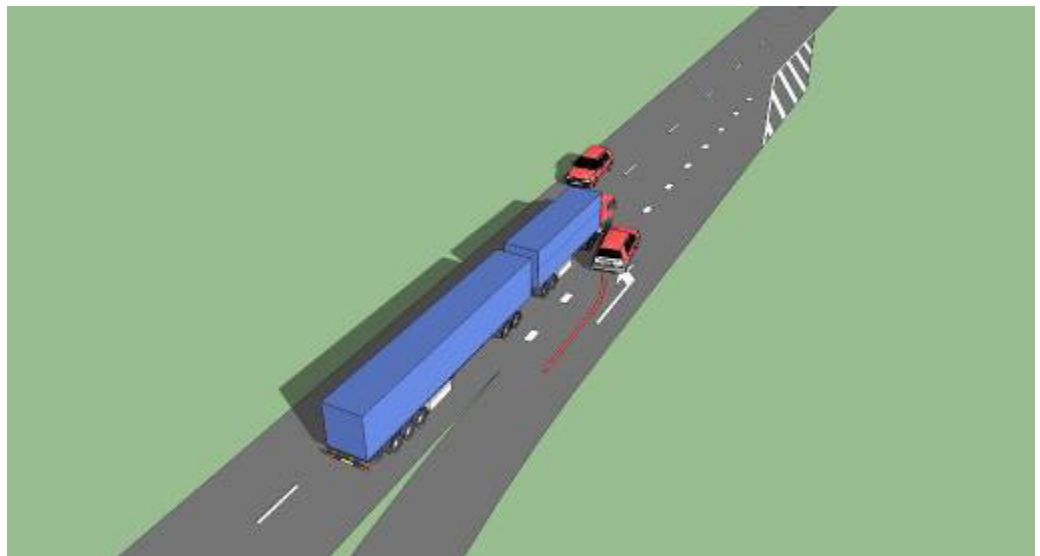
While merging on the N36, a passenger vehicle collides with the right side of an LHV. The accident resulted in material damage only. The accident report does not contain any further details on the circumstances.

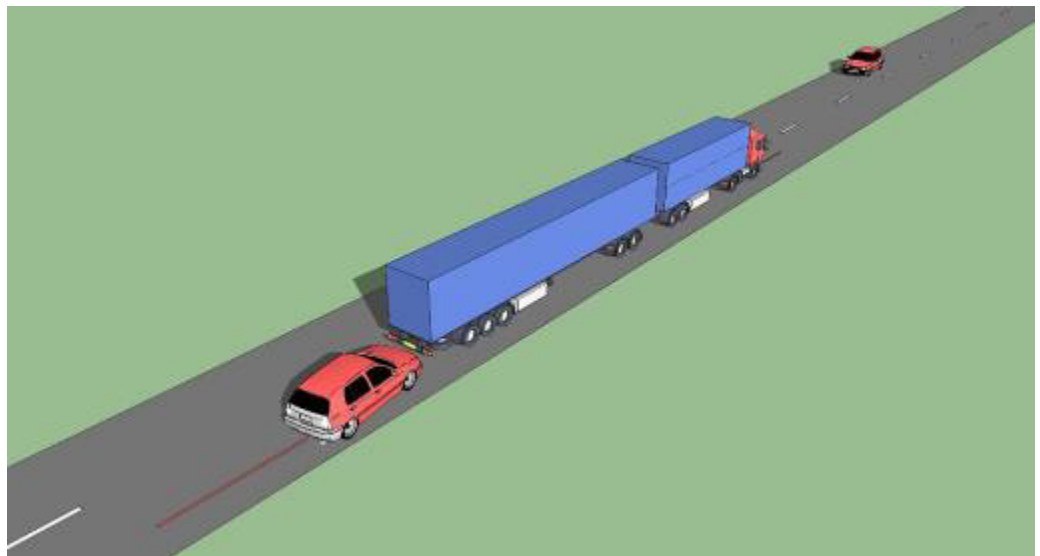
While the LHV was travelling on the N369, two children of eight and nine years of age threw chestnuts at the side of the cabin. This shocked the LHV driver and caused him to slam on the brakes, because of seeing children playing on the roadside. The passenger vehicle travelling behind the LHV subsequently collided with the LHV; this in spite of the fact that the passenger vehicle was travelling at a safe distance from the LHV. Both vehicles were driving around 70 kph, and there was no reason why the passenger vehicle would have expected the LHV to suddenly brake. After the collision the driver of the passenger vehicle suffered injuries to her neck and shoulder. After being checked by ambulance staff on site, she was allowed to go home.

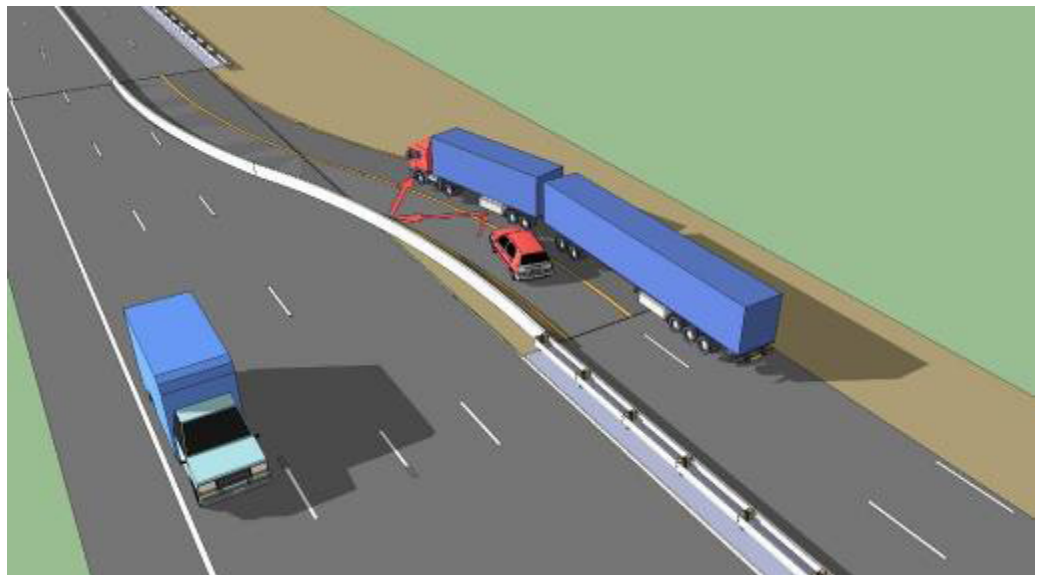
Comment: there were roadworks at the time of the accident. A top speed of 90 kph applied at the time. In view of the fact that this road section is normally a straight road, it is highly likely that the narrow lanes and curve in the road meant there was less room for both vehicles to make sideways movements. The accident resulted in material damage only.

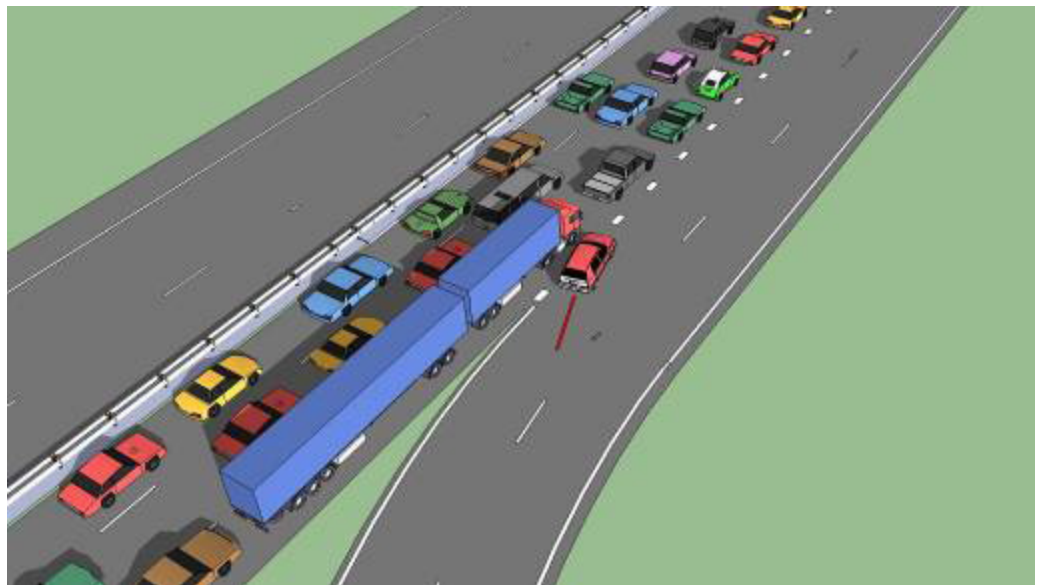
Upon merging onto the A15, a passenger vehicle from the A4 hit the front right side of the LHV, which was standing still on the A15. This caused a side collision with material damage only.

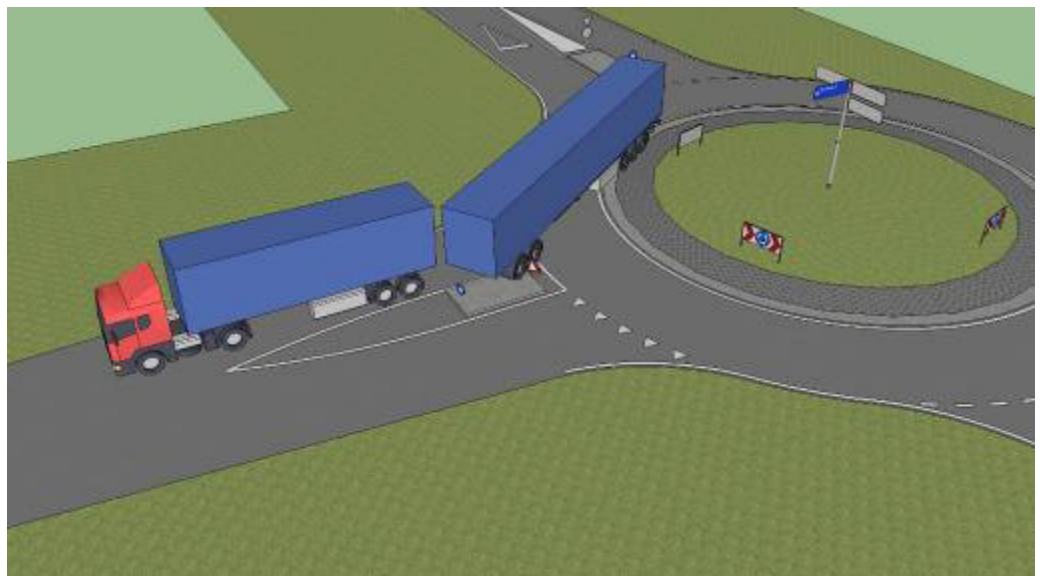
Upon negotiating three-quarters of the roundabout, the trailer separated from the rest of the combination upon exiting the roundabout. This caused the trailer to partially fall onto the road and onto the guide island on the roundabout. The trailer and the guide island with the traffic sign were damaged. No other vehicles were involved in this accident, which resulted in material damage only.

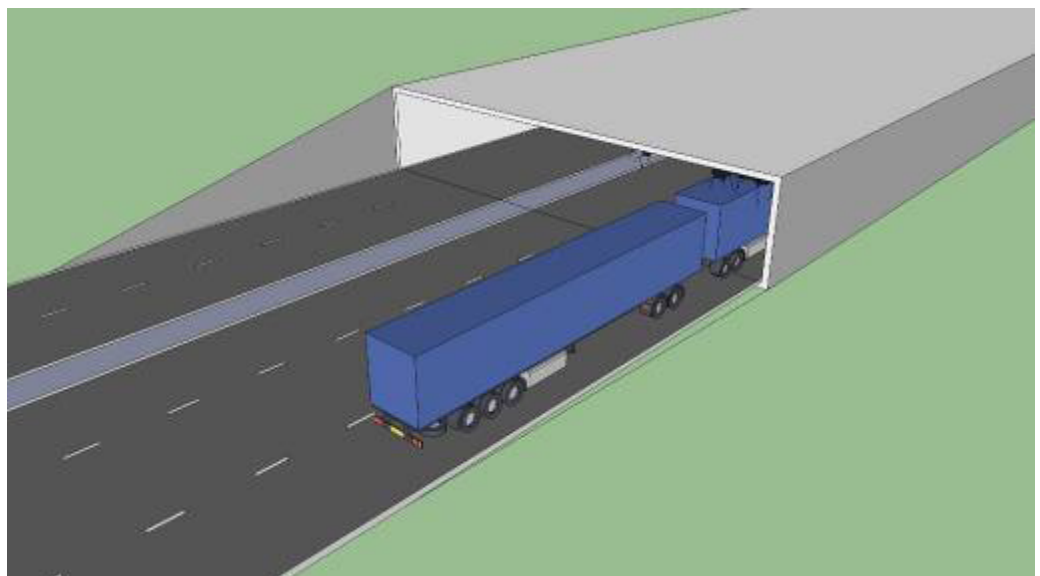
Upon entering the Thomassen tunnel, an exceptional transport vehicle, consisting of a trailer with a mobile caterpillar crane, crashed into the installations positioned on the tunnel's ceiling. The mobile caterpillar crane supposedly collided with the installations because a plate on top of the crane was not properly attached, causing it to stick upwards. The tunnel installations were separated from the ceiling and, 23 vehicles, among which the LHV, were subsequently damaged by the loose installations. This resulted in material damage only. The LHV was damaged on the front, right side and top.
