Bishops Wood Reconstructed Anglo-Saxon Hall: a Study in Destruction by Fire

By CHRISTINE ELGY and DEREK HURST

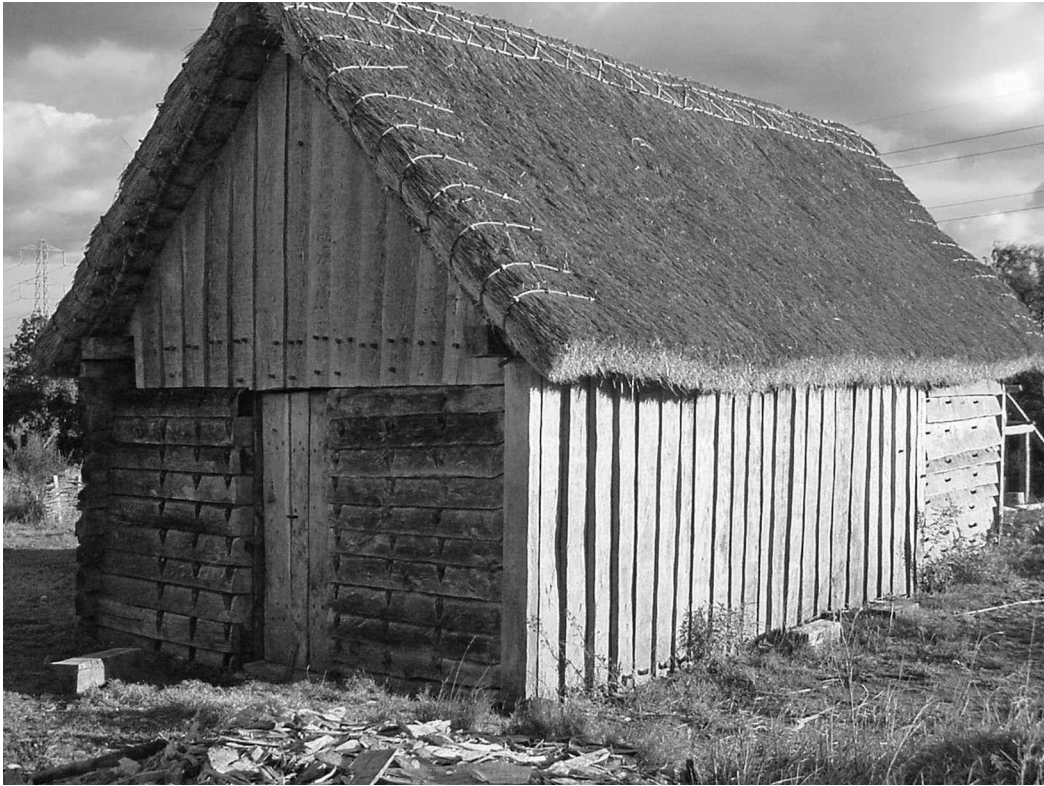
Fig. 1 Reconstructed Anglo-Saxon hall when first built; showing north end and west side (photograph by John Rhymer)

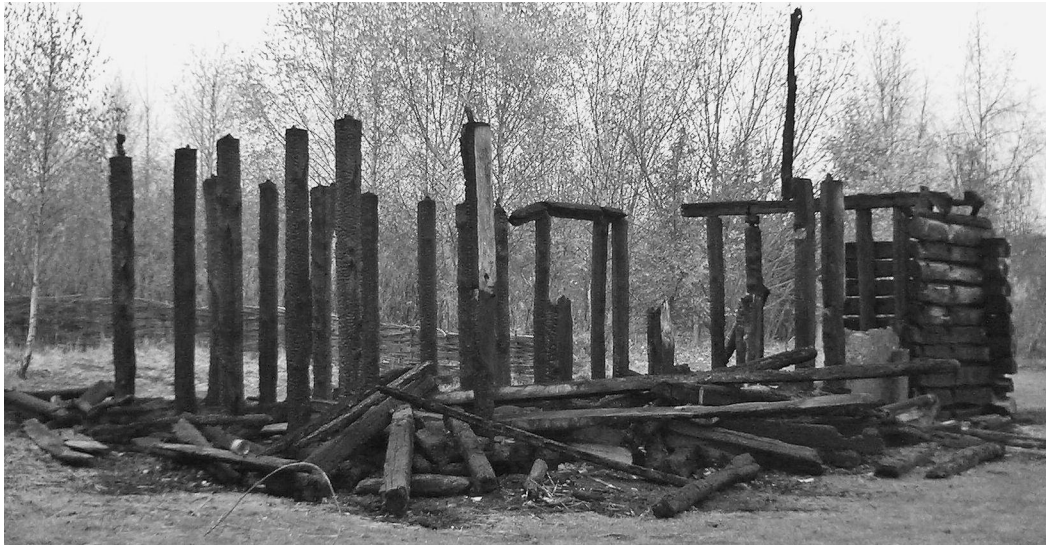
the fire some of the wall panels on the eastern side were pulled outwards and heaped up (Fig. 2 foreground left), and the wattle and daub panels were damaged by water. Some of the fallen timbers and floor planks were also removed from the structure to allow the cause of the fire to be investigated.

Fig. 2 Remains of the hall building after the 2008 fire; viewed from the south-east corner (photograph by Christine Elgy)

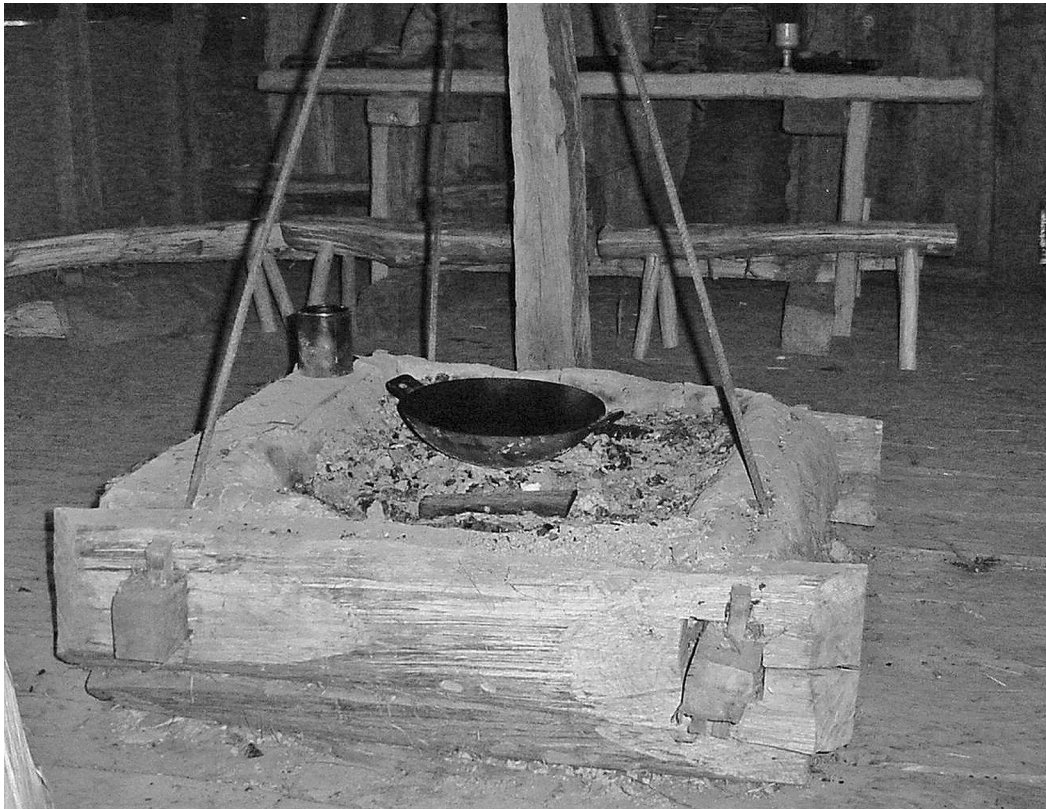
The cause of the fire was tracked down to the interior hearth, which was constructed as a thick clay lining in a wooden box set on the floorboards in the centre of the hall (Fig. 3), and, a crack having developed in the clay lining under the fire, this had allowed hot embers to fall through, so igniting the floor from underneath (Hereford and Worcester Fire and Rescue Service 2008). A rabbit burrow under the building had been a contributory factor, by providing ventilation to start the fire.

Fig. 3 Clay-lined fire-box (photograph by John Rhymer)

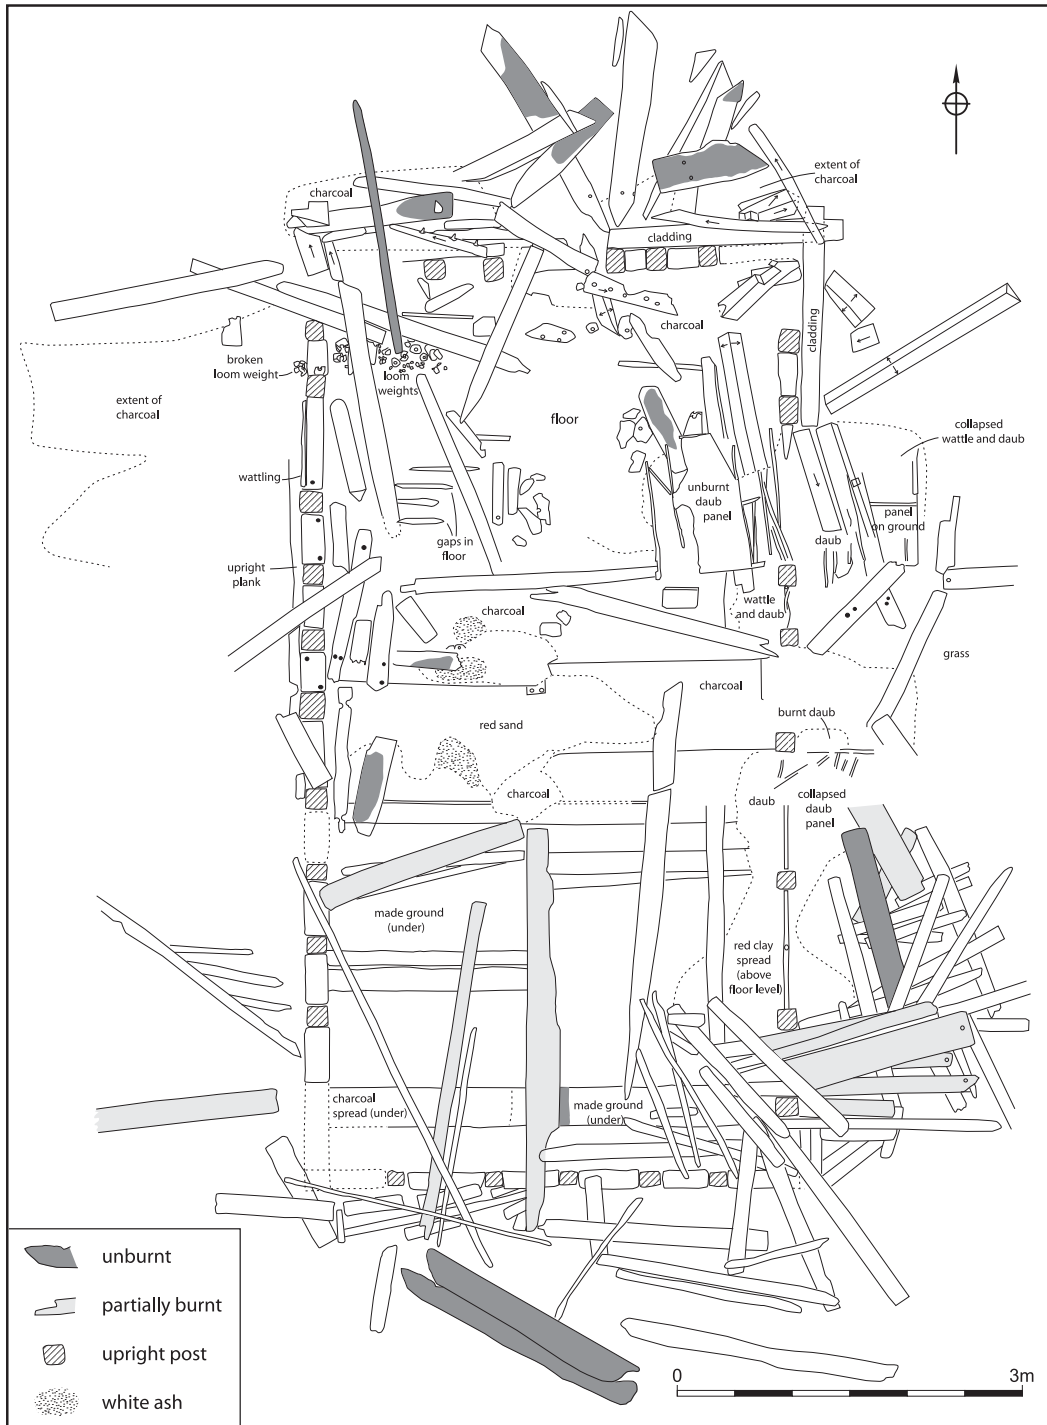
Various avenues of investigation were identified at the outset, but due to funding constraints some possibilities (eg excavation) could not be pursued. The immediate imperative was, however, the adequate recording of the ruined structure (Fig. 4), and its associated artefacts, and some scientific recording at the site was also undertaken (see below). For the longer term a continuing experiment was also set up recording changes over time, as the site decays.

Fig. 4 Plan of burnt remains of the building
