**ABERDEEN CITY COUNCIL SMR ENHANCEMENT
PERSLEY BRIDGE TO GRANDHOLM BRIDGE, SOUTH SIDE OF THE
RIVER DON**

**Alison Cameron
Cameron Archaeology
May 2014**

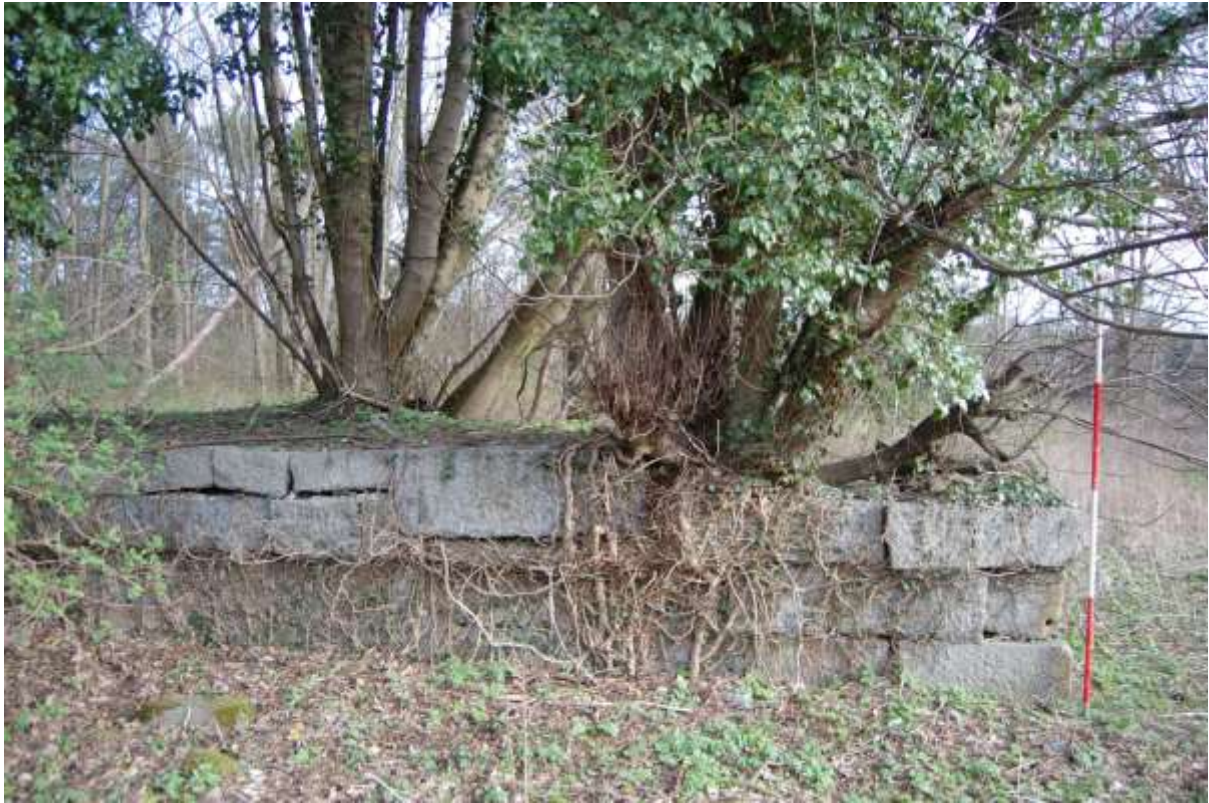
Illus 20 Facing of north wall of lade S6 at east end showing damage due to established trees; the line of the lade ran long the foreground of the photograph but has been completely infilled

The north face of the north wall of lade S6 (Illus 24, 25) had been rebuilt on several occasions. East of the steps the end had been replaced with shuttered and poured concrete. A repair to the west of the steps was of brick and the whole façade shows that it was originally buttressed or recessed and then infilled with stone infill (Illus 26). The wall was then coped with brick. This wall is being badly damaged by established trees which have been planted on to the top of this structure.

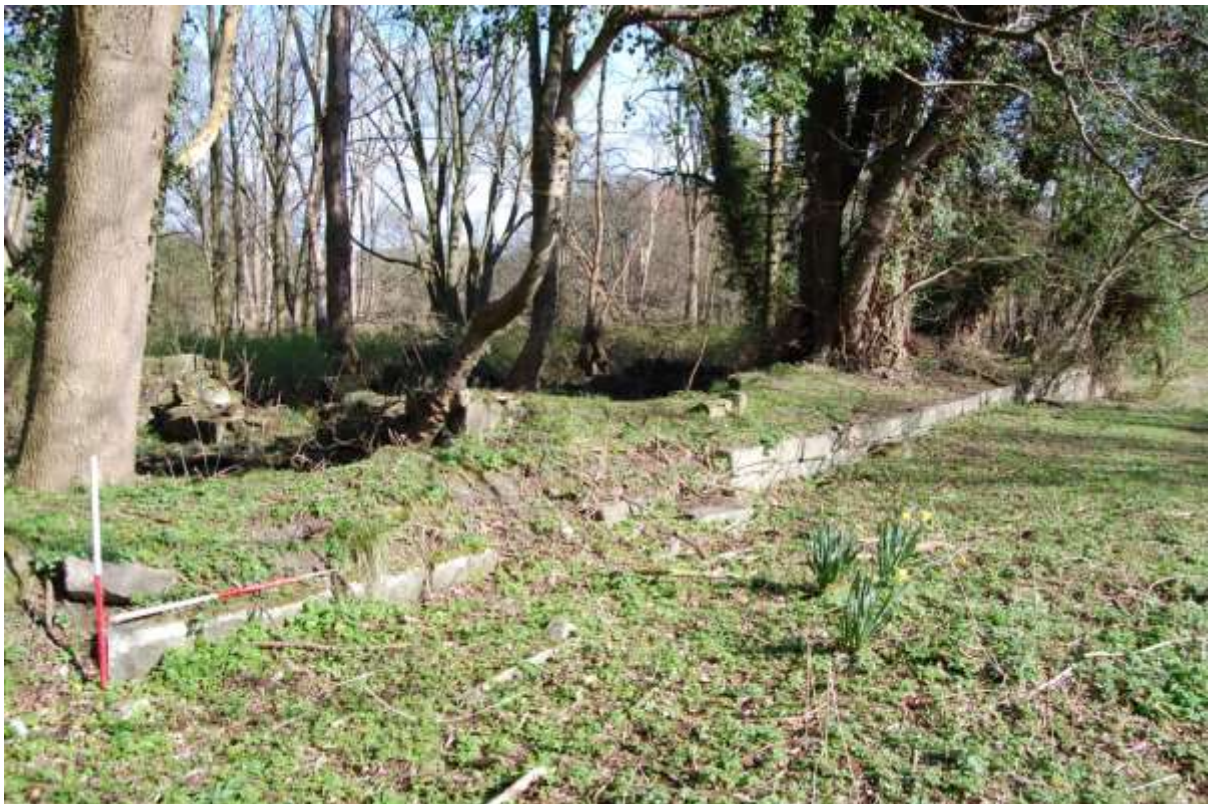
Illus 21 North wall of lade S6; the lade has been infilled (foreground)

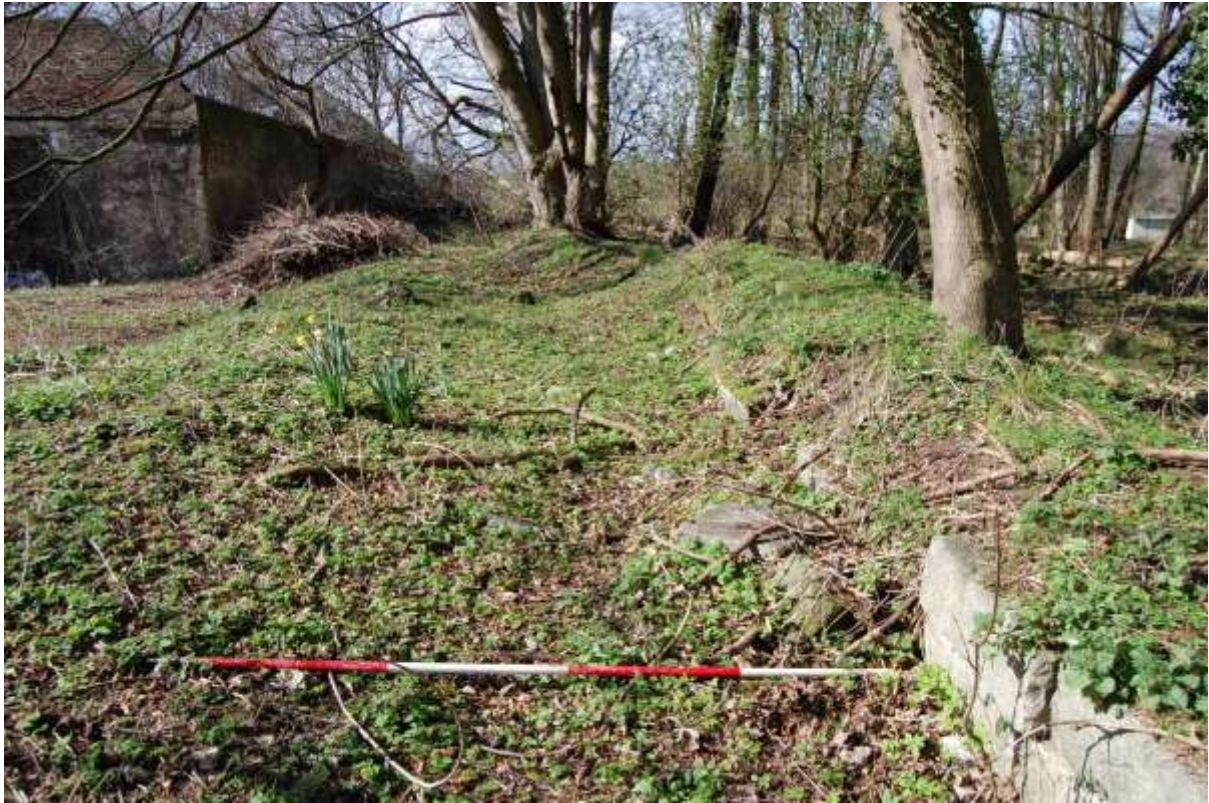
Illus 22 Lade S6 ashlar wall (right) with poorly built wall (centre right) and infilled lade (centre) building S3 (top left); facing W

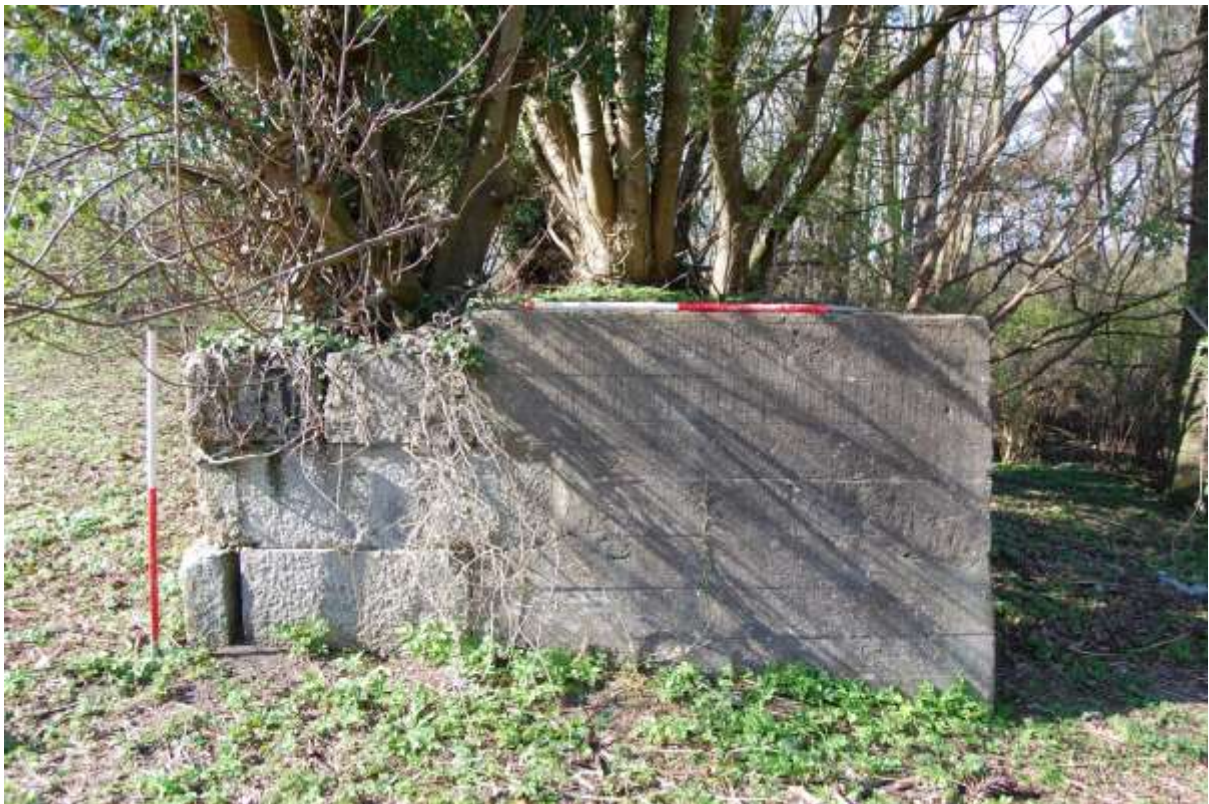
Illus 23 East end lade S6 wall showing stone structure (left) with poured concrete extension (right); facing W

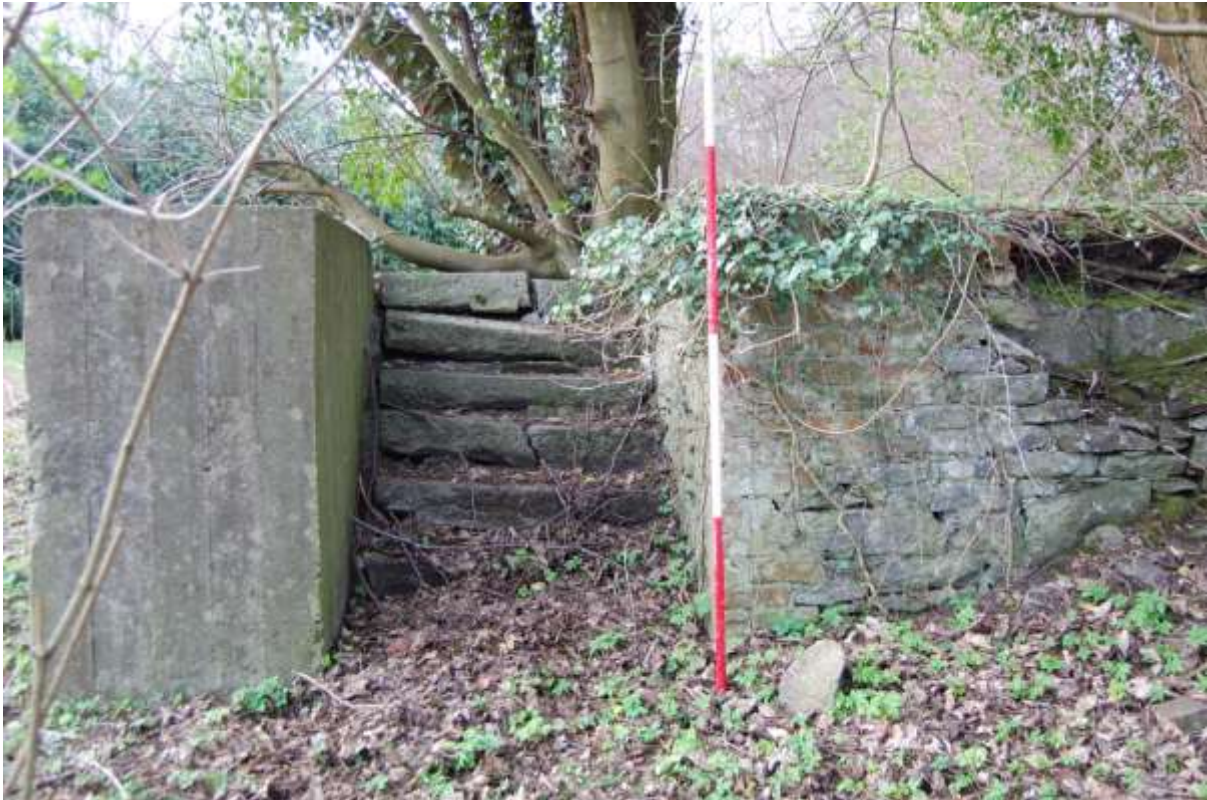
Illus 24 East end lade S6 wall showing stone steps and stone and brick structure (right) with poured concrete extension (left); facing W

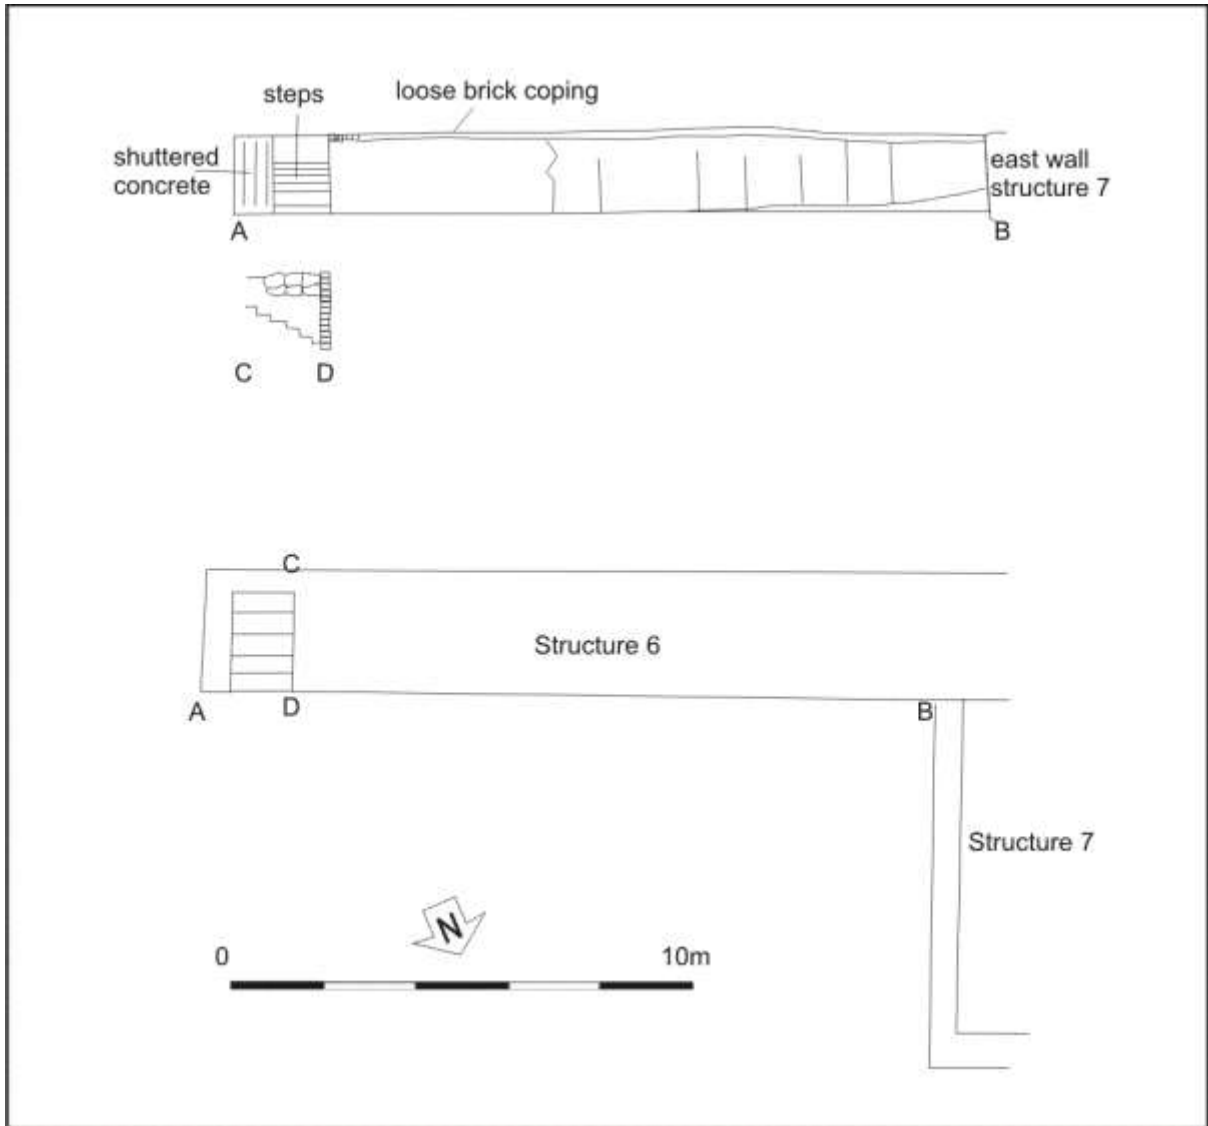
Illus 25 Plan of north wall of Structure 6 (bottom) and elevation of the north face of the structure showing evidence of rebuilding.

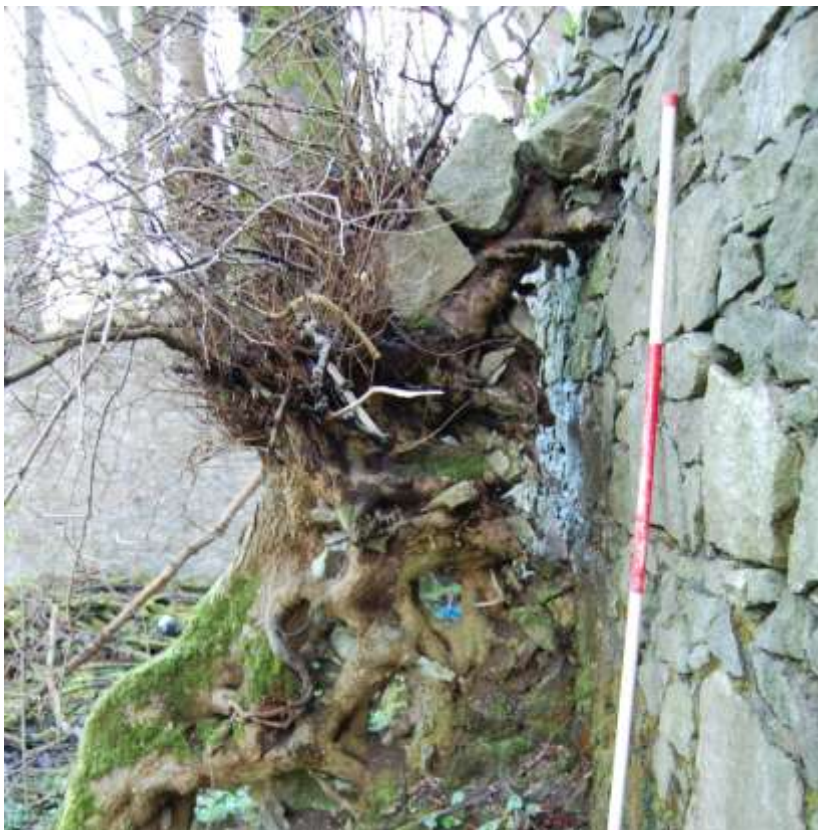
Illus 49 Buttress on the interior of the south wall of enclosure S11 showing damage from trees

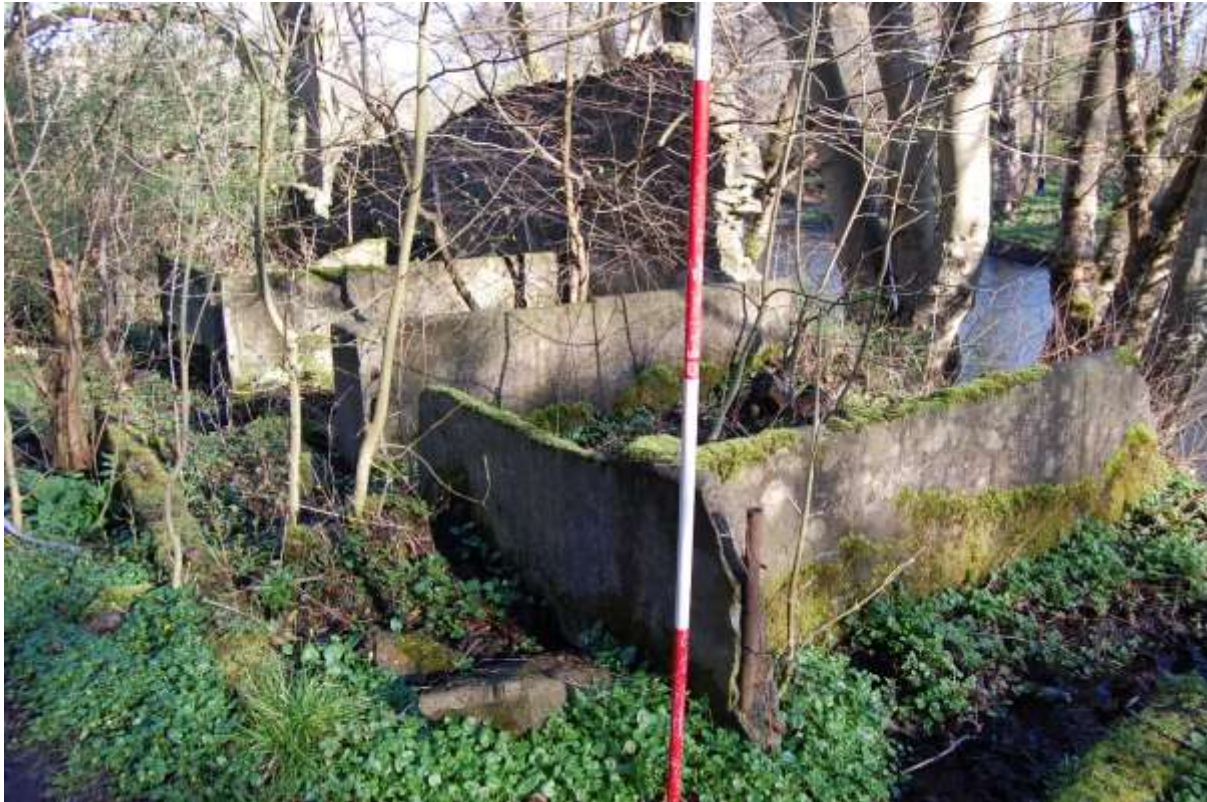
Structure 12 was a long narrow building c 20 x 4m in size. It has been modernised in the 20th century when the building was in use as a piggery (Illus 50). Concrete stalls have been inserted and the original walls of the building are mostly obscured.

Illus 50 Structure 12 showing concrete partitions in older granite building

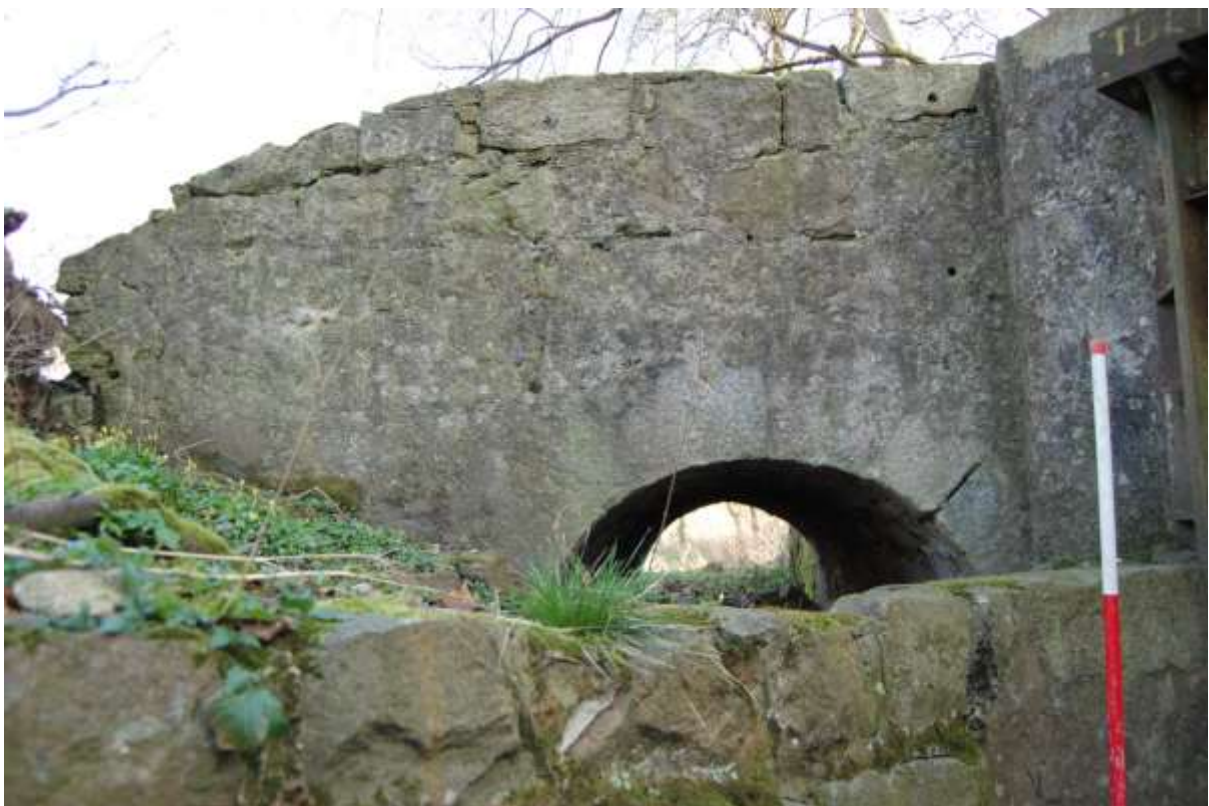
Illus 60 Earlier lade S15 blocked by north wall lade S6; facing ENE

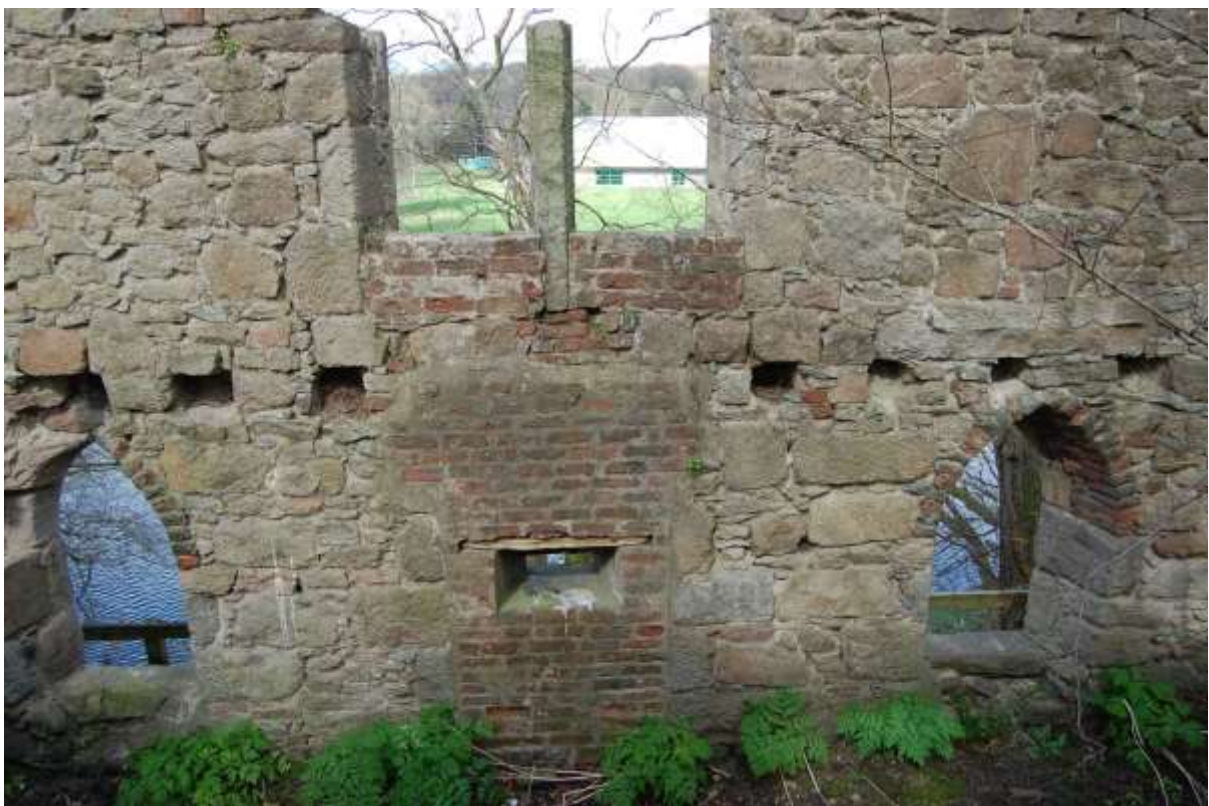
Illus 65 Structure 16 interior of north wall showing blocked window (above) and door (below) with loophole; facing N

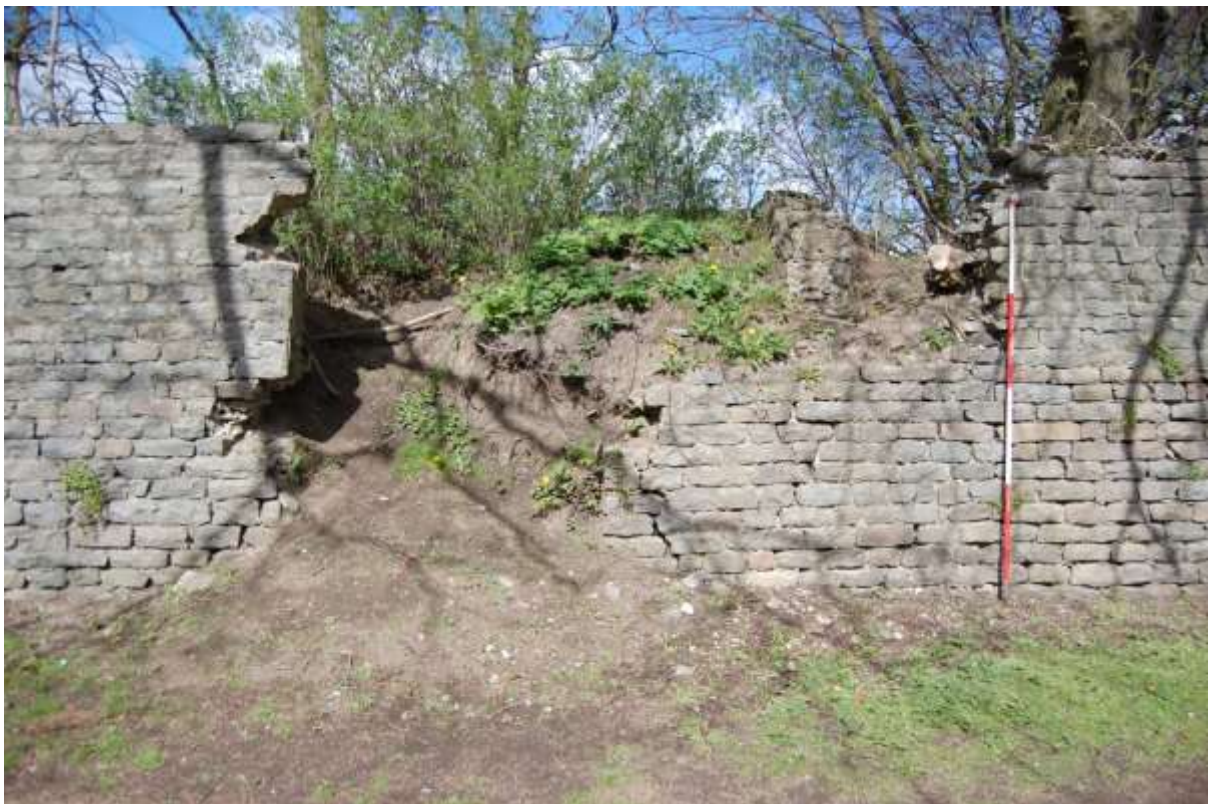
Illus 71 Wall S21 with wall of S17 (left of ranging rod) showing poor condition of walls and overgrown and infilled structure with remains of entrance (left of centre)

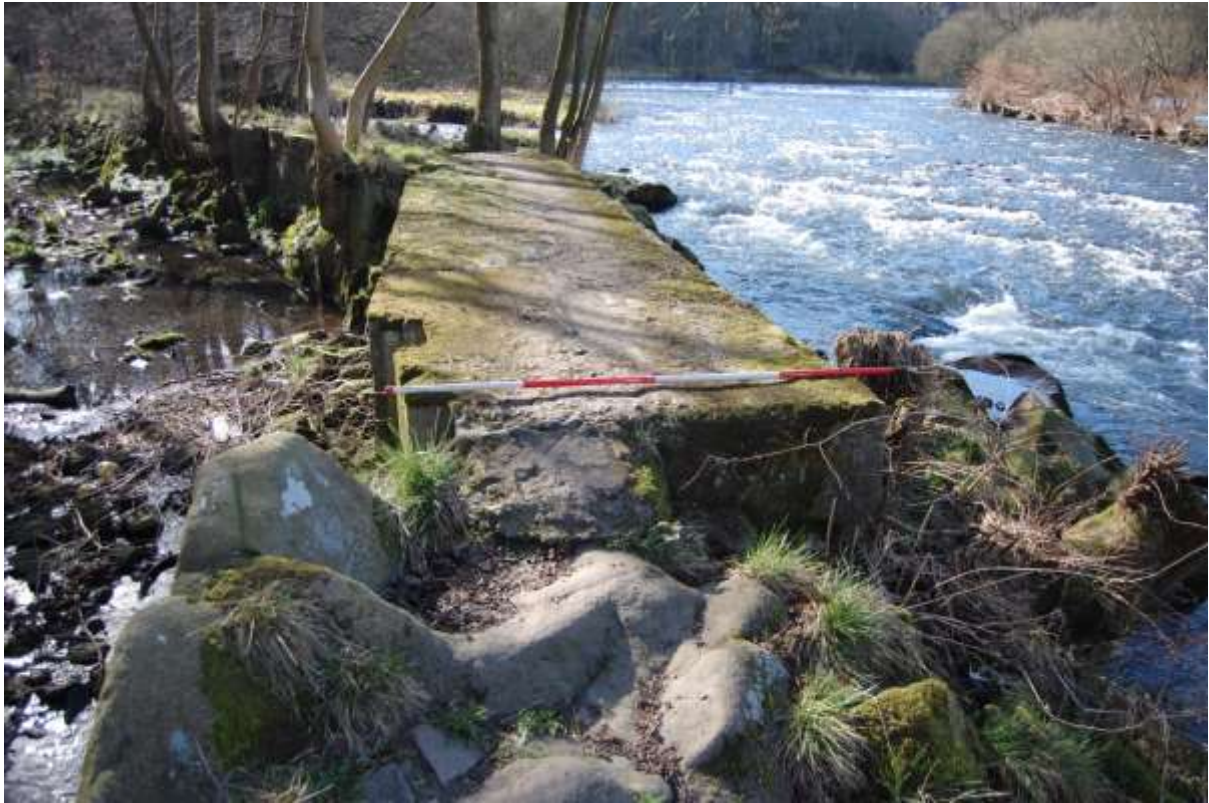
Access to this structure was limited by the proximity of the river Don to the west and the waterlogged lade S6 to the east.

Illus 85 Remains of sluice S26 with river Don (right) and lade S6 (left); facing S

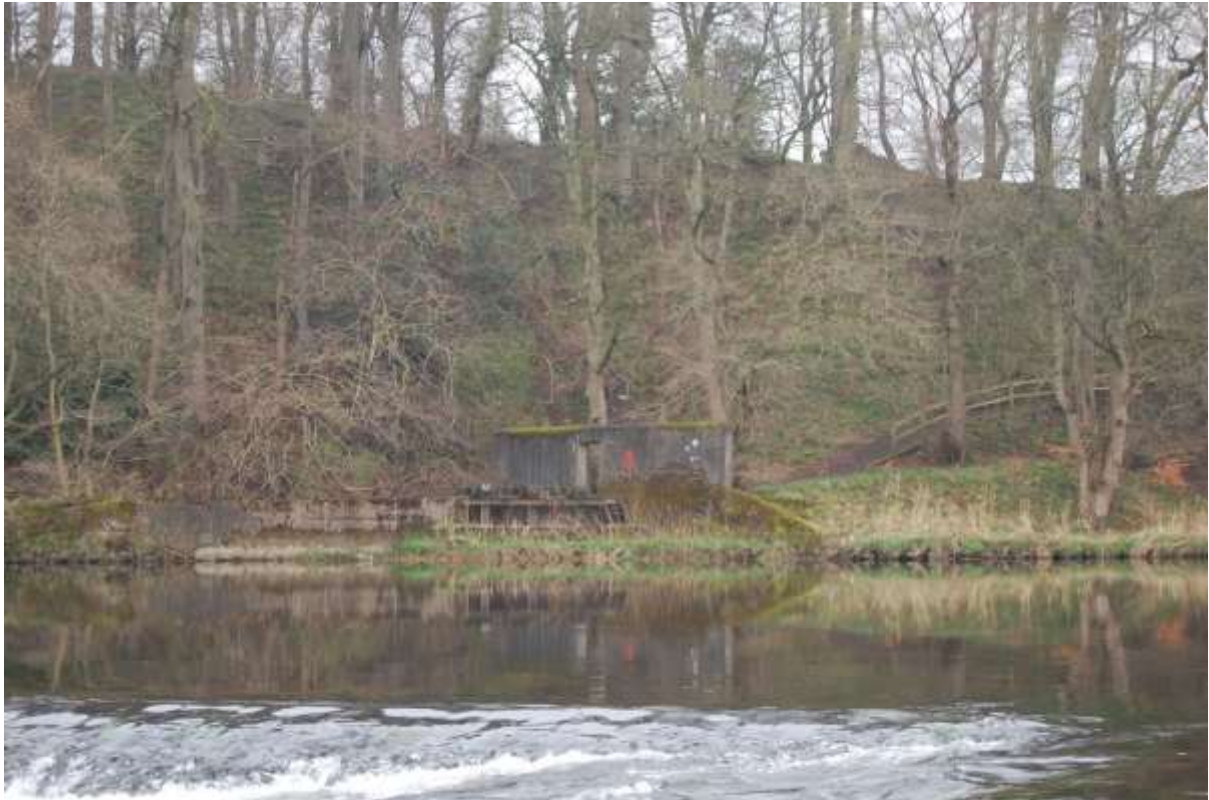
Access to this sluice is limited by its poor condition, overgrown nature and proximity of the river Don and it is not possible to access the lade at this location.

Illus 88 Sluice S27 from the north side of the river showing overgrown sluice mechanism and boundary wall; facing SE

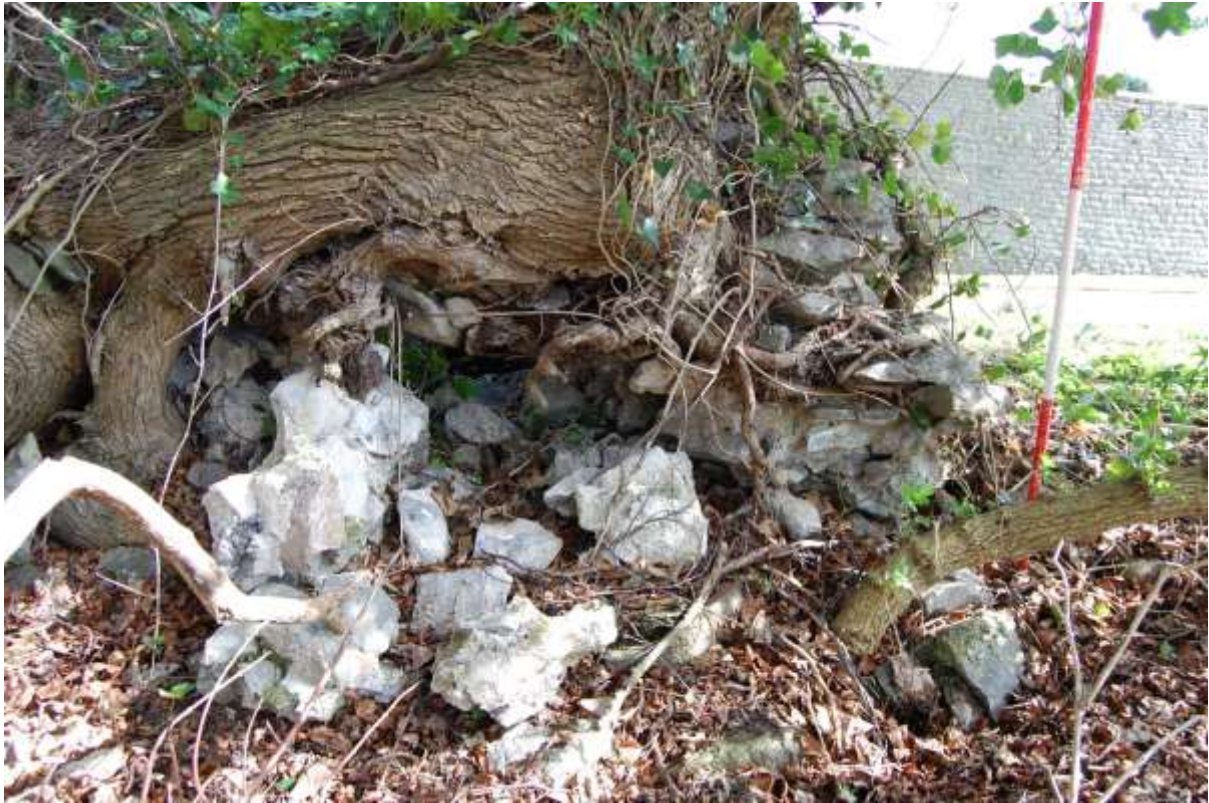
Illus 108 Rear (west side) of structure 37 showing damage due to tree virtually obscuring the feature

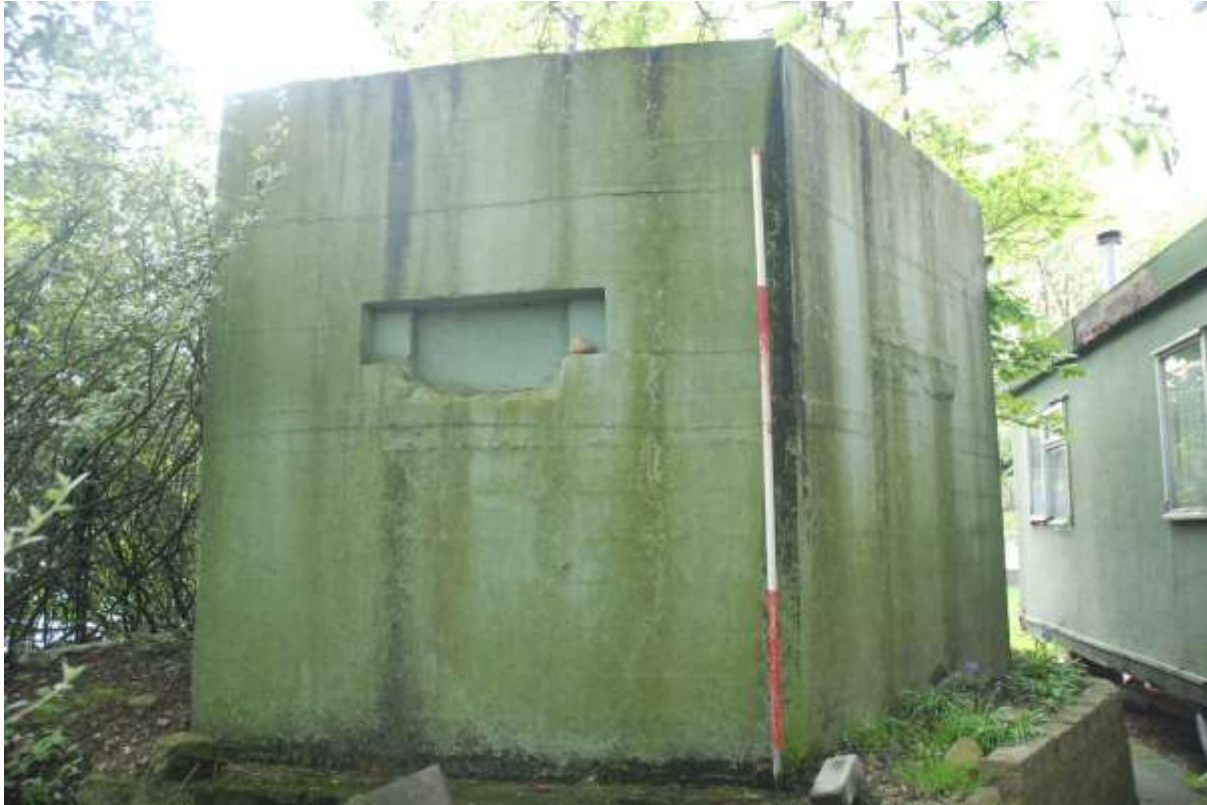
Illus 112 Pillbox Structure 41 north-facing elevation with blocked embrasure
