Developing a risk framework for assessing the impacts of climate change on cultural heritage

Helen Thomas

14.12.2022

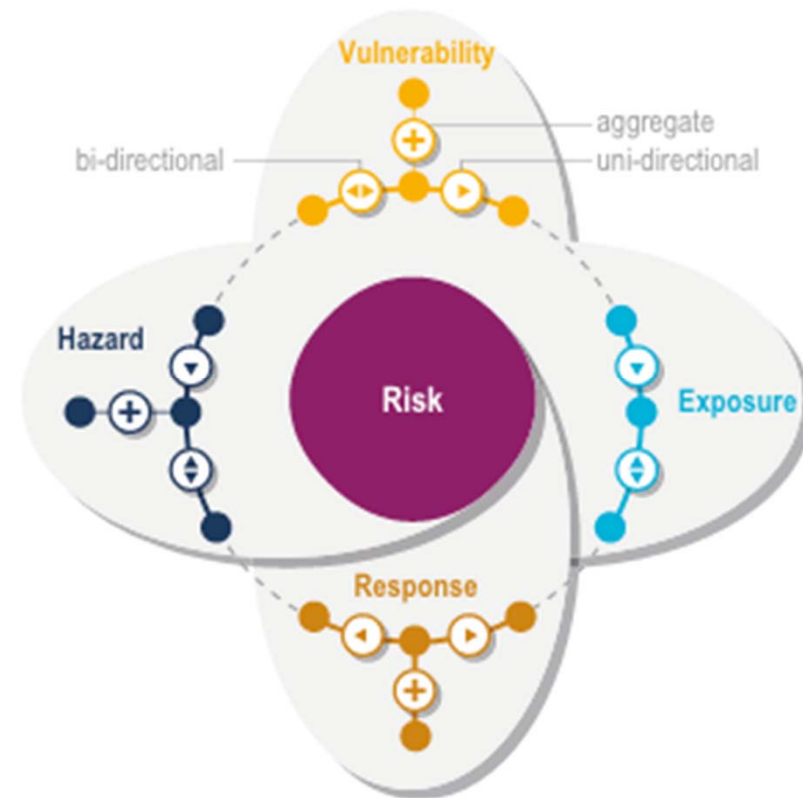
- This is the Intergovernmental Panel for Climate Change (IPCC)'s framework for risk which has 4 determinants
 - Hazard
 - Vulnerability
 - Exposure
 - *Response*

AR6 IPCC Risk Framework (Pörtner and Roberts 2022, 147)

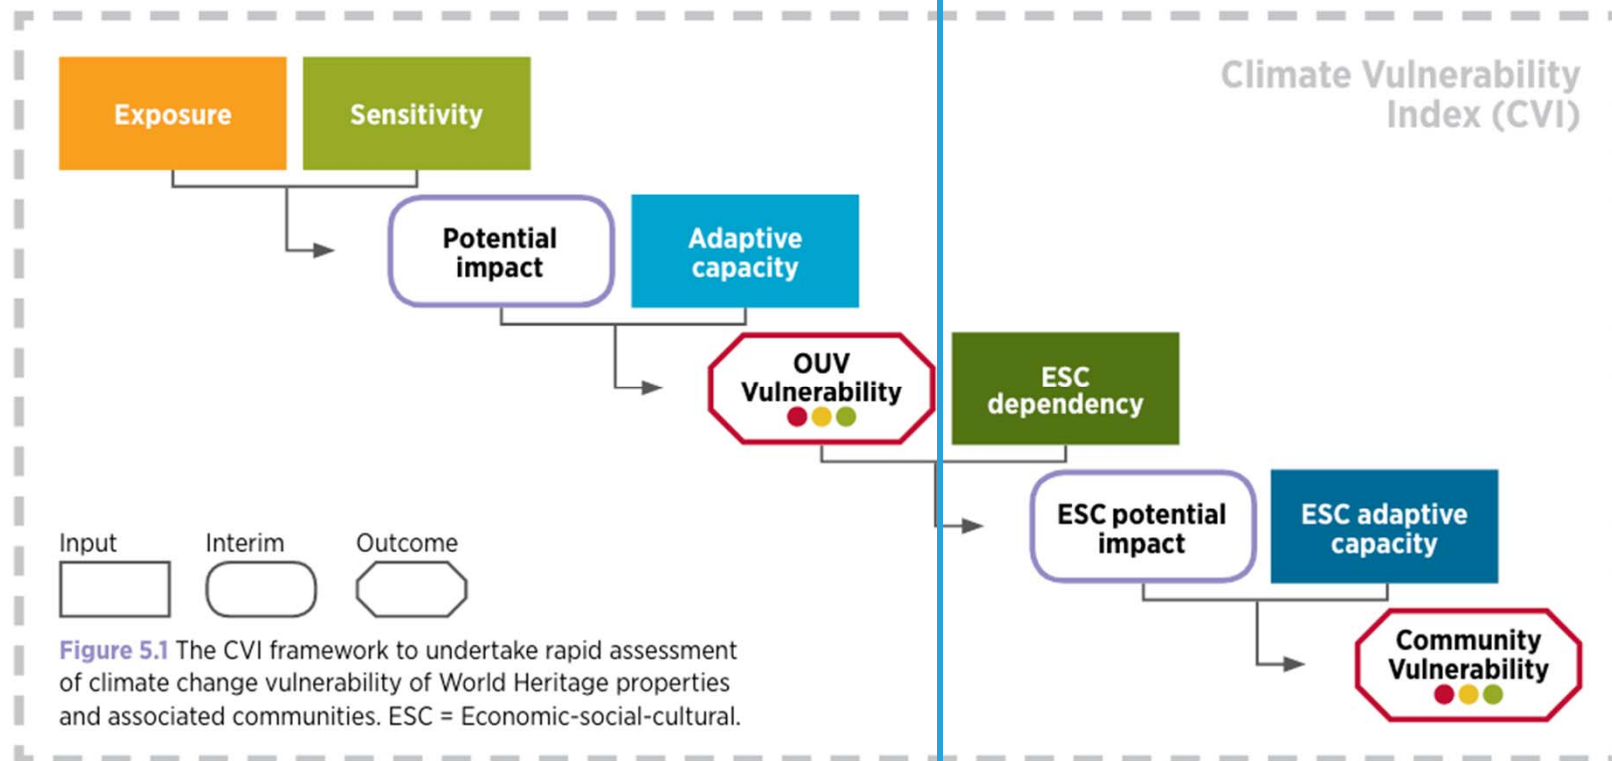
CVI Rapid Assessment

- OUV – Outstanding Universal Value
- ESC – Economic Social Cultural Dependencies

Key climate drivers	Sea Level Change	Precipitation Change	Storm Intensity and Frequency
Exposure	Very likely	Very likely	Possible
Temporal scale	On-going	On-going	Frequent
Trend	Moderate increase	Moderate increase	Slow increase
Exposure	Very likely ○○○○●	Very likely ○○○○●	Likely ○○○●○
Sensitivity	High-very high	High-Very high	High-Very high
Spatial scale	Extensive	Localised	Extensive
Compounding factors	Medium-High probability	High probability	Medium probability
Sensitivity	Very high ○○○○●	Very high ○○○○●	Very high ○○○○●
Potential Impact	Extreme ○○○●	Extreme ○○○●	Extreme ○○○●
Local management response	Moderate	Moderate	Moderate
Scientific/technical support	High	High	High
Effectiveness	Low	Medium	Low-Medium
Adaptive Capacity	Moderate ○●○	High ○○●	Moderate ○●○
OUV Vulnerability	High ○○●	Moderate ○●○	High ○○●
Combined OUV Vulnerability	High ○○●

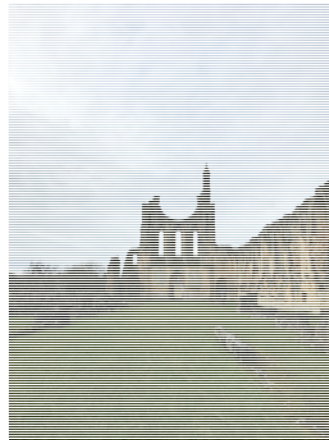
Abbey church and monastic buildings. **Now ruinous**. Late C12, early C13 and C15. **Limestone ashlar and rubble**. Substantial remains of church including west front standing almost to full height. Ruins of monastic buildings standing to height of approximately 5 metres in places

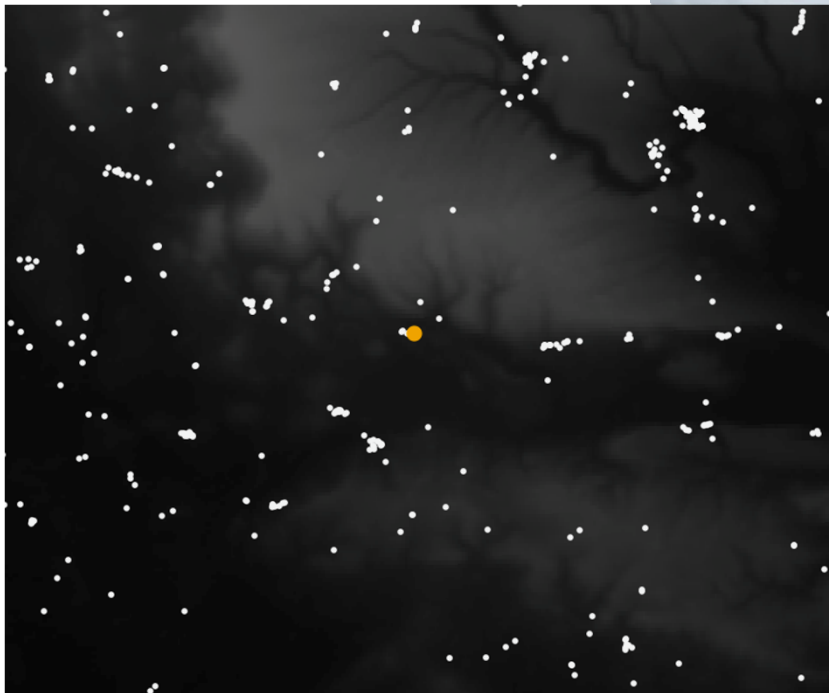
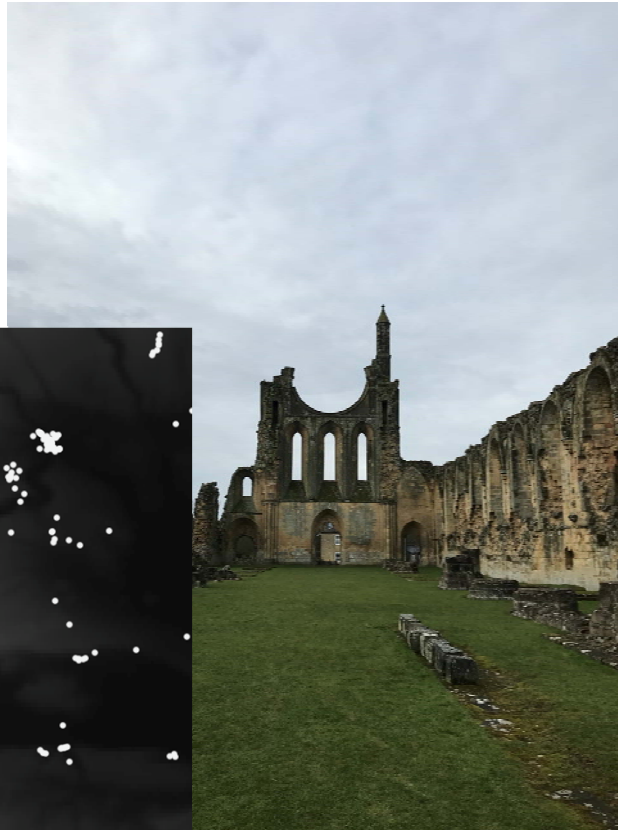
- GIS

“Substantial remains of church including west front standing almost to full height. Ruins of monastic buildings standing to height of approximately 5 metres in places”
