Preliminary Report

**Earthquake and Tsunami Damage Assessment in Port Vila**

January 2002

**SOPAC**

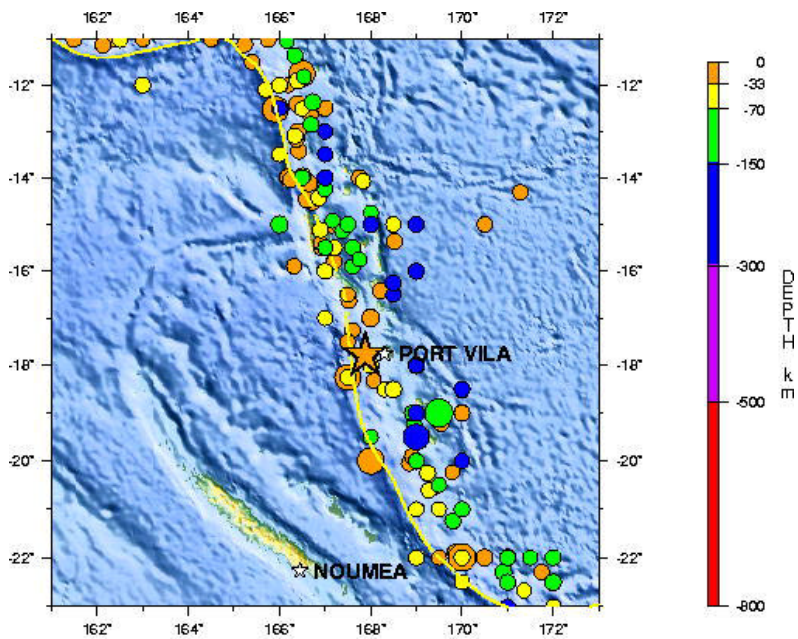
**Figure 1: Historical seismicity of Vanuatu; mag. 7 and larger since 1900**

On Thursday 3<sup>rd</sup> January 2002, a magnitude Mw 7.1 earthquake, the largest recorded so far in the vicinity, struck Port Vila (Figure 1). Although a significant event, it was by no means the largest possible in this setting. Estimates of maximum possible seismicity sit around magnitude 7.8

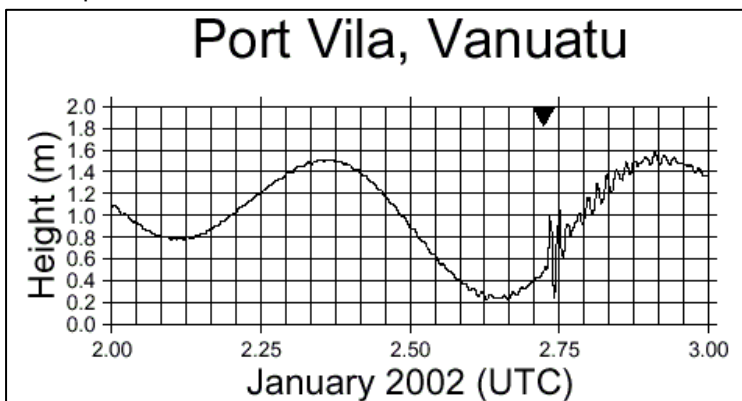
**Figure 2: NTF tide gauge record of the tsunami in Port Vila Harbour**

The shock occurred at 04:22 am local time (UTC 2002/01/02 17:22:50), only 50 km to the west of Port Vila and at the shallow depth of 21 km below the sea floor. Fifteen minutes after the main shock, a tsunami (Figure 2) struck Port Vila Harbour. The event was followed that same night by another large aftershock of magnitude Mw 6.4 which also produced a tsunami, though much smaller.

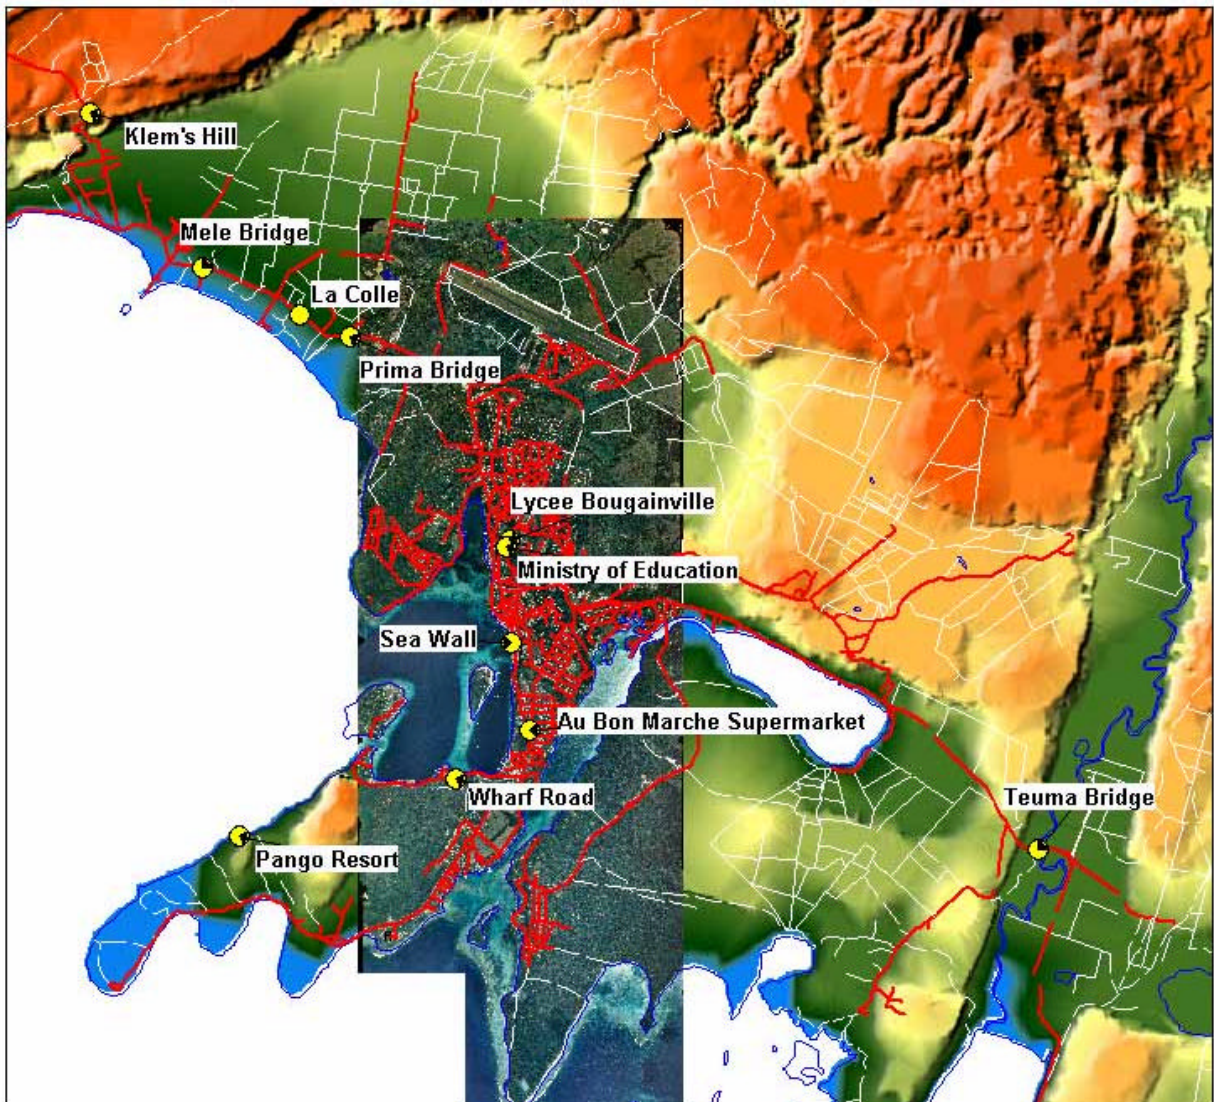
Figure 3: Locality map of Port Vila area showing areas of major damage

Damage to the city and to southeast Efate in general was surprisingly light, although several bridges were destroyed and much cracking in concrete structures and superficial damage was recorded (Figure 3). The tsunami that struck Port Vila Harbour some 15 minutes after the first shock, was fortunately small enough, given the low tide at the time, not to cause any significant flooding above Highest Astronomical Tide level.

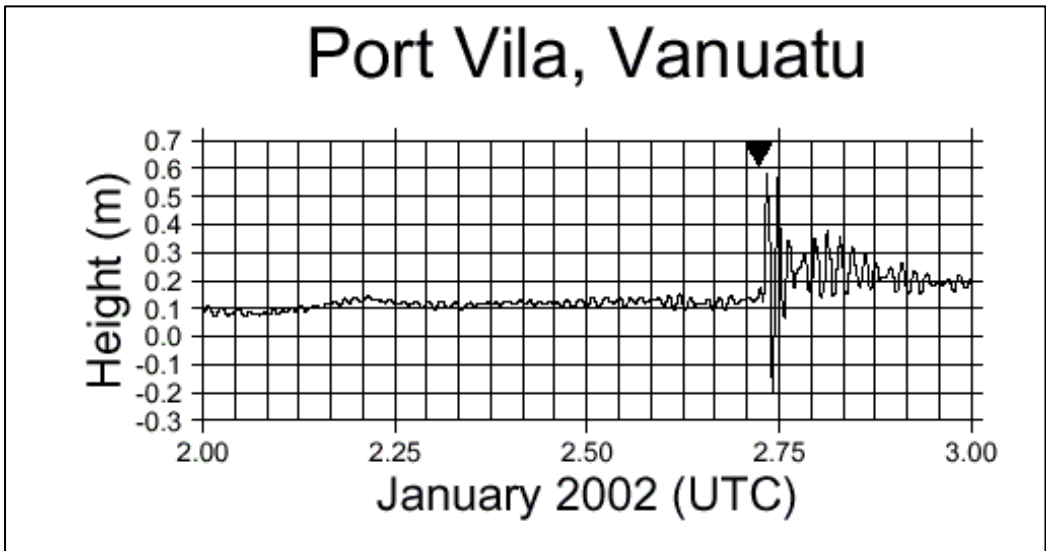
Figure 21: Tsunami record, Port Vila Wharf – differences between observed and predicted sea level

A tsunami generated with the earthquake struck Port Vila Harbour some 15 minutes later according to records of the National Tidal Facility supplied by Bill Mitchell through the Acting Director of the Vanuatu Meteorological Office.

Although the tsunami only registered on the tide gauge as having a crest to trough amplitude of 0.8 m (Figure 21), eyewitness accounts in different parts of the harbour put the maximum effect at around 3.0 m (Figure 22), several times that of the recorded height, making it large

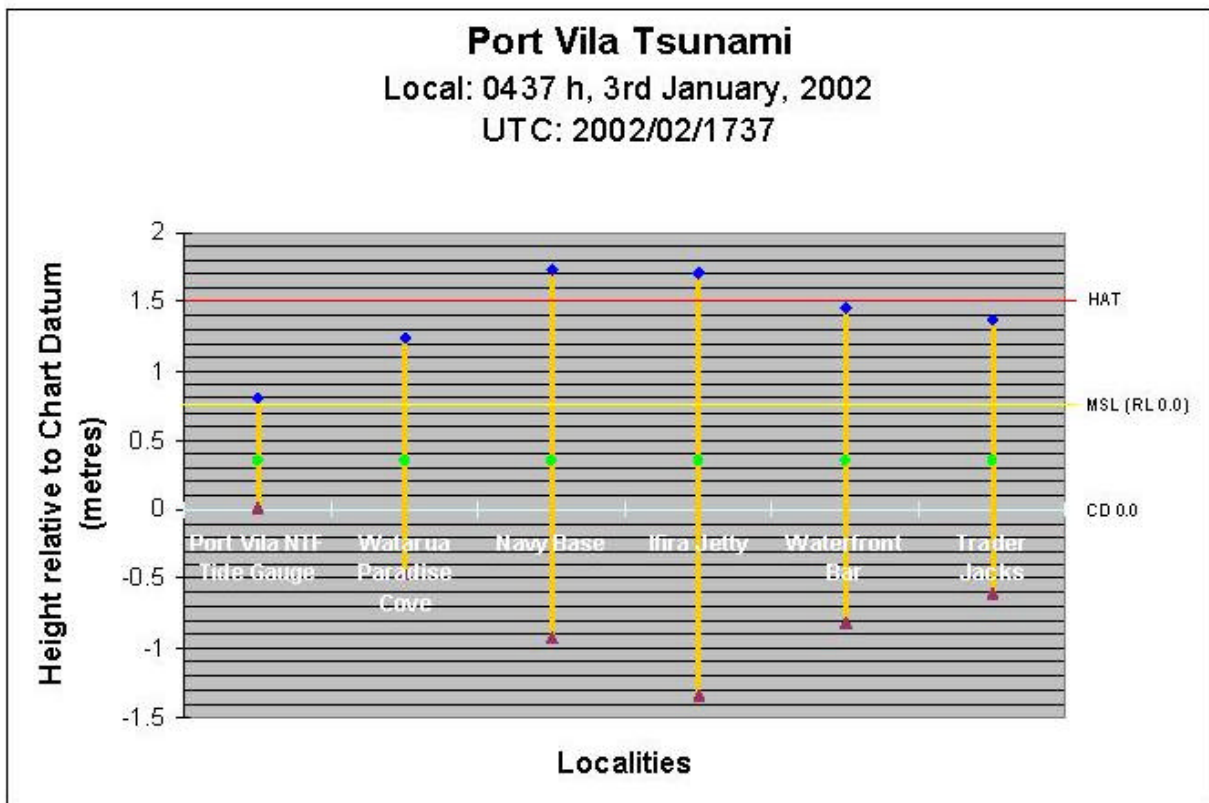
Figure 22: Eyewitness account of the tsunami effects around Port Vila Harbour

enough to cause significant damage.

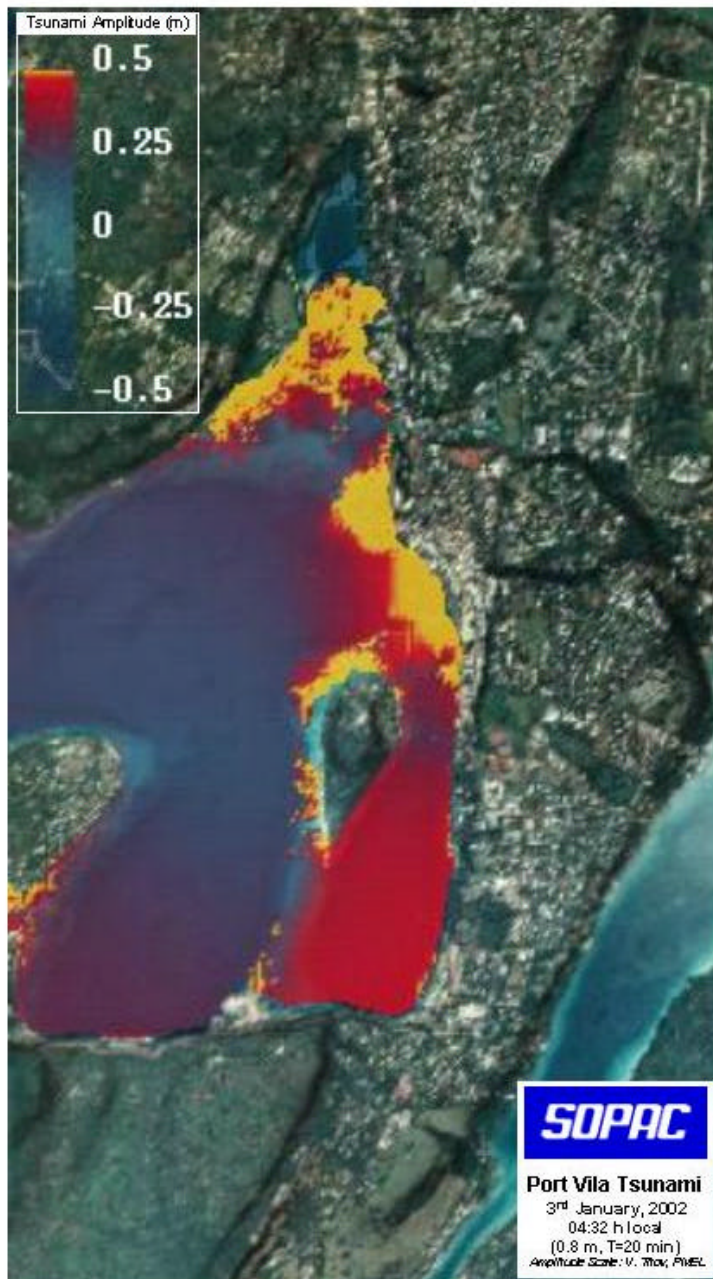
**Figure 23: Model of tsunami heights in Port Vila Harbour based on tide gauge record**

Predictive tsunami modelling carried out by Vasily Titov and the Pacific Disaster Center, Hawaii as part of the Port Vila Pacific Cities project prior to the actual event, confirms that such amplifications are likely due to resonance and interference effects within the harbour (Figure 23). A video-animation of the simulated tsunami in Port Vila harbour, based on the scenario of a larger, M 8.2 earthquake occurring in a similar location, is available from SOPAC.

Fortunately the tsunami occurred at a time close to one of the very lowest tides of the year (predicted CD+0.15 m), when the tide was close to Chart Datum. If the earthquake had occurred four hours later

at high tide (CD+1.35 m), flooding would have reached up to 1 metre over the top of the sea wall in the CBD area. A much smaller tsunami occurred following the major aftershock that night, but passed unnoticed.
