**ABERDEEN CITY COUNCIL SMR ENHANCEMENT
PERSLEY BRIDGE TO GRANDHOLM BRIDGE, SOUTH SIDE OF THE
RIVER DON**

**Alison Cameron
Cameron Archaeology
May 2014**

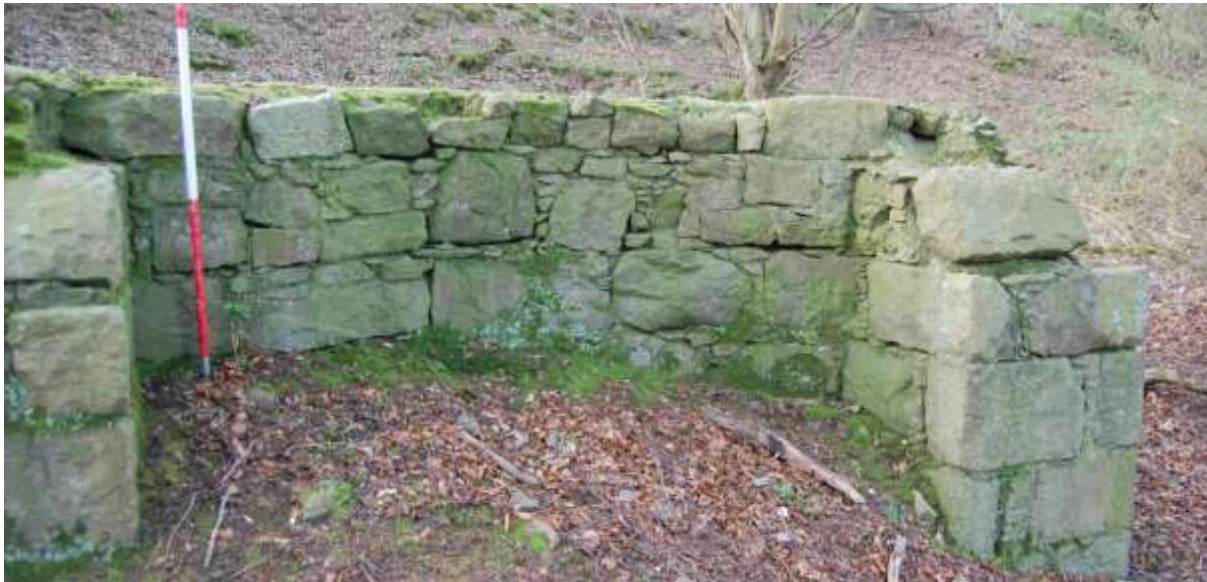
Structure 1 is the remains of a water tank. It is 20.6m long (W-E) and the north wall survives with the remainder of the structure as an earthwork (Illus 3). The north wall consists of exterior buttresses 1m wide and a maximum of 1.84m high constructed of large granite blocks with cherry cocking (Illus 4). Between the buttresses section of convex curved wall sections c0.6m wide and up to 1.5m deep with large and medium stone blocks and cherry cocking on the north face (Illus 4) with traces of mortar; the south (inner) face of the wall is constructed of overlapping medium-sized granite blocks with no evidence of mortaring (Illus 7). This may have become eroded or there may have been no requirement for bonding in the inner face. An aperture has been created between two of the buttresses but the wall would have continued as an unbroken structure when it was first built.

Illus 4 Structure 1 showing sections of convex curving wall between buttresses; facing S

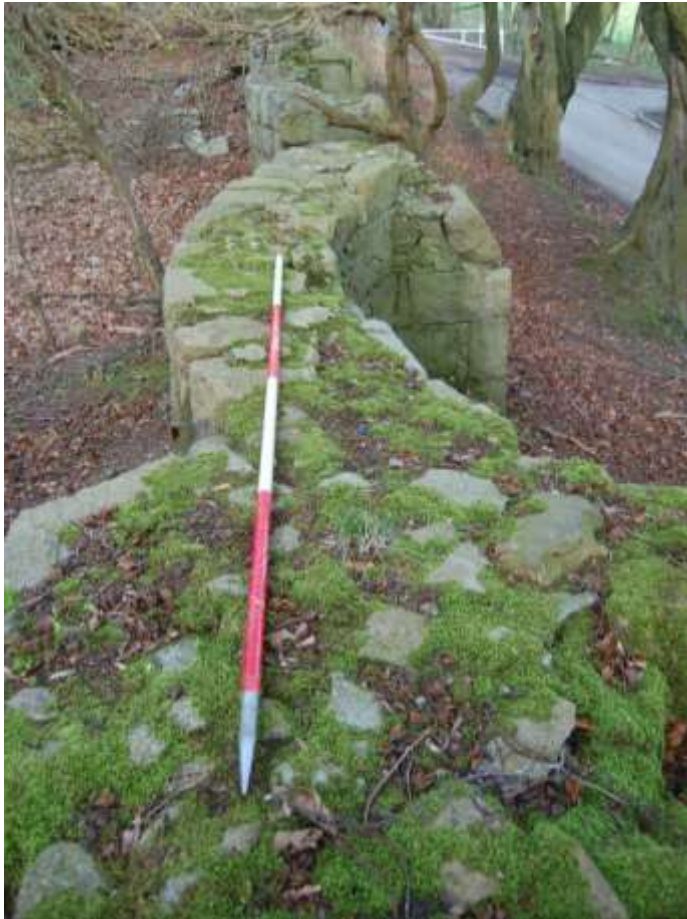
Illus 5 Structure 1 showing sections of convex curving wall between buttresses; facing ENE

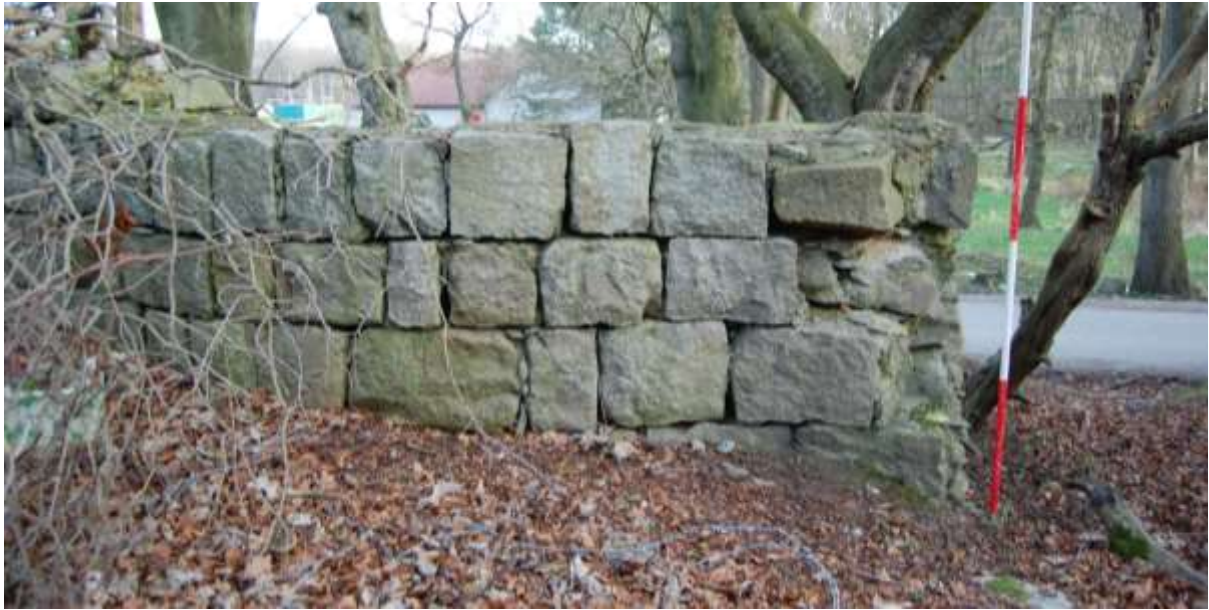
Illus 7 Structure 1 south (inner) face of wall; facing N

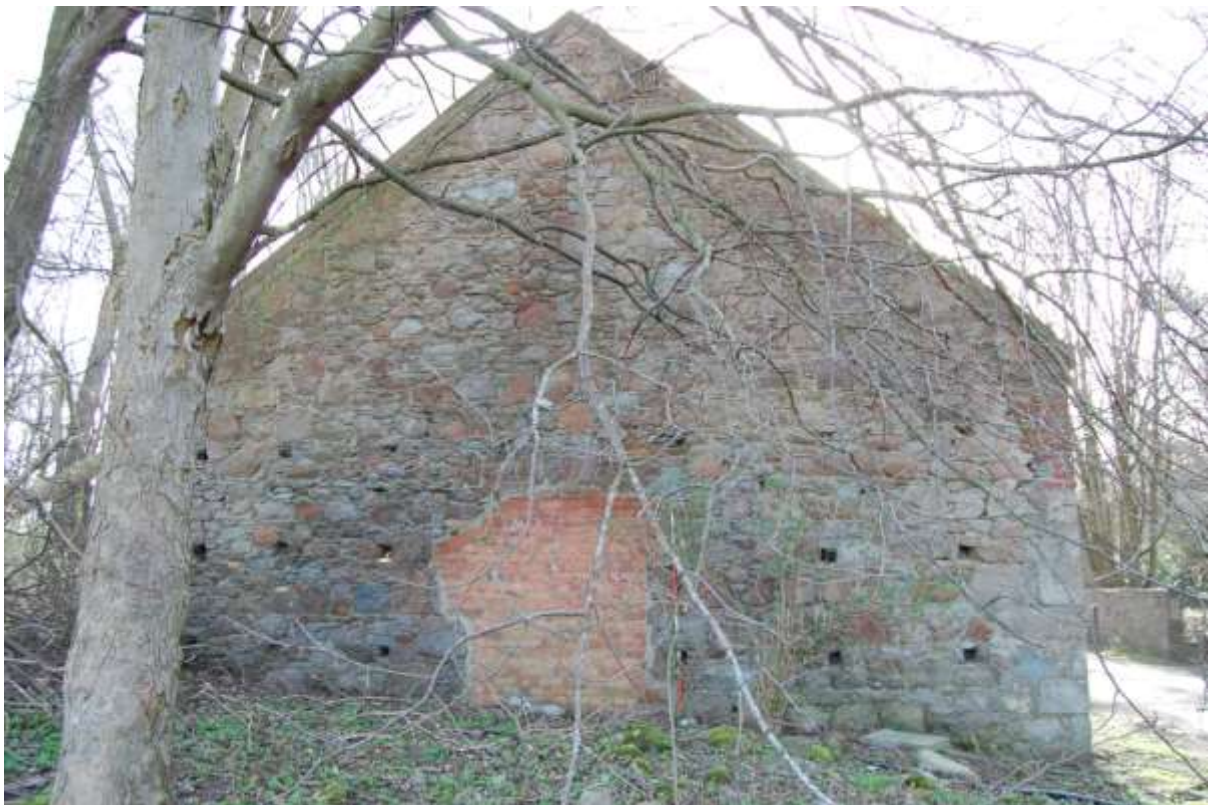
Illus 12 West gable of Structure 3, originally an interior wall prior to demolition of west end of building; facing E

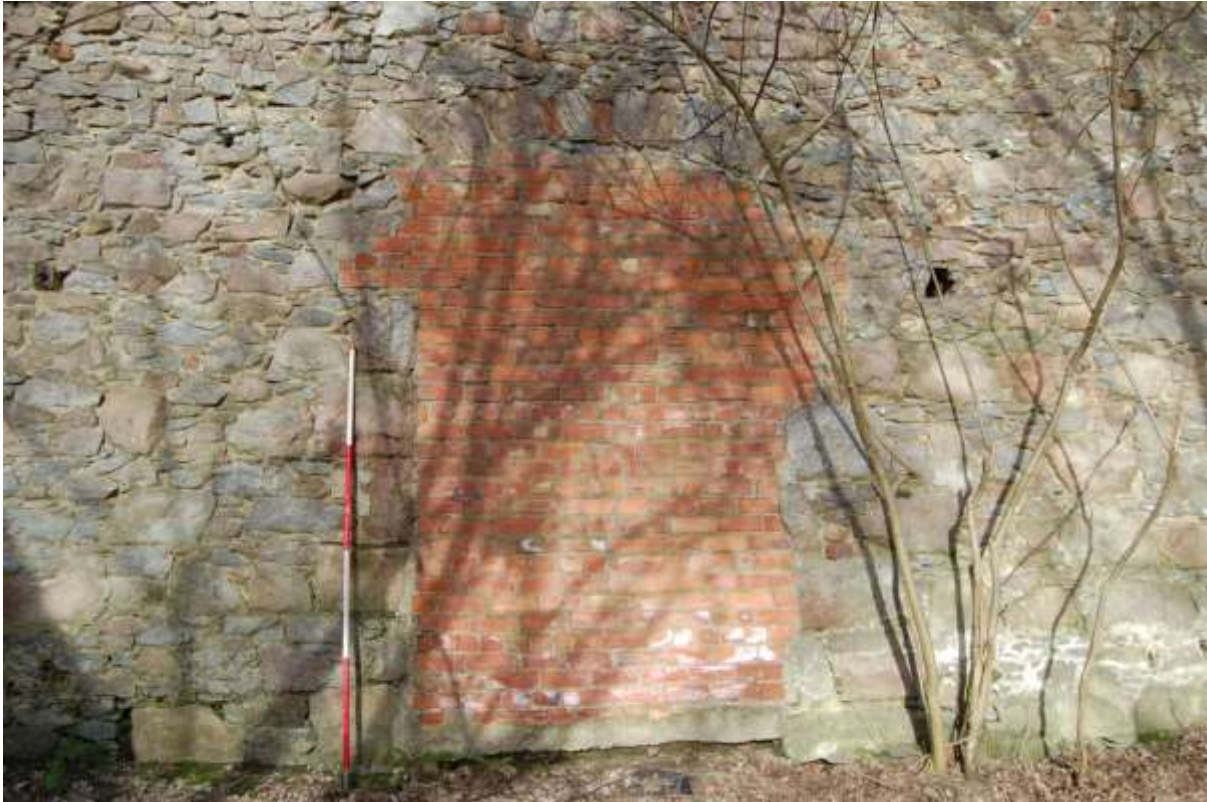
Illus 13 Structure 3 west gable interior face showing blocked door; facing W

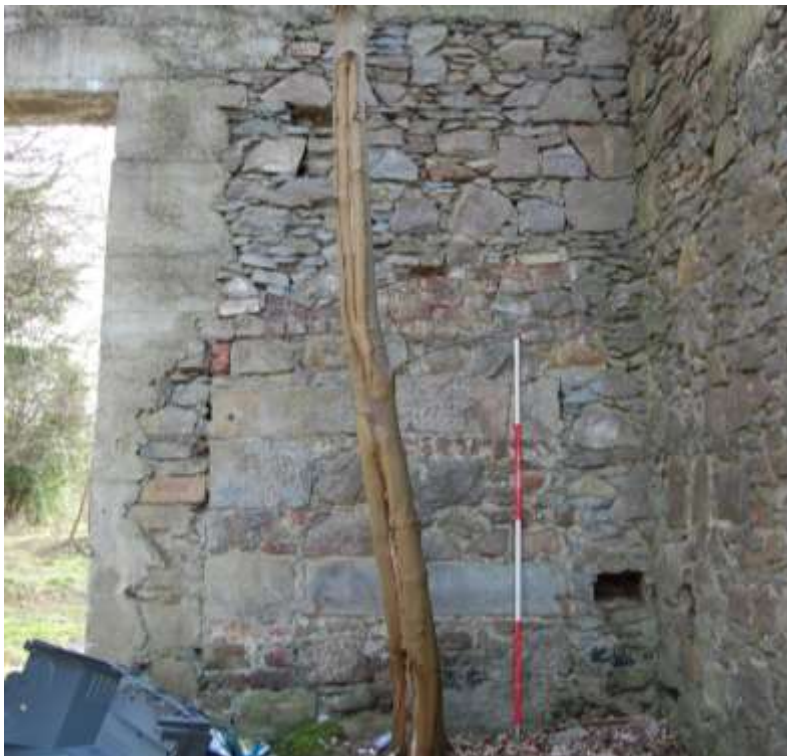
Illus 14 Structure 3 east gable interior face showing blocked doorway on south side of the newer larger central door; facing E

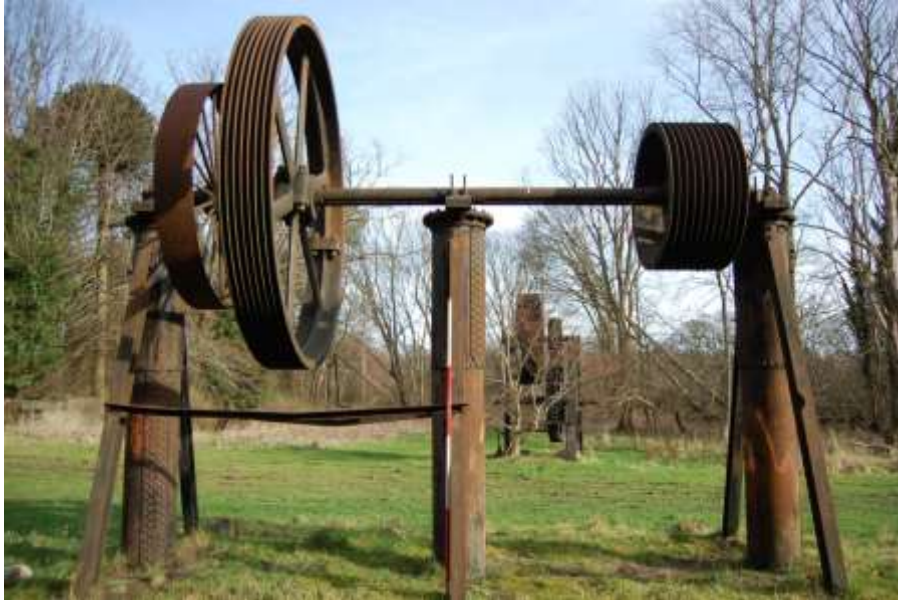
Structures 4 (Illus 15) and 5 (Illus 16) are the remains of two pieces of machinery left when the buildings were demolished. The remains of floor survive underneath. These structures align with buildings added between the 2nd and 3rd OS editions (c 1899-1924; Illus 17).

Illus 15 Structure 4; facing N

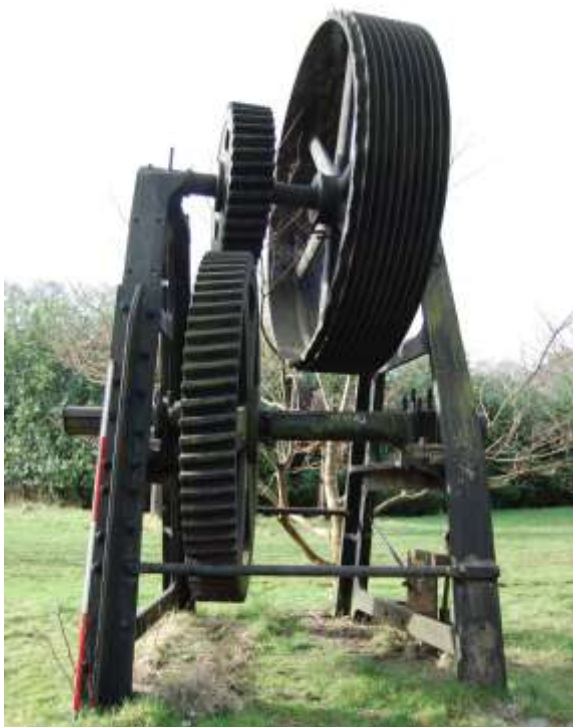
Illus 16 Structure 5 with cassies underneath, the remains of a floor; facing N

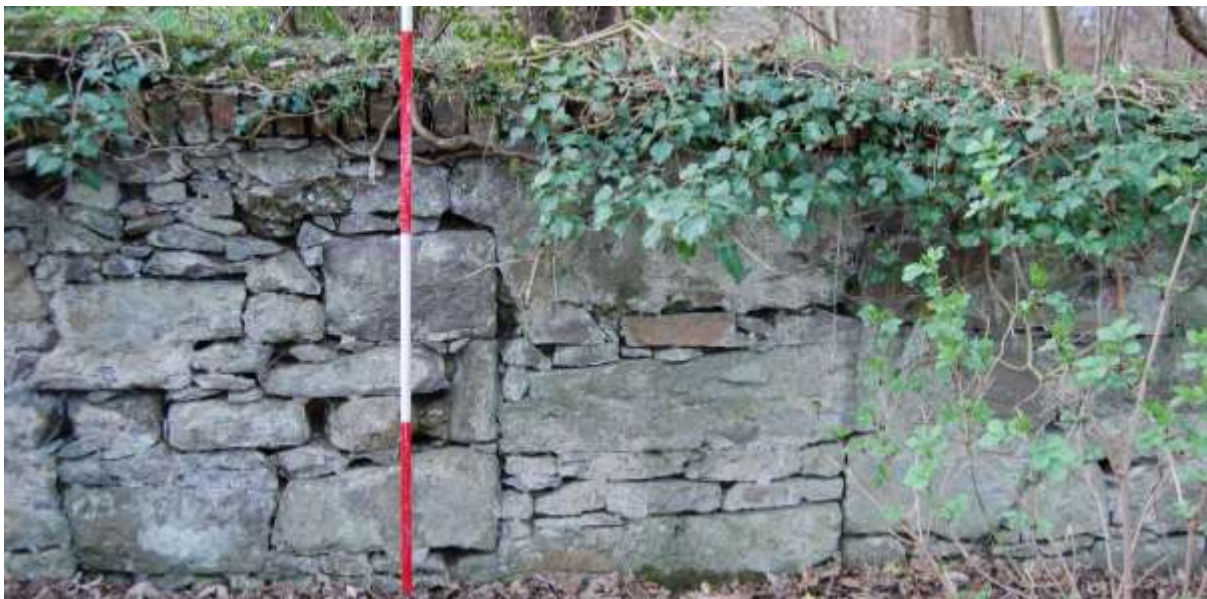
The north face of the north wall of lade S6 (Illus 24, 25) had been rebuilt on several occasions. East of the steps the end had been replaced with shuttered and poured concrete. A repair to the west of the steps was of brick and the whole façade shows that it was originally buttressed or recessed and then infilled with stone infill (Illus 26). The wall was then coped with brick. This wall is being badly damaged by established trees which have been planted on to the top of this structure.

Illus 26 North façade of north wall of lade S6 showing one of the inserts of masonry

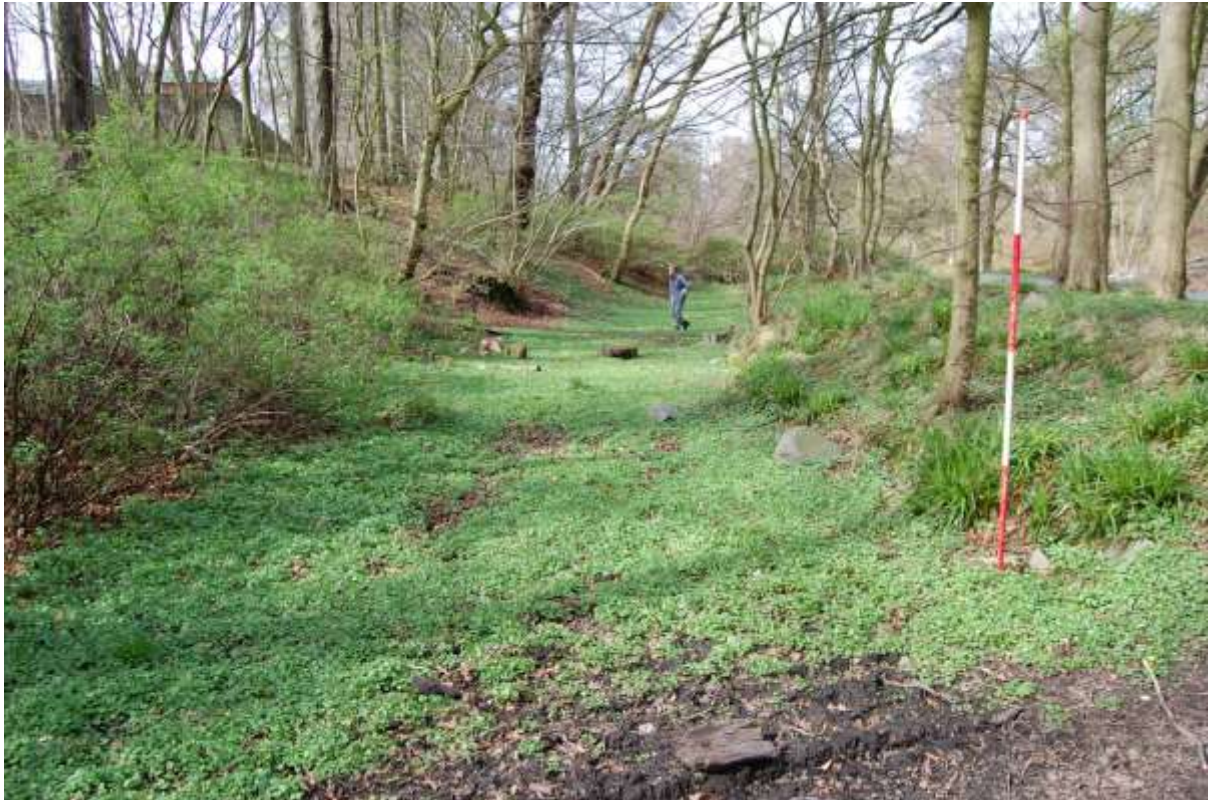
Illus 29 Lade S6 adjacent to Woodside House (left) partly infilled; facing W

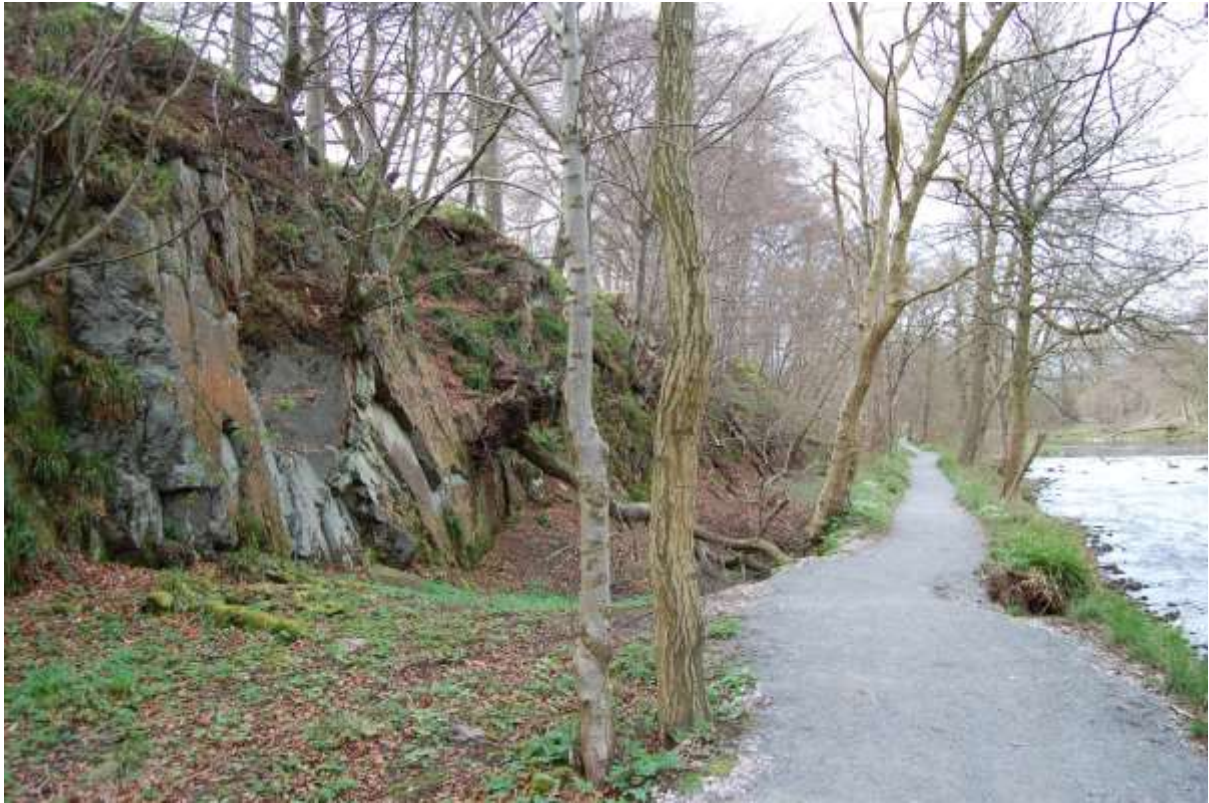
Illus 31 Lade S6 infilled (left) and shallow but still visible (top centre) in area between Woodside House and Persley Castle; facing WSW

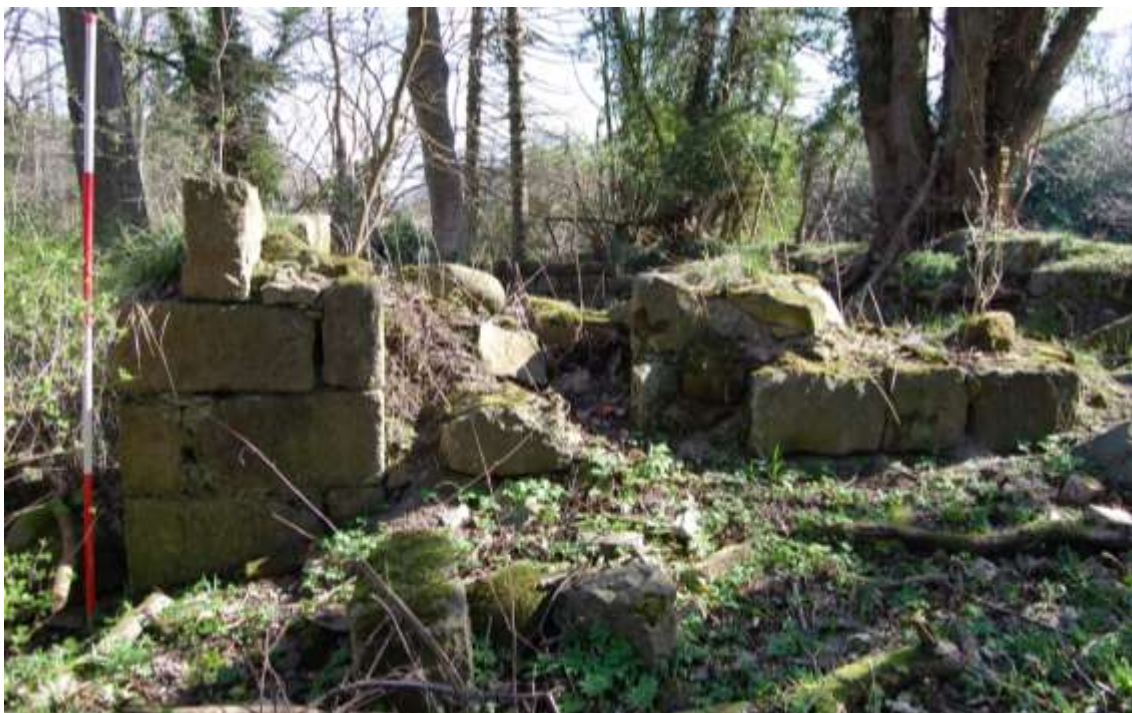
Structure 7 is a building attached to the north wall of Lade S6. The building is 8.10m N-S and 11.9m E-W. The walls are constructed of granite rubble and are 0.63-0.7m wide. There is a door in the north end of the west wall (Illus 34) and one in the north wall and the remains of an extension which is clearly seen on the First and Second Edition OS maps. This building is unroofed by the Third Edition OS (Illus 35).

Illus 34 Structure 7 west wall with wall of lade S6 (right); facing E

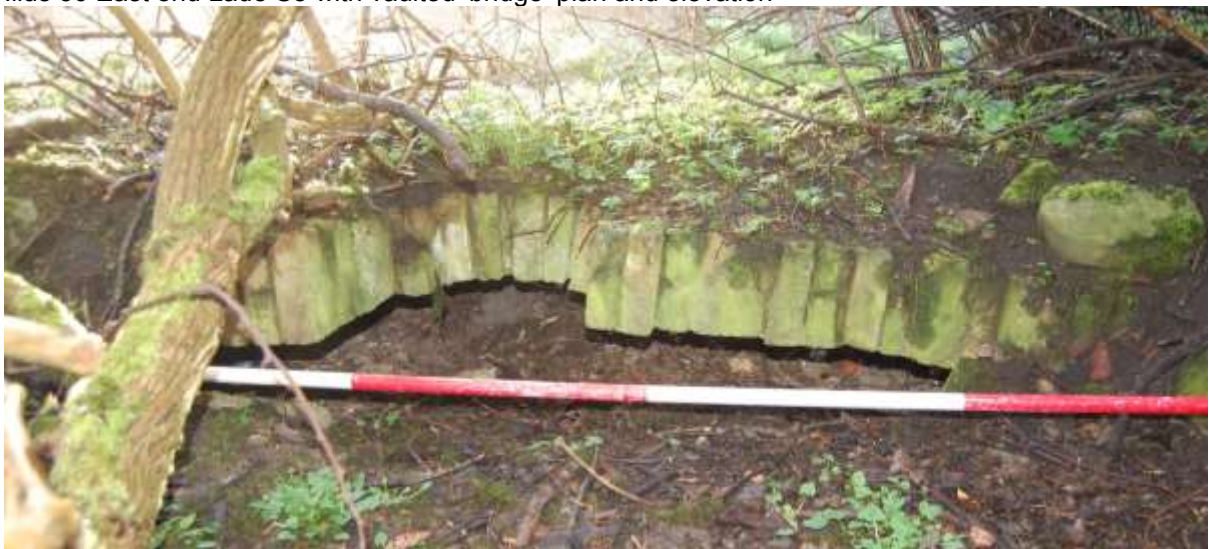
Structure 8 (Illus 19) is a lade parallel to and to the north of Lade S6. At the east end animal burrowing has revealed a brick vaulted 'bridge' over the lade (Illus 36, 37). There are at least 28 bricks in the shallow arch and the bricks are 22 x 10 x 7cm in size with the length of the brick used for the thickness of the arch. The lade survives as a shallow trench overgrown with mature trees and undergrowth. It is c 2.6m wide and survives to a depth of c 0.5m. There is some stonework visible at the east end and the remains of a set of steps (Illus 19). There are several footbridges (F.B.) marked on the OS maps of this lade (Illus 35) and these steps align with the location of one of these bridges.

Illus 37 West side of brick vaulted 'bridge'; for location see Illus 36

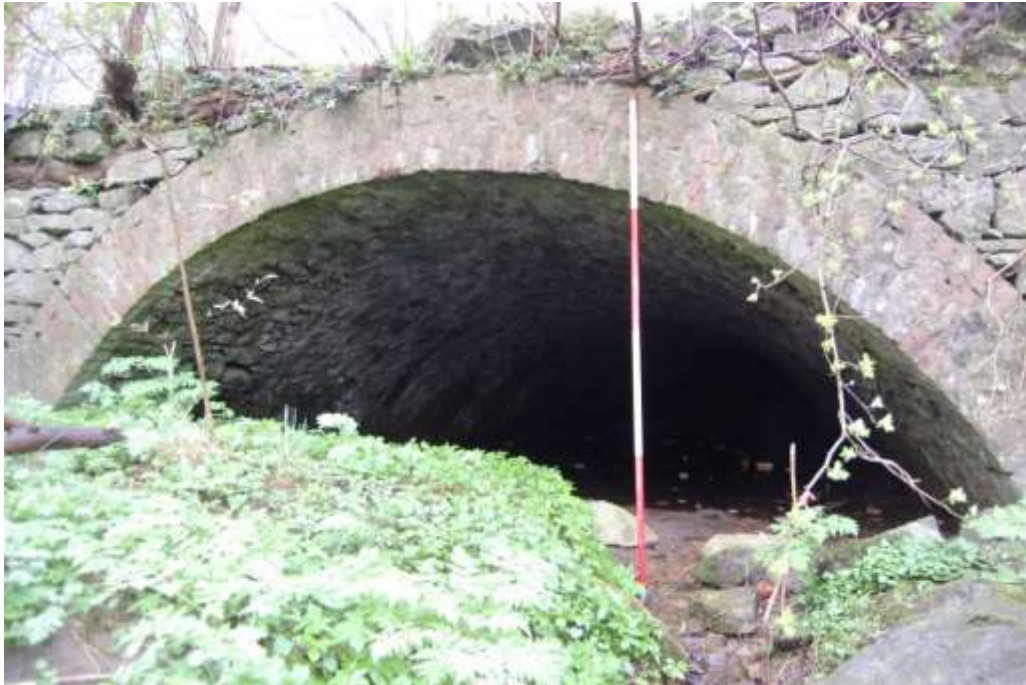
Structure 10 is a brick faced stone vaulted arch outflow for a lade into the river Don. The brick facing is 0.46m thick and contains bricks 21 x 10 x 9cm. The entrance is heavily silted. There is no evidence of the lade which leads to this culvert on the ground but there is a line on the First Edition OS map which might indicate it comes from the mill to the NW.

Illus 43 Culvert S10 at outflow into river Don; facing SW

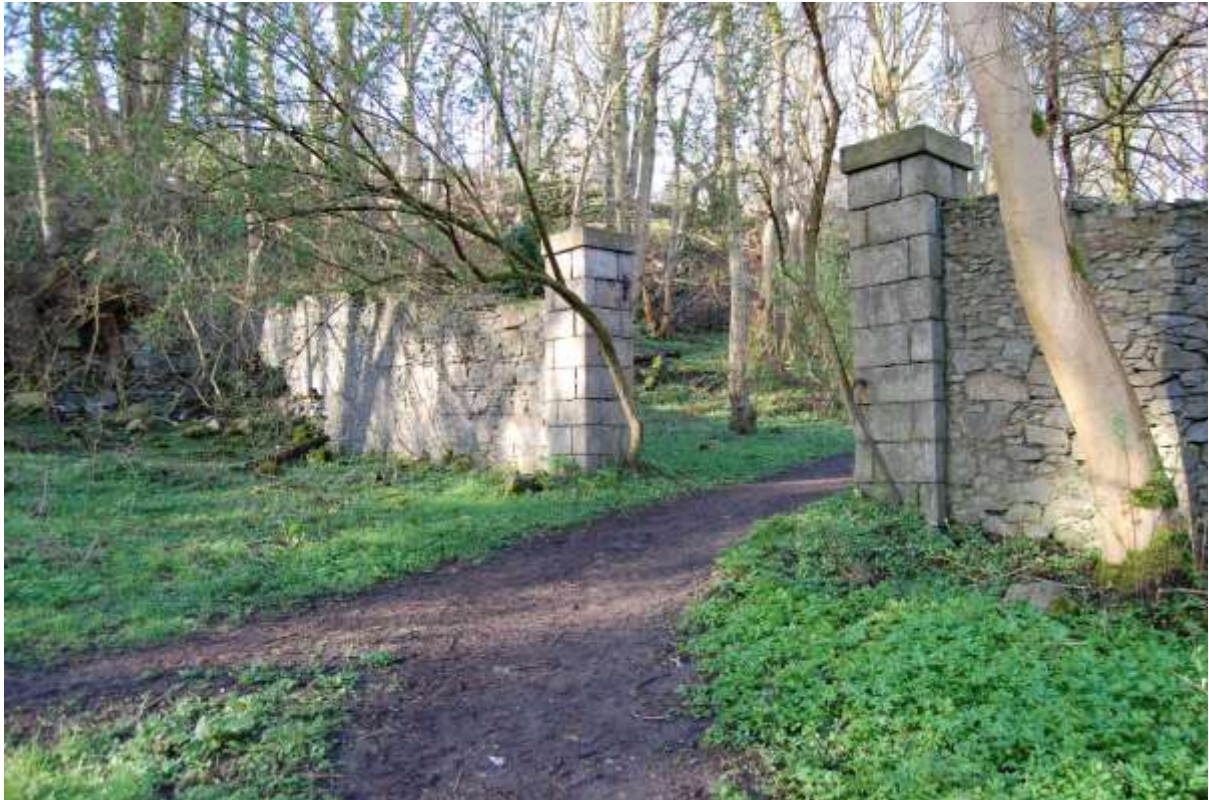
There are two gateways into enclosure S11 one from the NW and one from the SW. Both entrances are flanked by gate pillars (Illus 44) which form impressive entrances into the mill. The enclosure has now been breached on the north side by Core Path 7.

Illus 44 Pillared gate into enclosure S11 from SW; facing SW

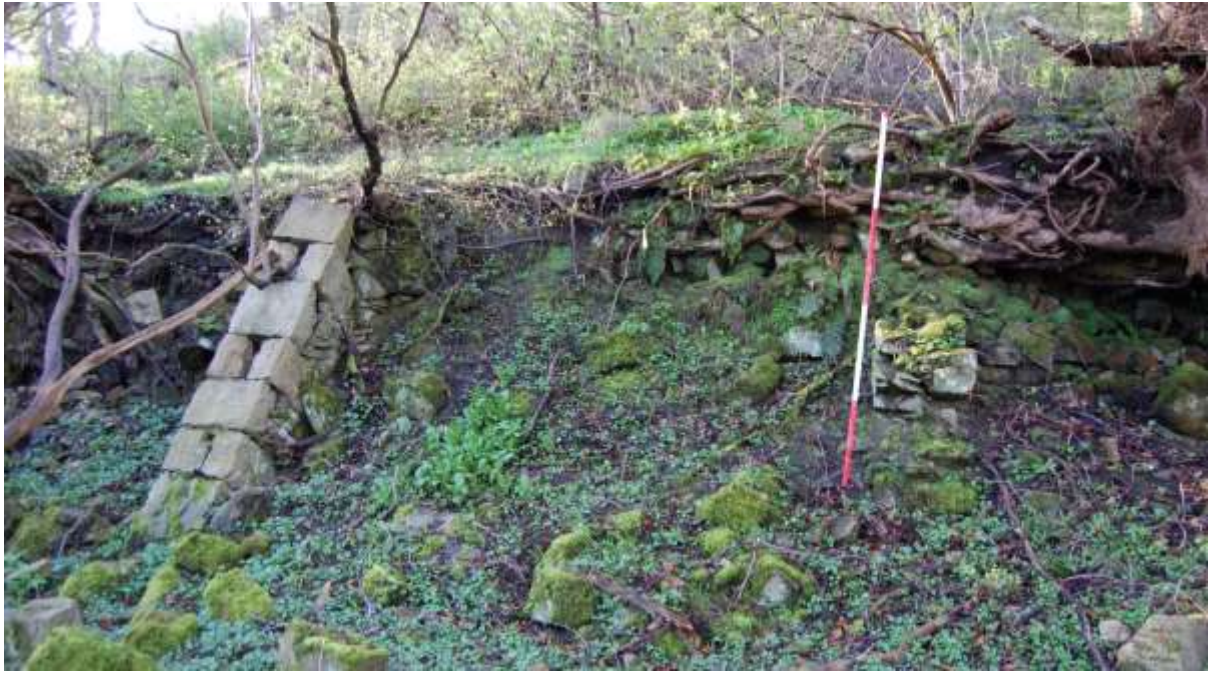
Illus 48 Buttresses on the interior of the south wall of enclosure S11

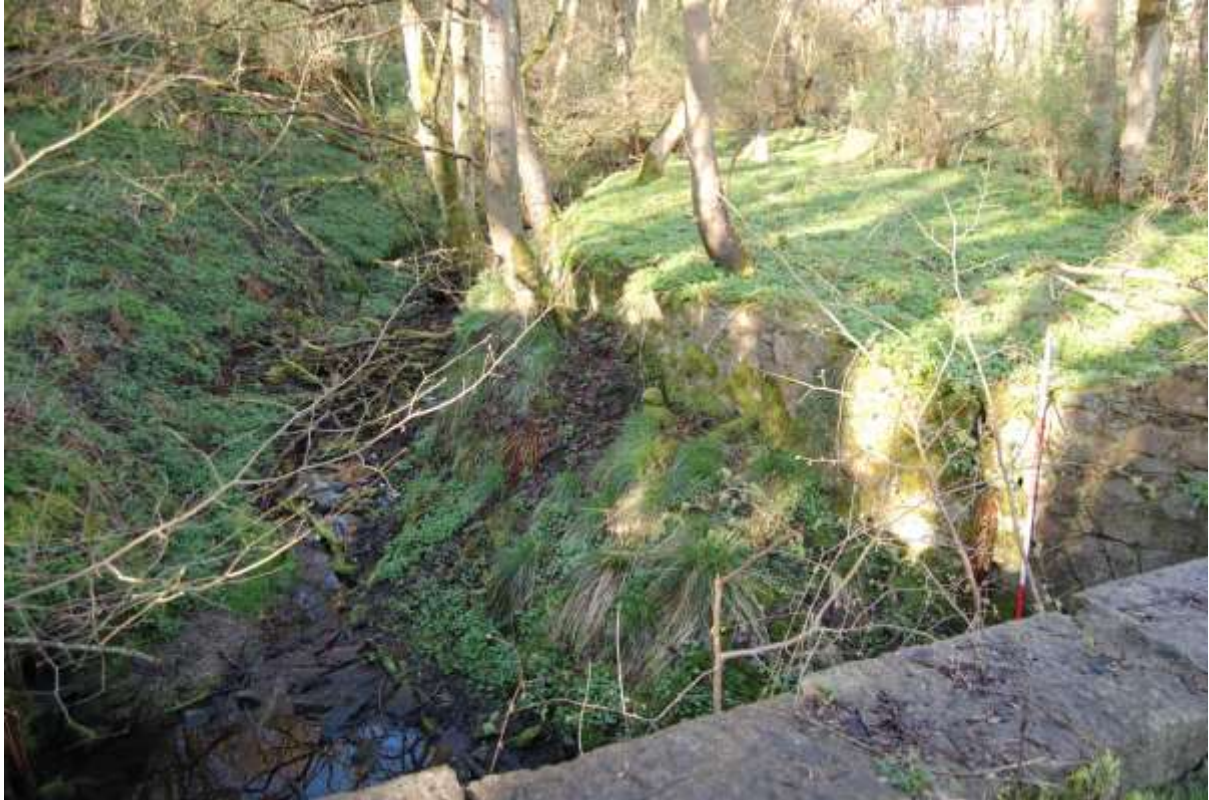
Lade S13 is at the east of the site and probably took water from lade S25 out to the Don. It was c8m wide at the west end and 3m wide at the east (Illus 51). The north wall of the lade is a stone wall constructed of granite rubble and survives 0.3-0.5m deep along most of its line; the south edge of the lade is overgrown and the edge obscured by material falling down the steep incline on the south side of the lade.

Illus 51 Lade S13 from bridge S33; facing WSW

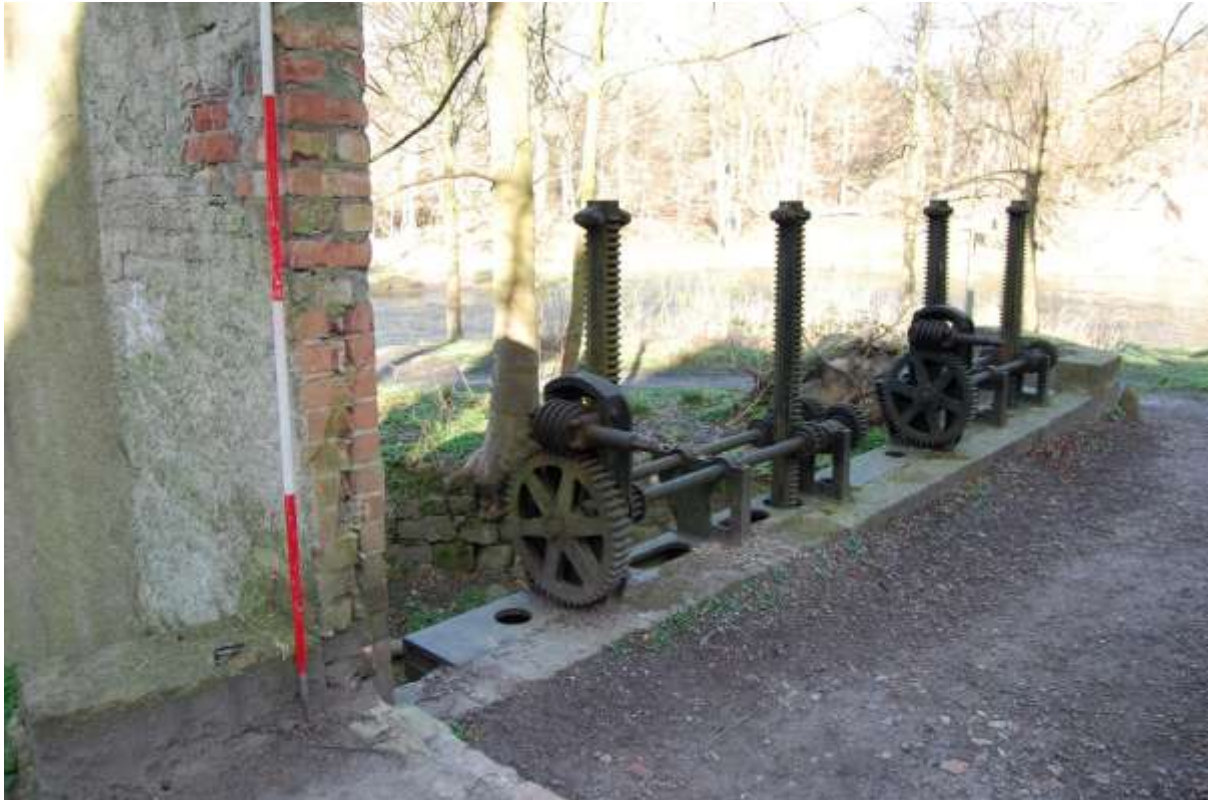
Illus 54 Sluice gate mechanisms on the west side of the bridge

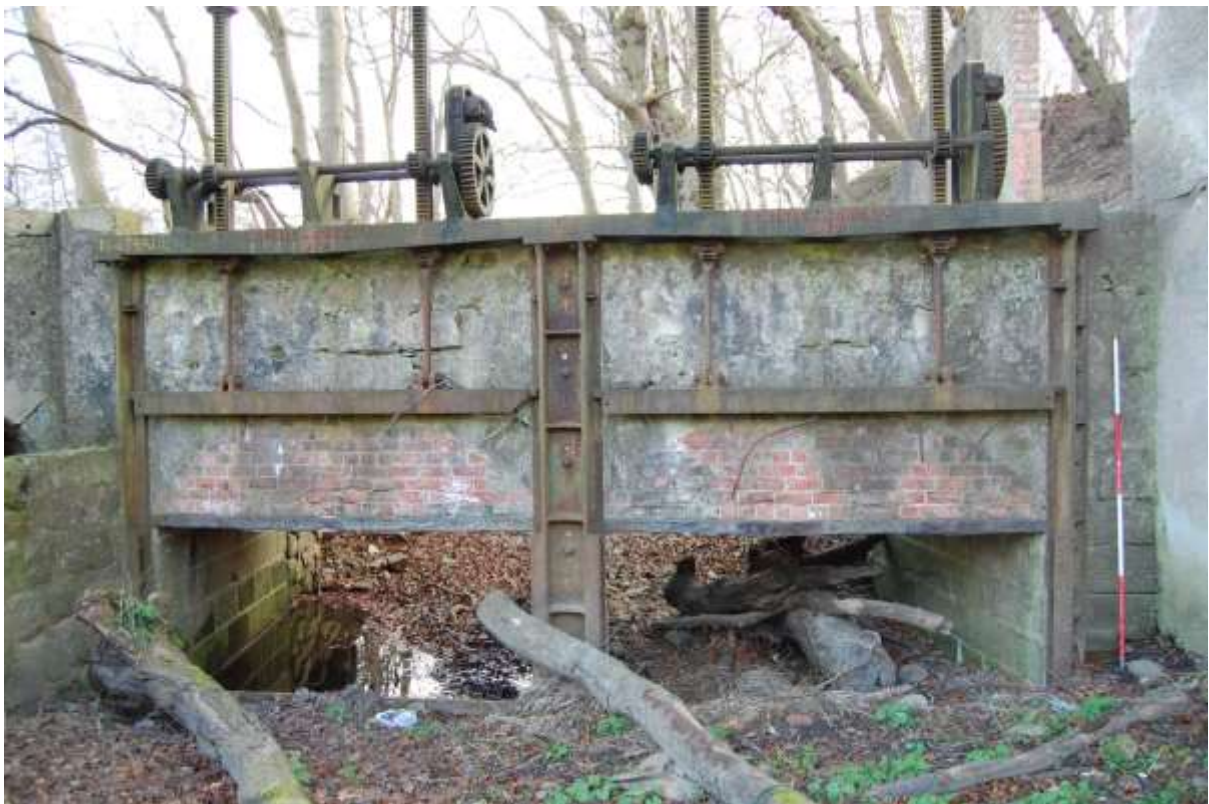
Illus 55 Sluice gate structure on the west side of the bridge marked 'A Pirie & Sons 1919'.

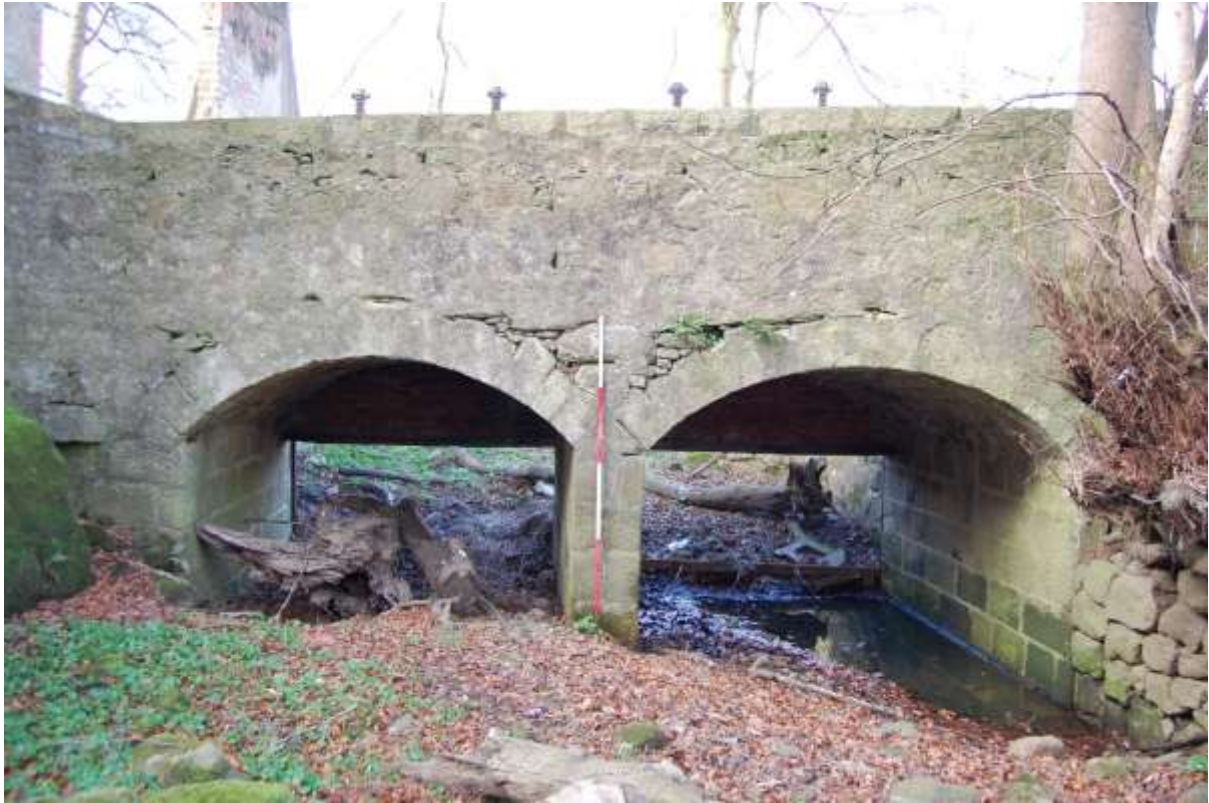
Illus 56 Bridge S15 over Lade S6; facing SW

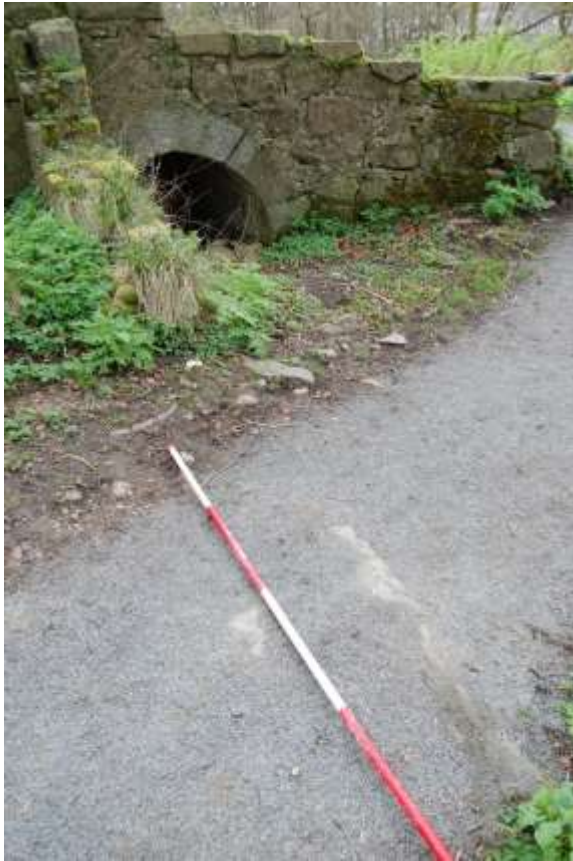
Lade S15 is an earlier lade which went out of use when the larger lade S6 and sluice gate S14 were constructed. Lade S15 was wider and shallower than the later lade; it survives to 5m wide and 0.9m deep (Illus 57-59). It has been infilled in several places and Core Path 7 has been laid on top of the lade although the edging stones can be seen on the path.

Illus 57 Lade S15 stonework under Core Path 7 with culvert (top); facing WSW

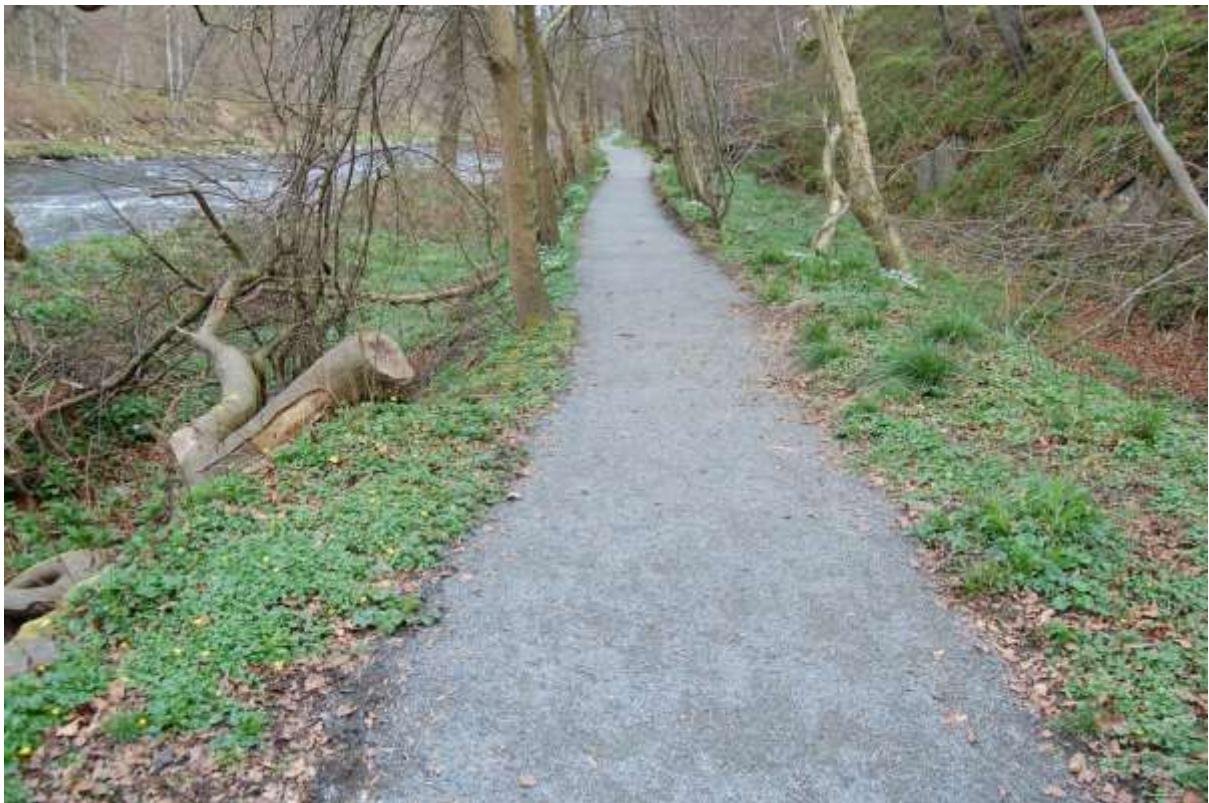
Illus 58 Lade S15 (left) and S6 (right) north of Persley Castle; facing E

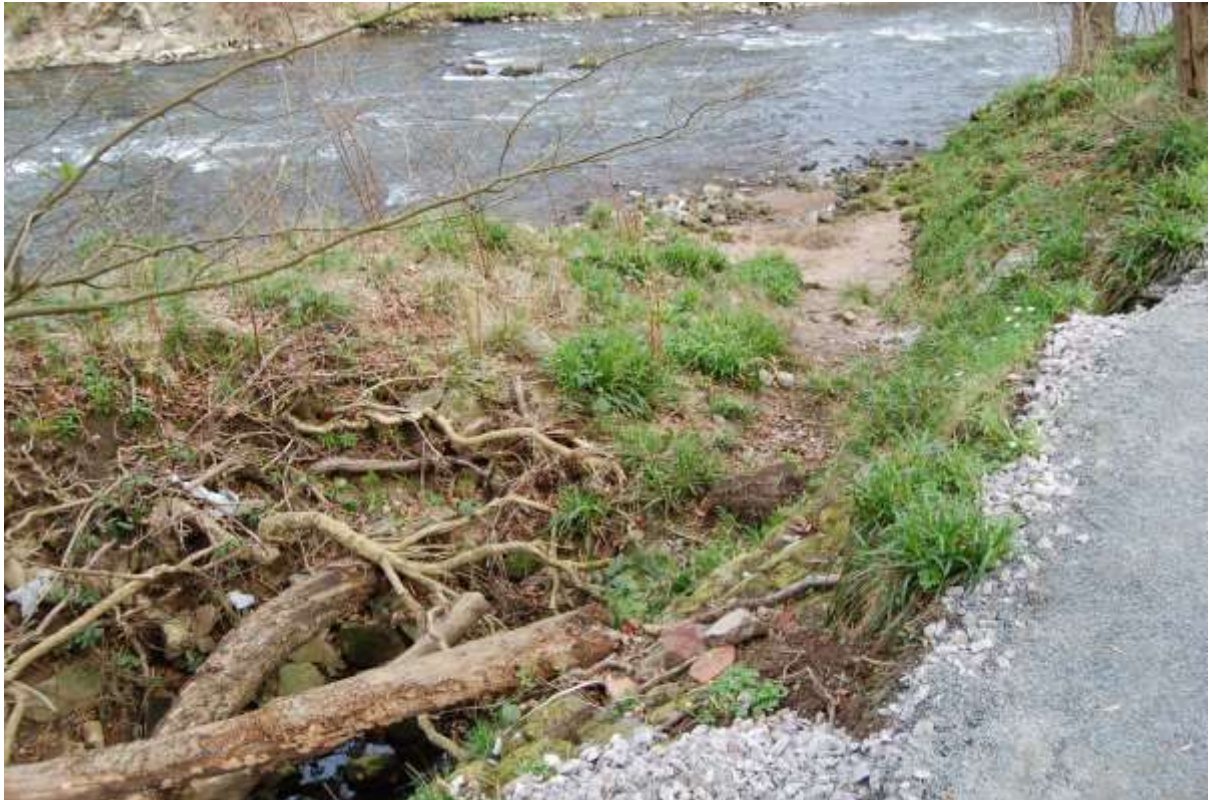
Illus 59 Outflow of lade S15 at junction with river Don; facing NE

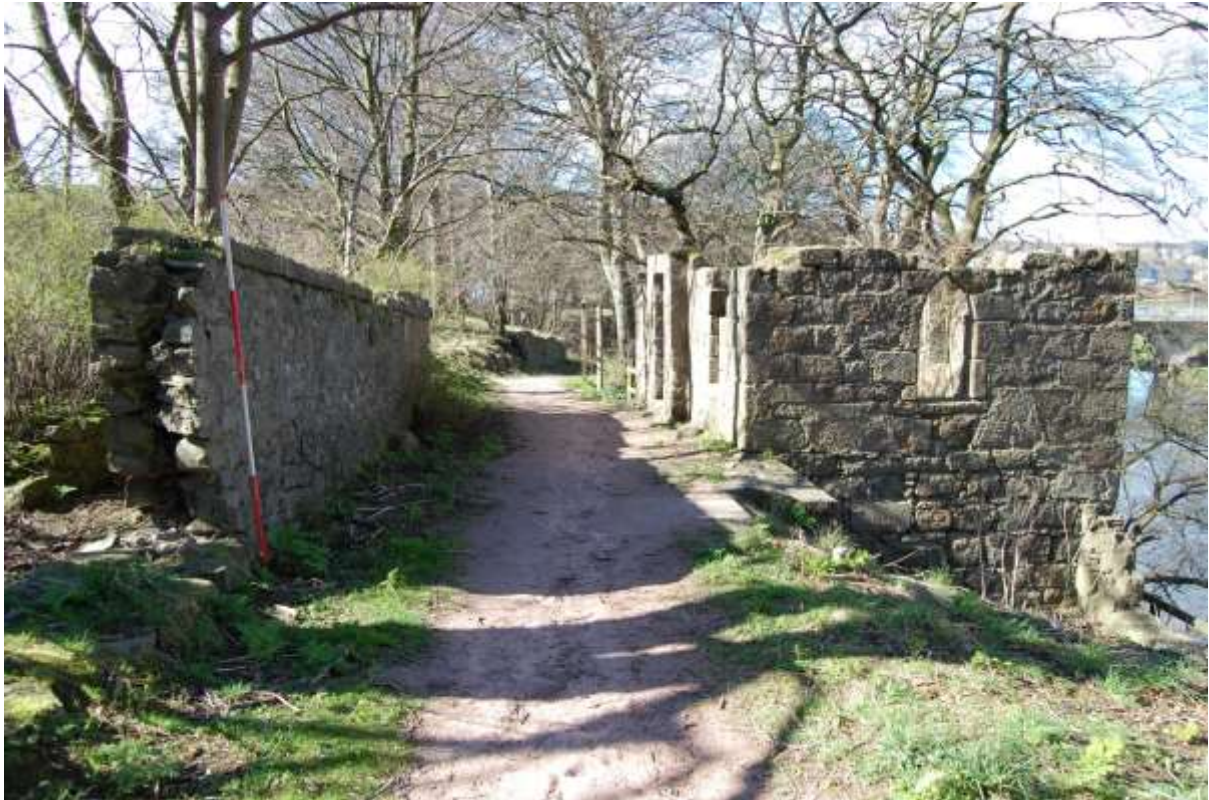
Illus 63 Building S16 (right), track and remains of boundary wall S20 (right); facing W

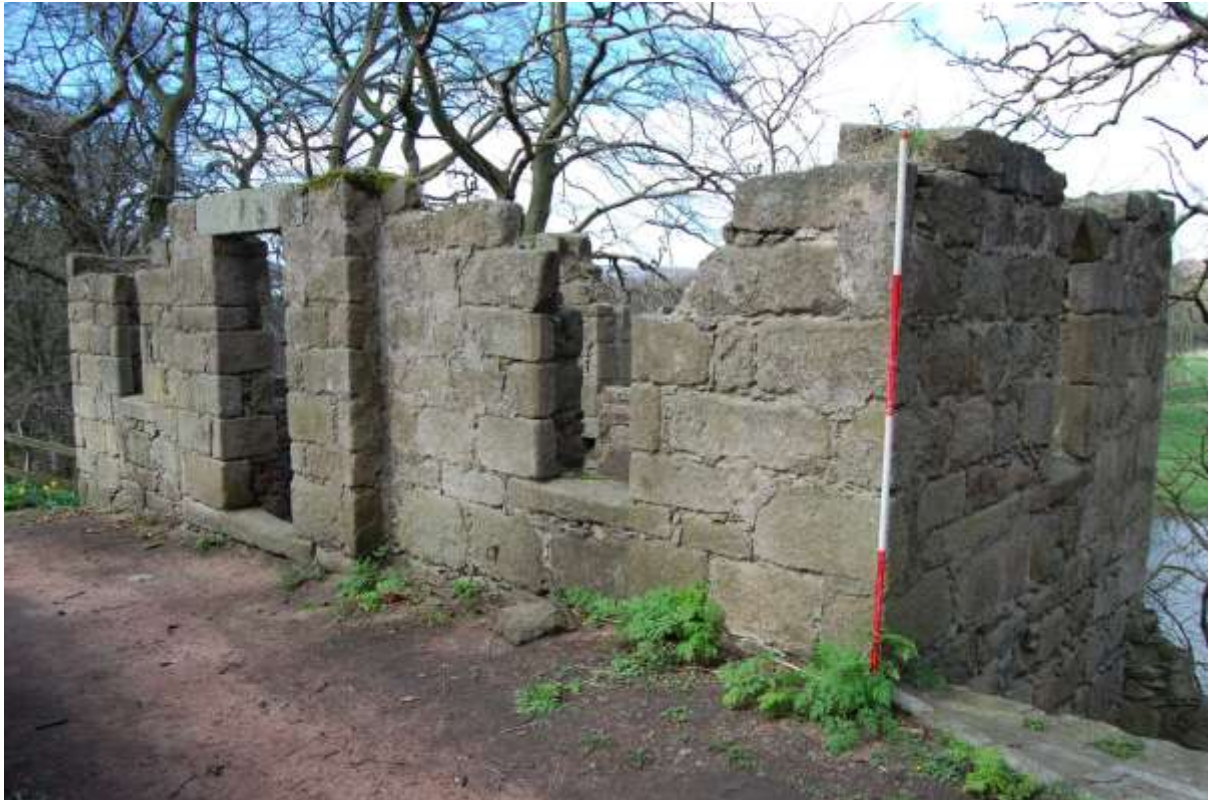
The south wall contains a central door which would have accessed onto the first floor of the building. All walls have small arched windows (Illus 66) constructed of worked granite blocks; the interior of the arched windows on the north wall are infilled with brick which may be an original feature or a repair. Both wall overlooking the river had originally a large door in the ground floor and a large mullioned window on the first floor. Both have been infilled with brick and a loophole constructed using a wooden beam for a lintel in the brick blocking (Illus 65). The loophole is 0.48m internally and 0.35m externally. The building is roofless and the tops of the walls and windows has been lost and the interior is overgrown with vegetation.

Illus 64 Structure 16 south façade; facing NW
