**ABERDEEN CITY COUNCIL SMR ENHANCEMENT
PERSLEY BRIDGE TO GRANDHOLM BRIDGE, SOUTH SIDE OF THE
RIVER DON**

**Alison Cameron
Cameron Archaeology
May 2014**

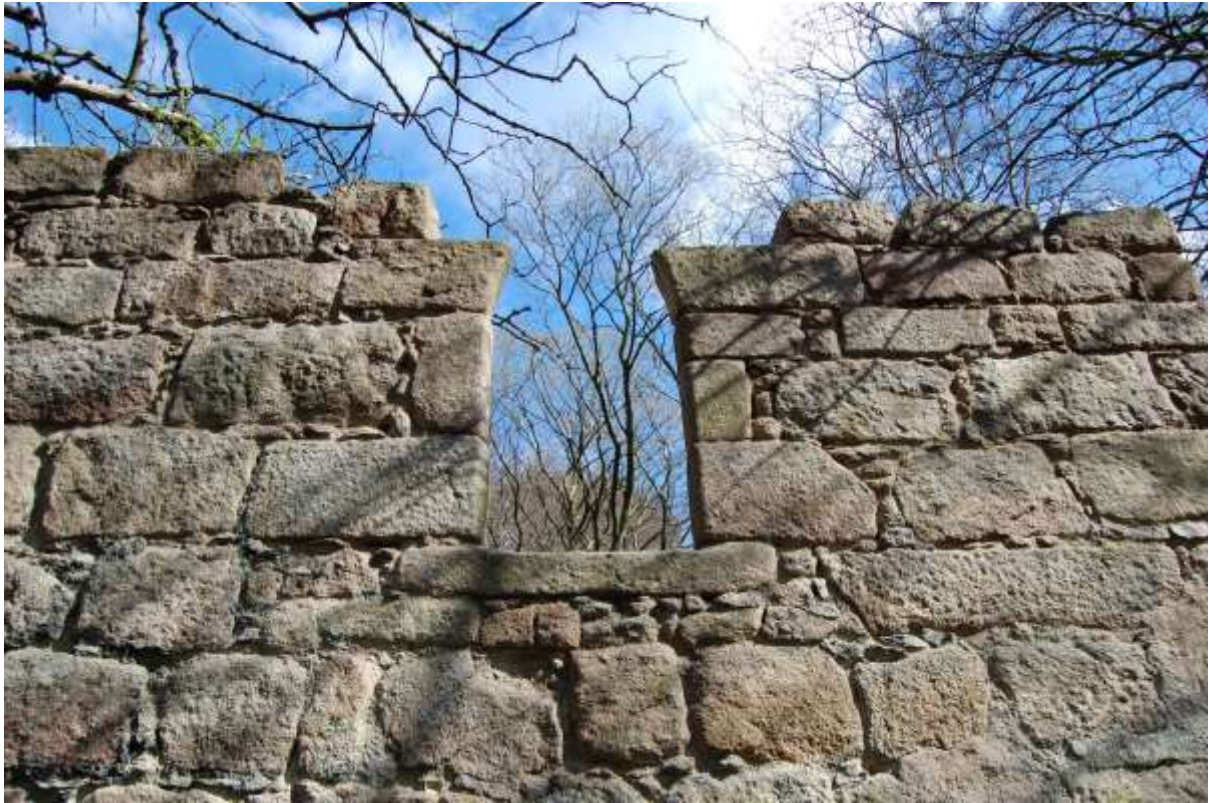
The south wall contains a central door which would have accessed onto the first floor of the building. All walls have small arched windows (Illus 66) constructed of worked granite blocks; the interior of the arched windows on the north wall are infilled with brick which may be an original feature or a repair. Both wall overlooking the river had originally a large door in the ground floor and a large mullioned window on the first floor. Both have been infilled with brick and a loophole constructed using a wooden beam for a lintel in the brick blocking (Illus 65). The loophole is 0.48m internally and 0.35m externally. The building is roofless and the tops of the walls and windows has been lost and the interior is overgrown with vegetation.

Illus 66 Structure 16 West wall showing arched window formed using granite blocks; facing E

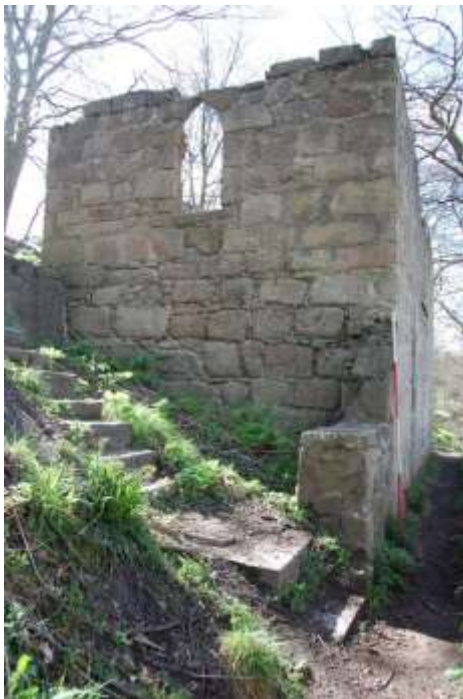
Illus 67 Structure 16 east wall showing structure built into the slope and the narrow path adjacent to the slope down to the river (right); facing WSW

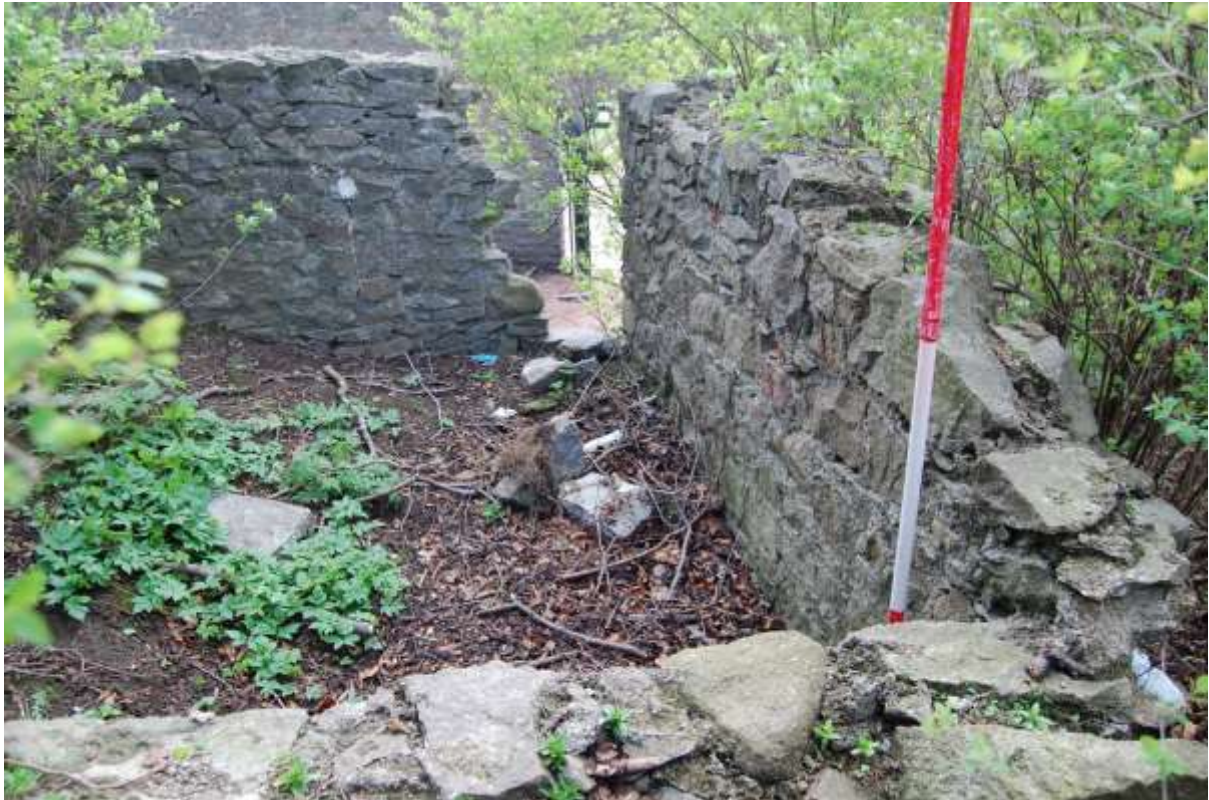
Structure 17 is a small building 2.9m N-S and 6.0-5m E-W. It is constructed of granite rubble and is butted up against the north façade of boundary wall S21 between this wall and S20 (Illus 69). The structure is poorly preserved and overgrown and there was very limited access to the exterior of the building (Illus 71). The entrance into the building was 1.64m wide and on the south wall opposite the greenhouses north of the walled garden suggesting this structure was related to the activities in the walled garden.

Illus 70 Structure 17 interior facing walled garden; facing S

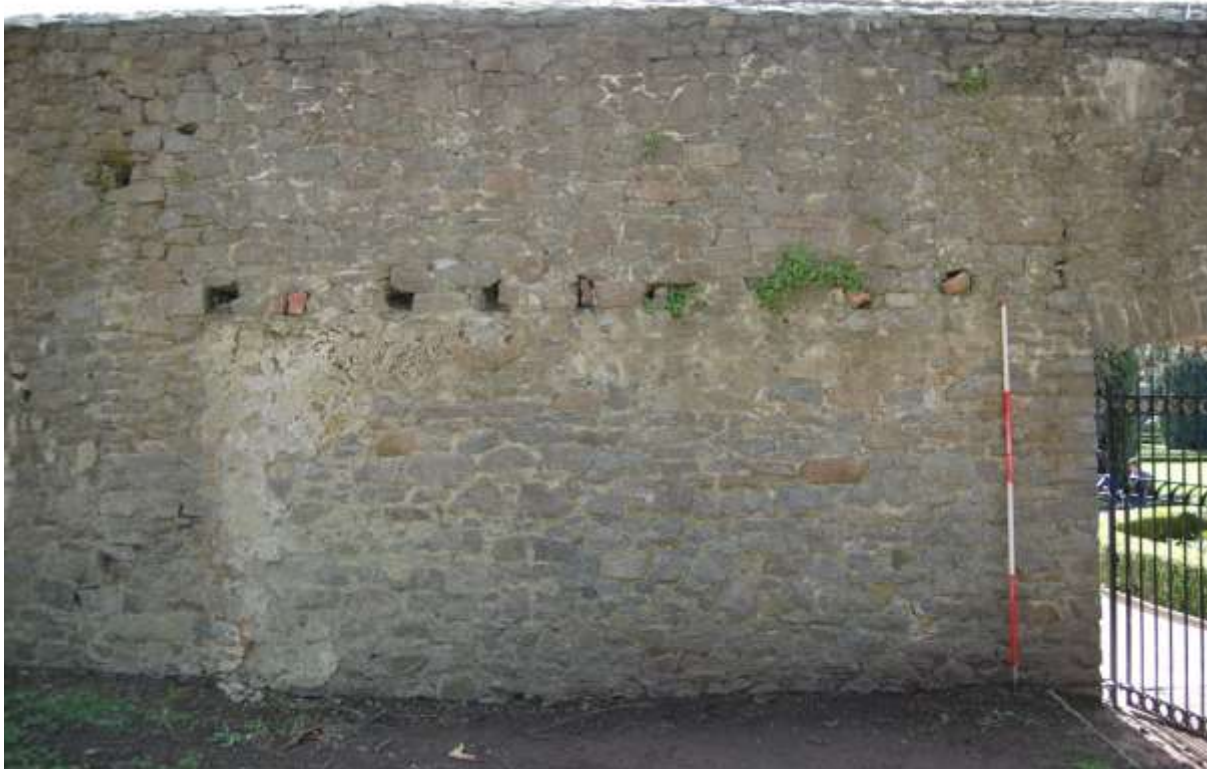
Structure 18 is visible on the First, Second and Third Edition OS maps (Illus 81) and was probably one of a series of lean-to greenhouses on the exterior of the north side of S19 Woodside House (Persley) Walled Garden. The joist holes in the north face of the wall survive (Illus 72, 73) indicating that the building was 5m long and 2.2m high. Scars of other greenhouses appear on the east end of the wall. There were also freestanding and lean-to greenhouses inside the walled garden but no trace of the freestanding ones survive and the inner walls are not visible on the brick wall lining. The building is roofed on the First, Second and Third OS maps. East of this building were greenhouses on the Second and Third OS maps and a concrete scar can be seen on the wall (Illus 73).

Illus 72 Joist holes from demolished building on exterior of north wall of walled garden S19; facing S

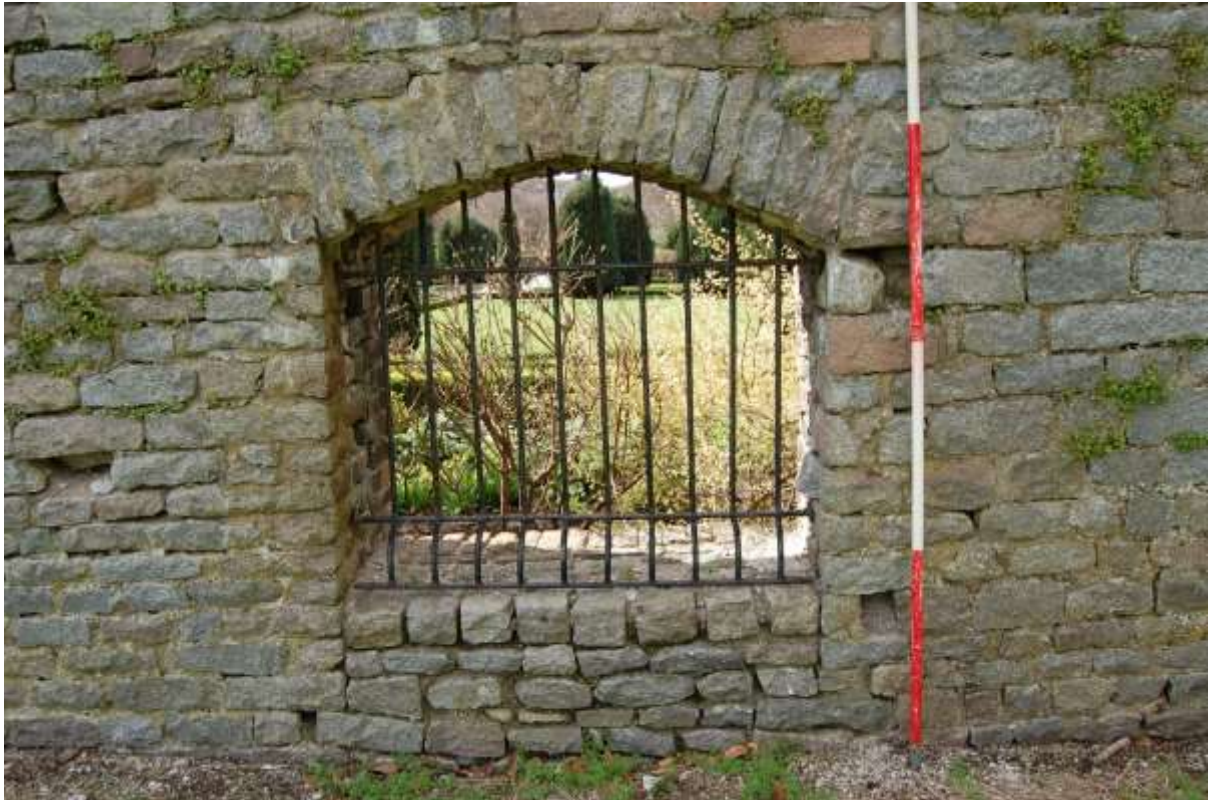
There was a gate in the east wall which was converted to a window (Illus 79).

Illus 79 Former door converted to window in centre of east wall; facing W

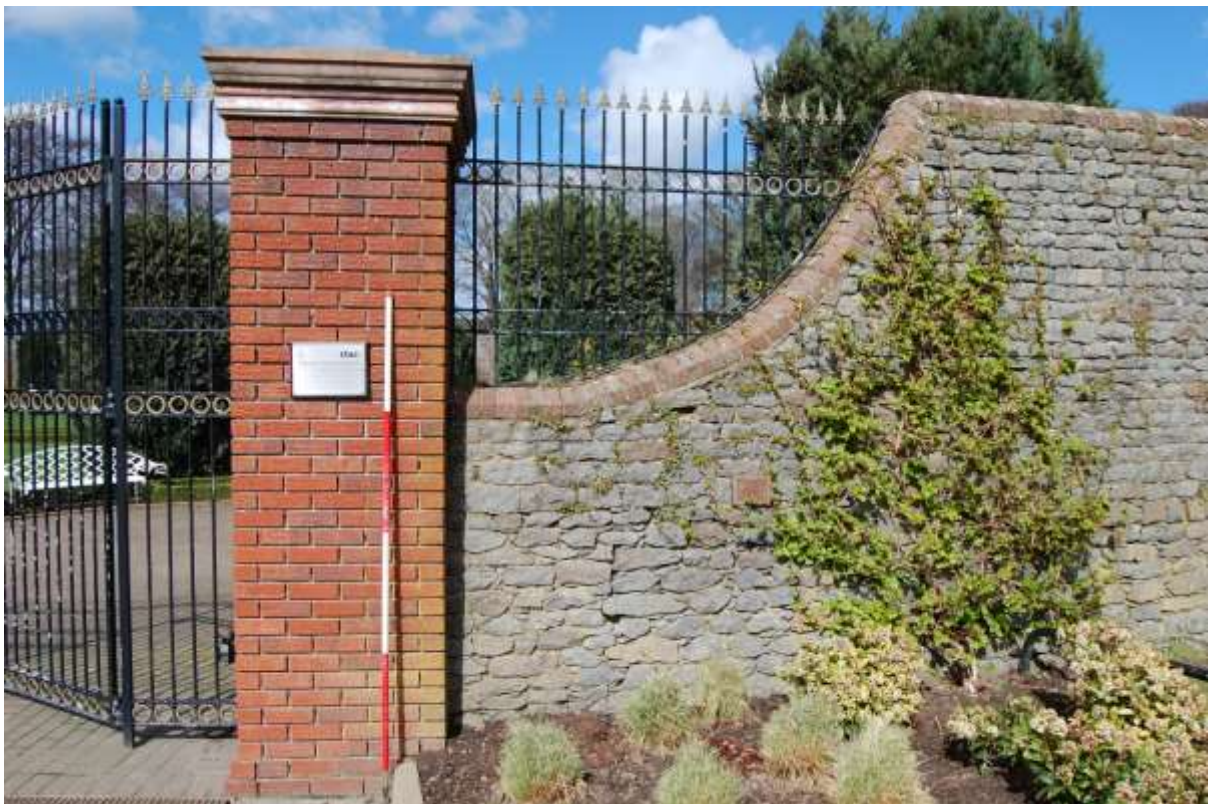
Illus 80 The modern entrance on the SE of the garden showing older wall line (right)

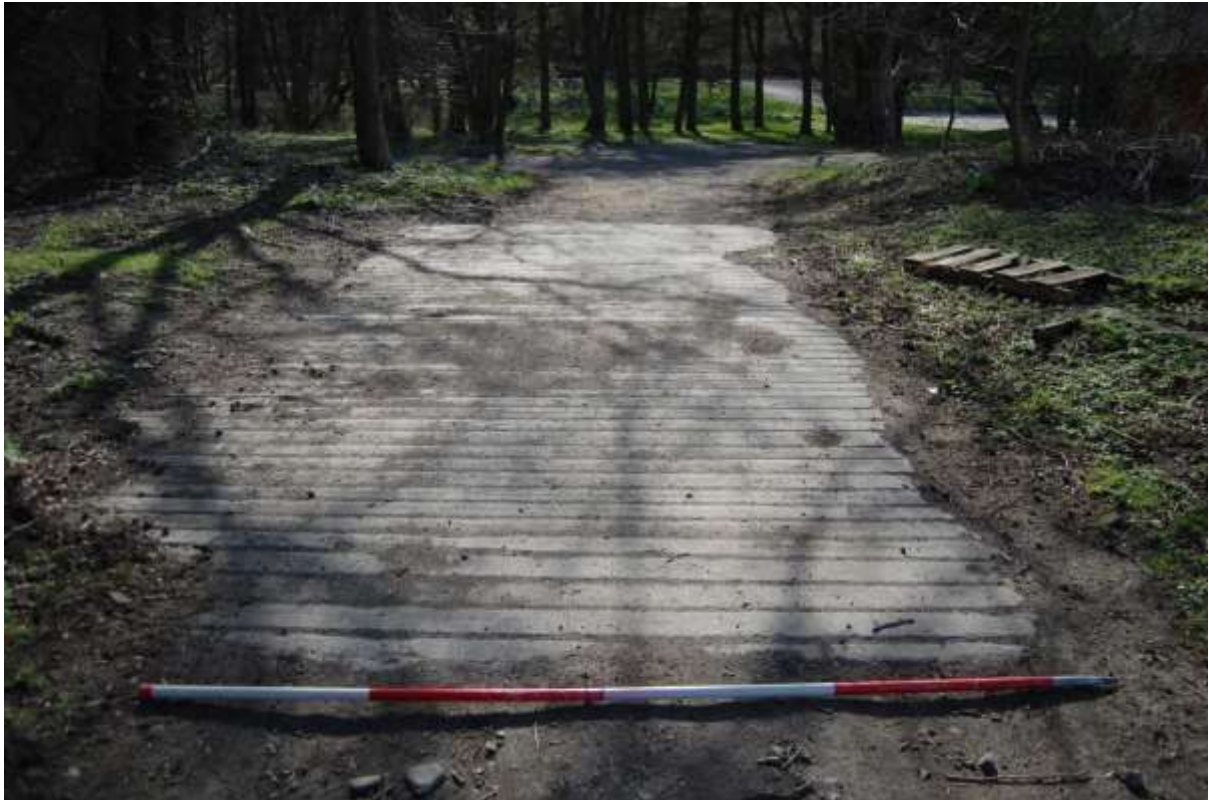
Illus 82 Poured concrete bridge taking footpath over remains of Lade 6; facing NNE

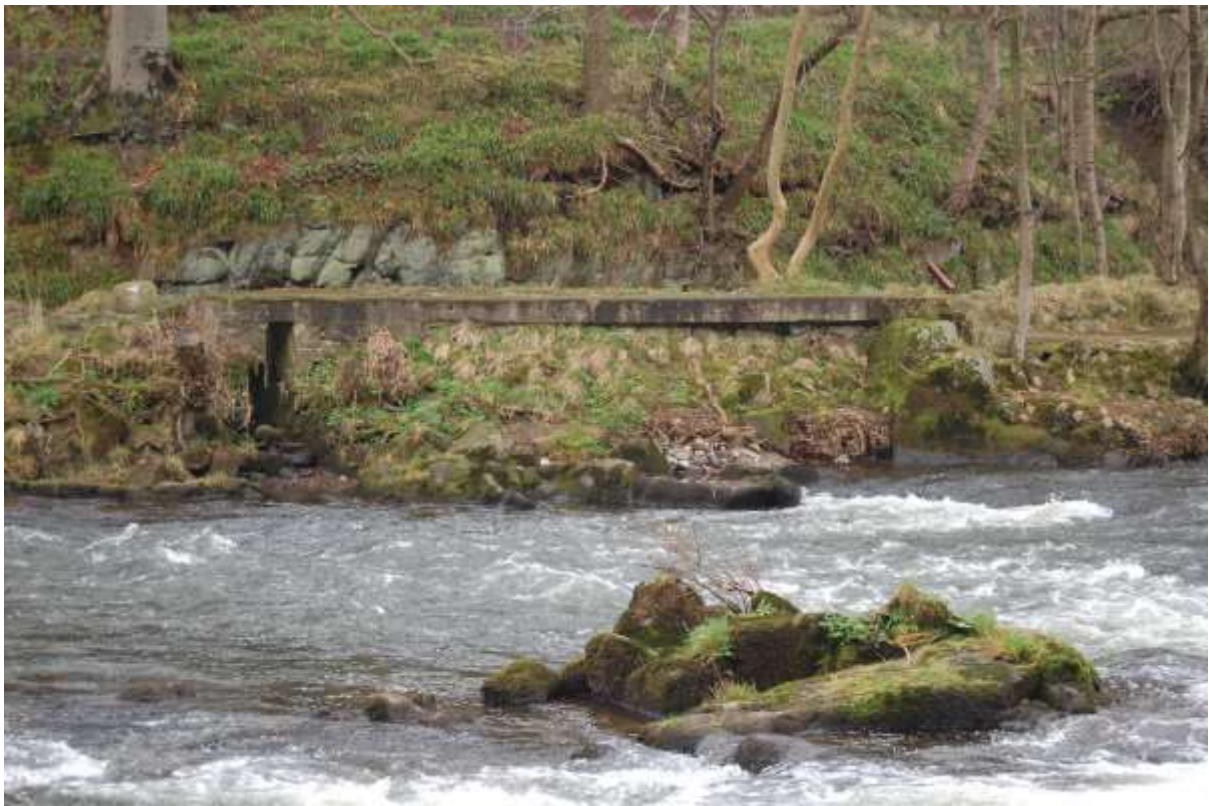
Access to this structure was limited by the proximity of the river Don to the west and the waterlogged lade S6 to the east.

Illus 86 Sluice 26 from north bank of river Don; facing ENE

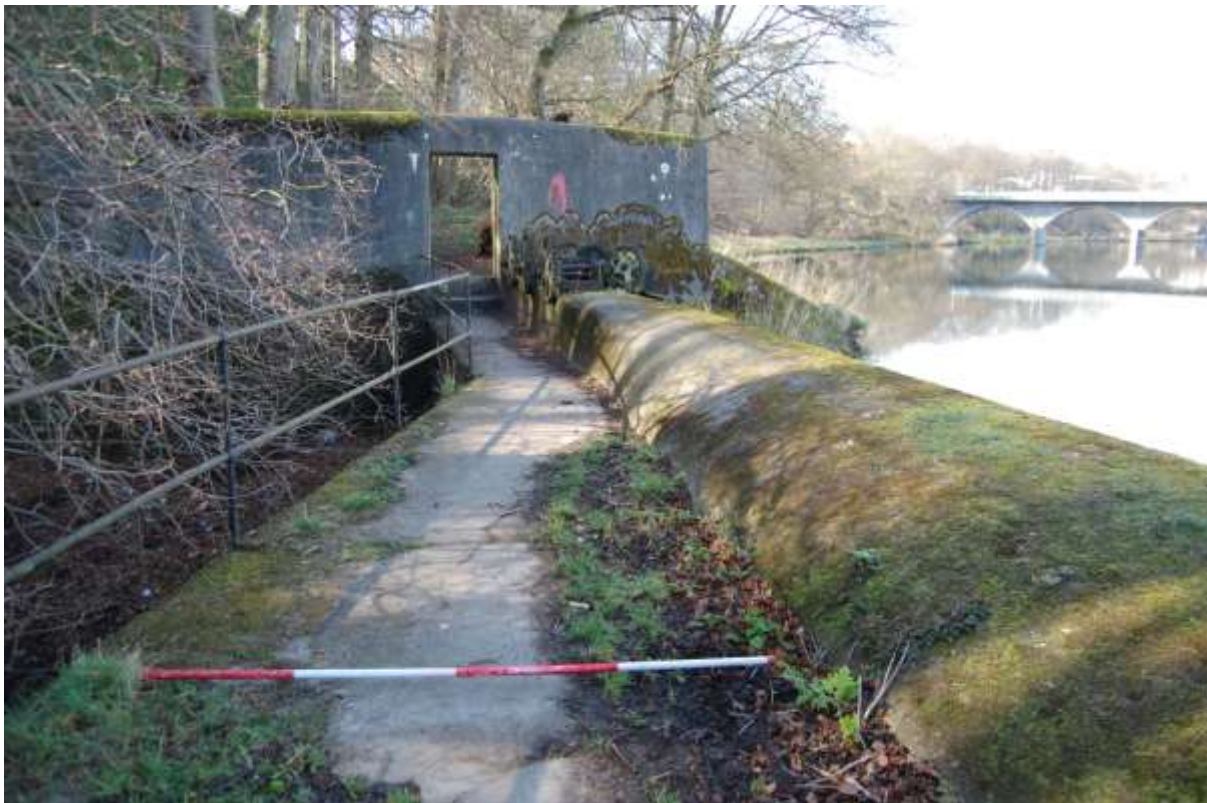
Access to this sluice is limited by its poor condition, overgrown nature and proximity of the river Don and it is not possible to access the lade at this location.

Illus 87 Sluice S27 with lade S6 (left), concrete sluice (centre), boundary wall (centre) and Structure 46 Persley Bridge (top right); facing SW

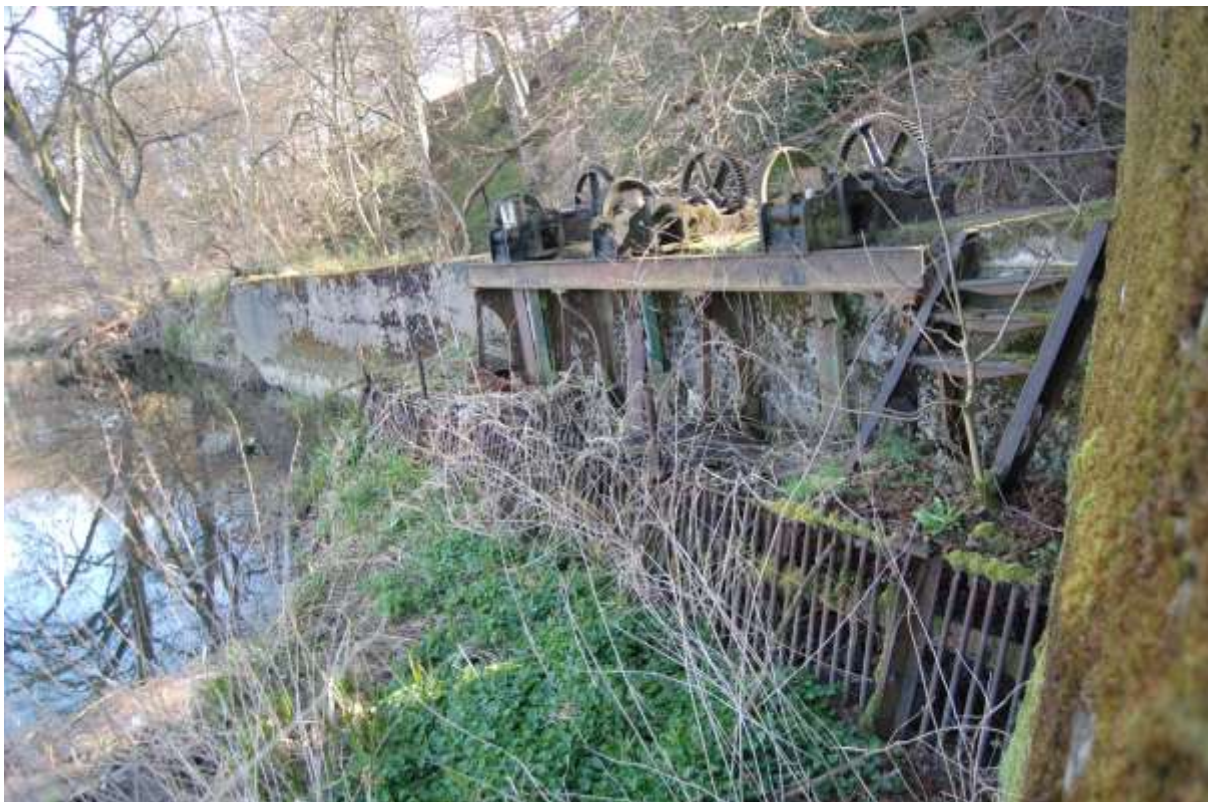
Illus 89 S27 sluice mechanism; facing E

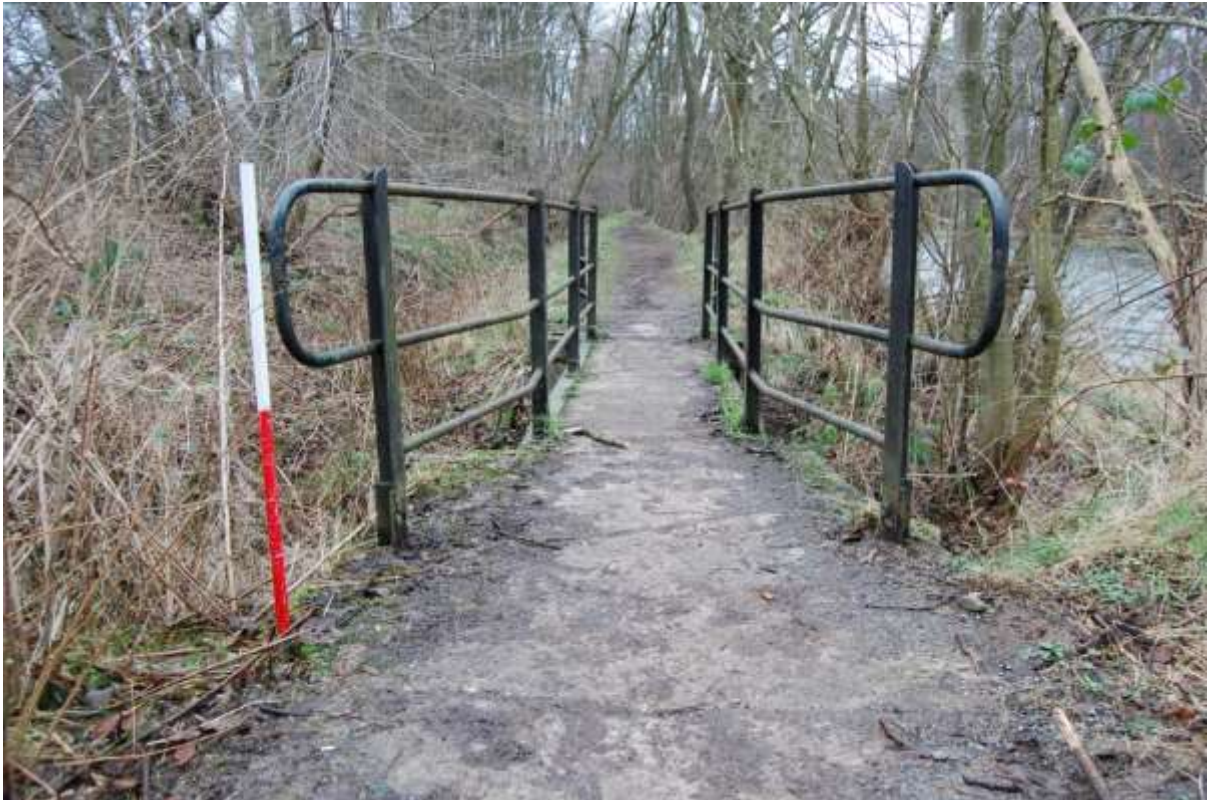
Structure 28 is a bridge is 9m long (W-E and the poured concrete piers are 2.8 x 3.6m and at least 2m deep (Illus 90, 91). The piers have been poured in shuttering and the marks can be seen on the internal faces of the piers (Illus 92). Two steel beams form the main structure of the walkway with pouted concrete in between. The steel beams are marked LANARKSHIRE STEEL CO LTD SCOTLAND 7 x 4' with 'BRITISH STEEL' in a rectangular logo (Illus 93) indicating 7 x 5 inches in size. The Lanarkshire Steel Co Ltd opened 1890 and closed in 1978. This structure was demolished in early 2014 to allow for construction of a wider bridge on Core Path 7.

Illus 91 The bridge S28 facing west

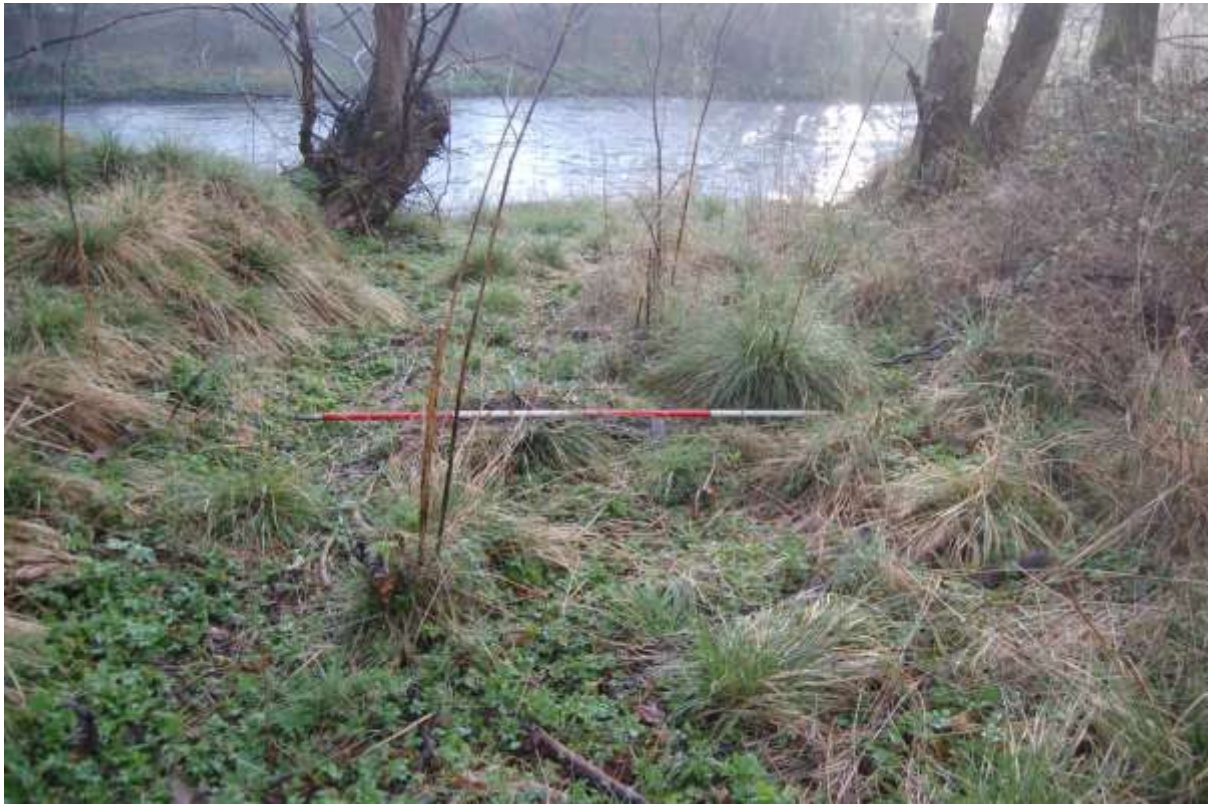
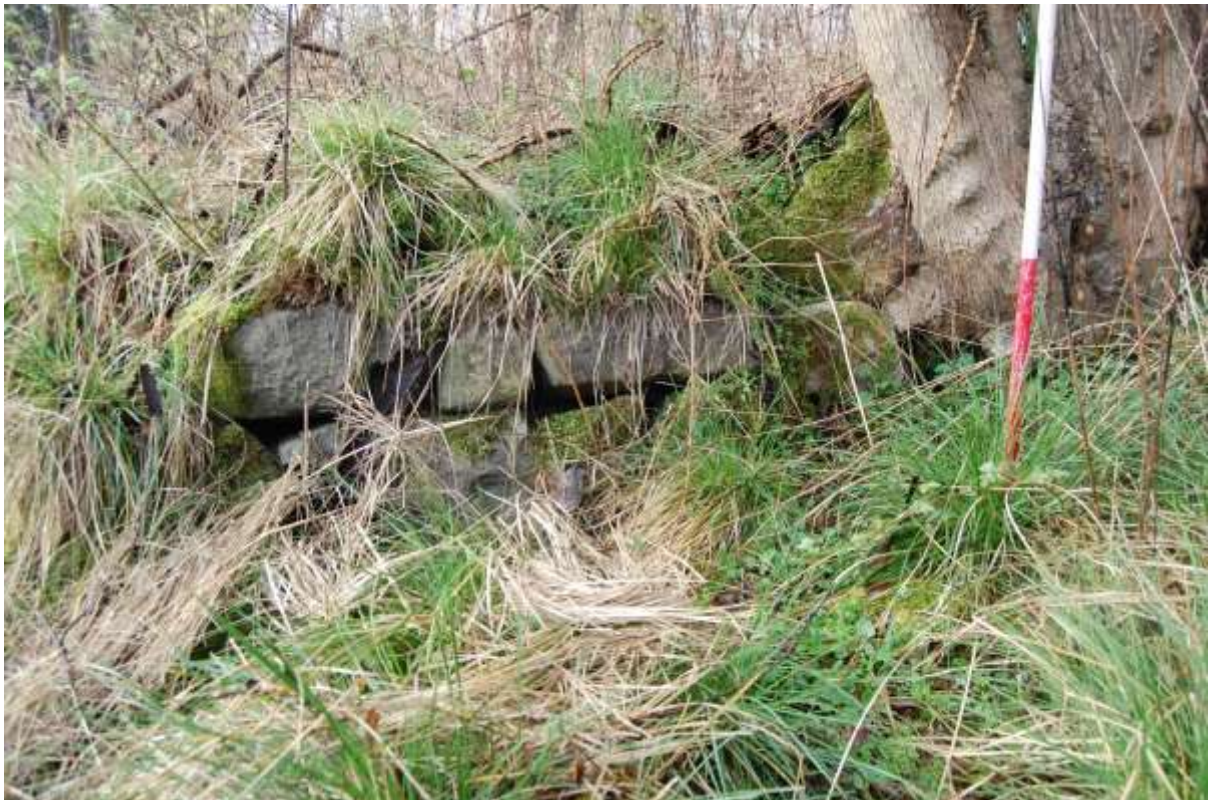
Structure 32 is an outflow of lades S6 and S8 at the north of the Woodside Mill complex. It survives now as a shallow channel with rough stone wall visible on the south side (Illus 97).

Illus 96 Remains of channel S32 outflow into river Don (top); facing ENE

Illus 97 Remains of stone wall on south side of channel S32 outflow into river Don; facing S

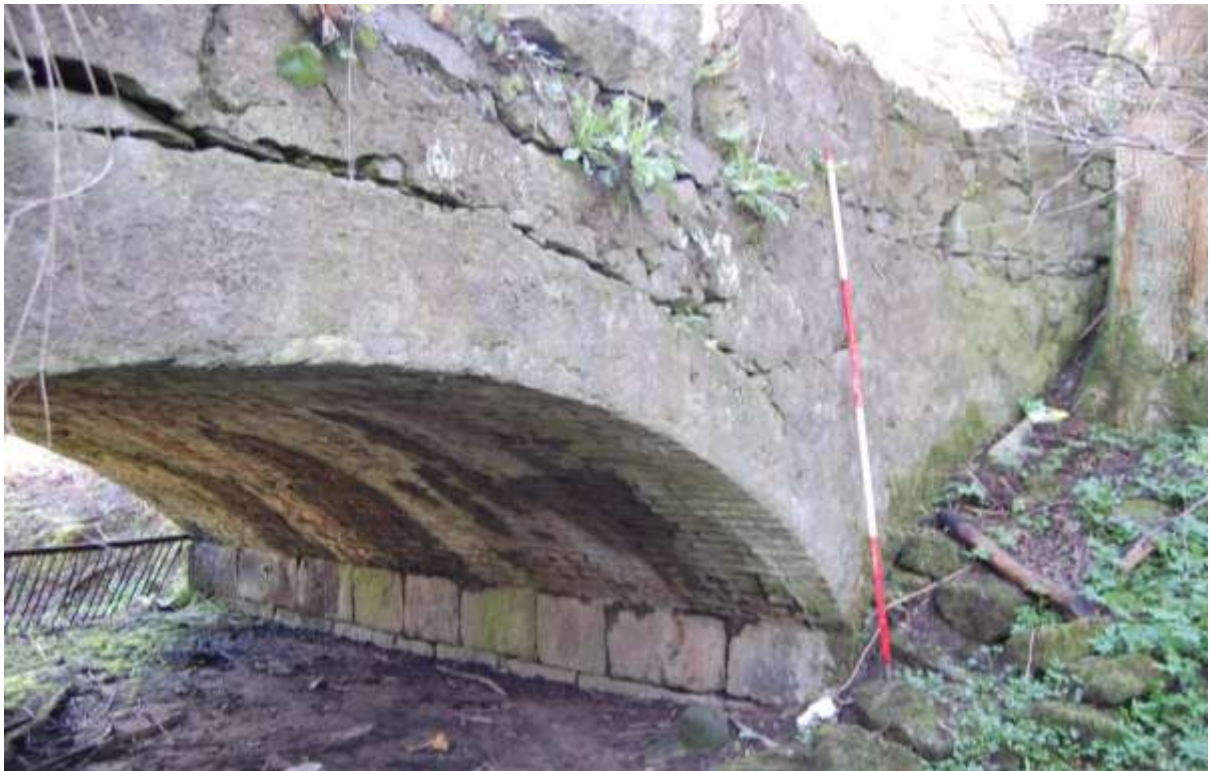
Structure 33 is a culvert and bridge over lade S13 with decorative gateposts on the west side (Illus 98). The culvert is formed by a brick arch on a stone foundation (Illus 99, 45).

Illus 99 South face and east pier of culvert S33 with bridge above showing brick vaulting on stone foundation; facing E

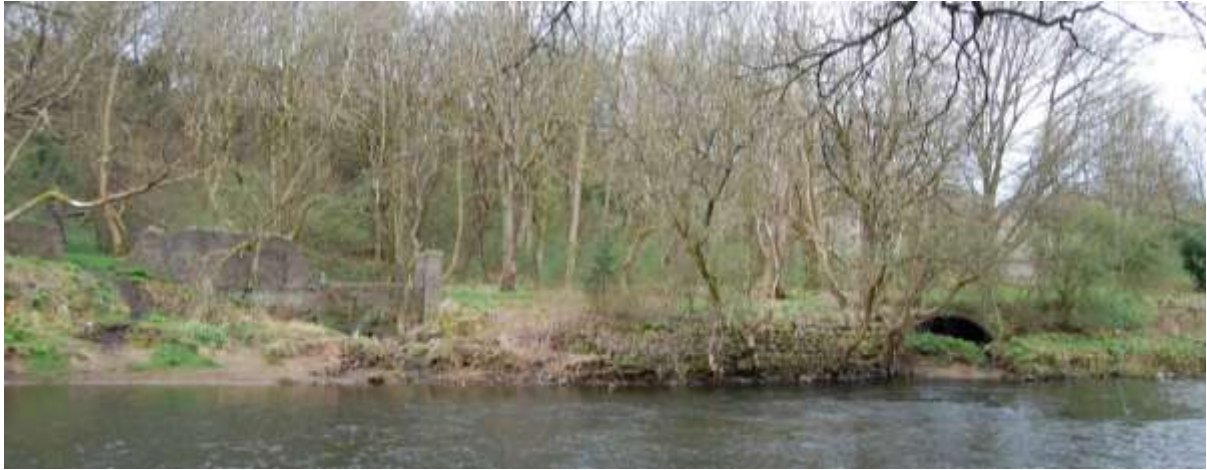
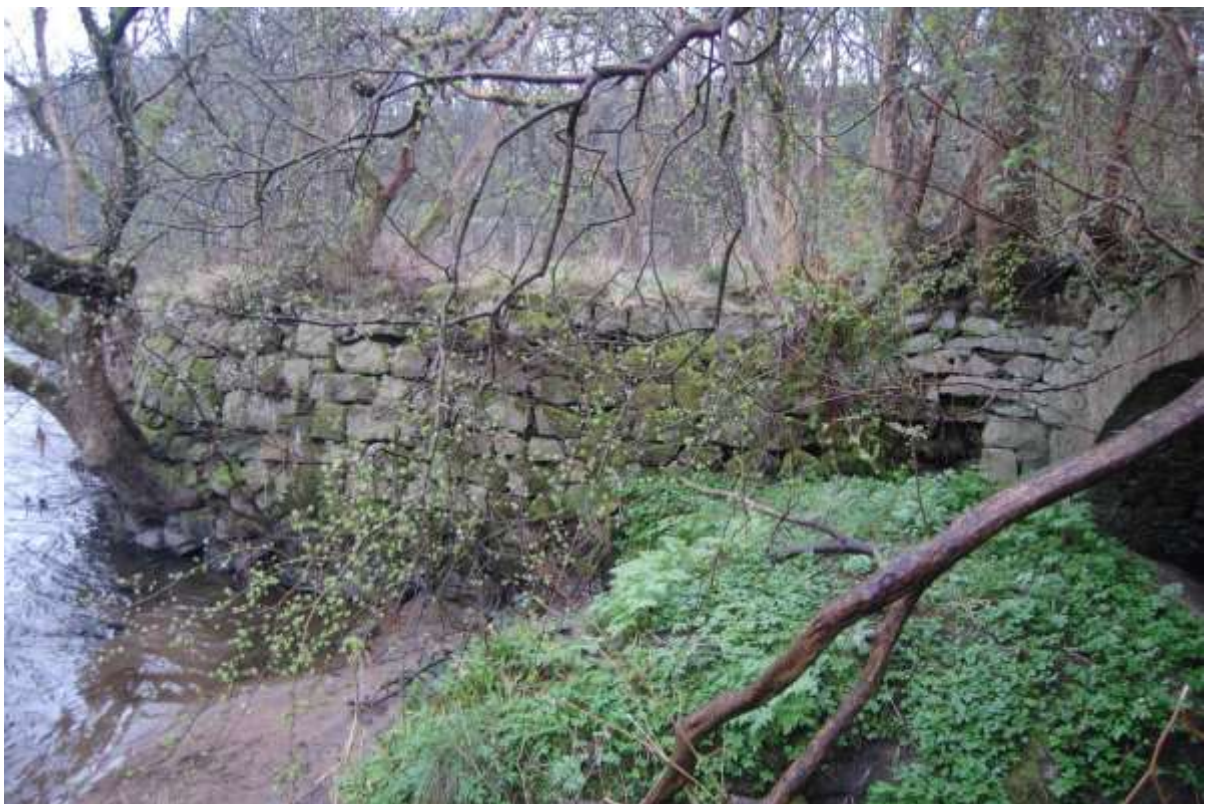
Illus 100 Culvert S10 (right) and S33 (left) with S34 between from north bank of river Don; facing SW

Structure 34 is a stone embankment on the south bank of the river Don between lade outflows S10 and S33 (Illus 100, 101). It was not possible to access this due to its poor condition and proximity to the river.

Illus 101 Stone embankment S34 (centre) with culvert S10 (right)

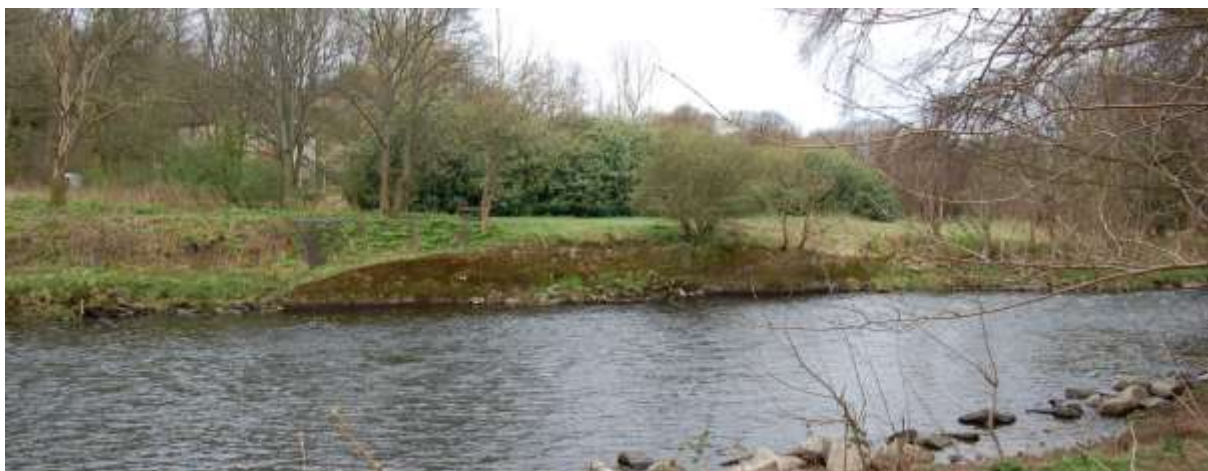
Structure 35 is a stone embankment blocking the outflow of lades S6 and S8 (Illus 102); the lades and outflow have been completely infilled and are not visible on the ground. It is constructed of granite rubble and is not easily accessible but can be seen clearly from the north bank of the river Don (Illus 103).

Illus 103 Stone and concrete embankment at the junction of outflow of Lades 6 and 8 to river Don; from north bank of the Don; facing SW

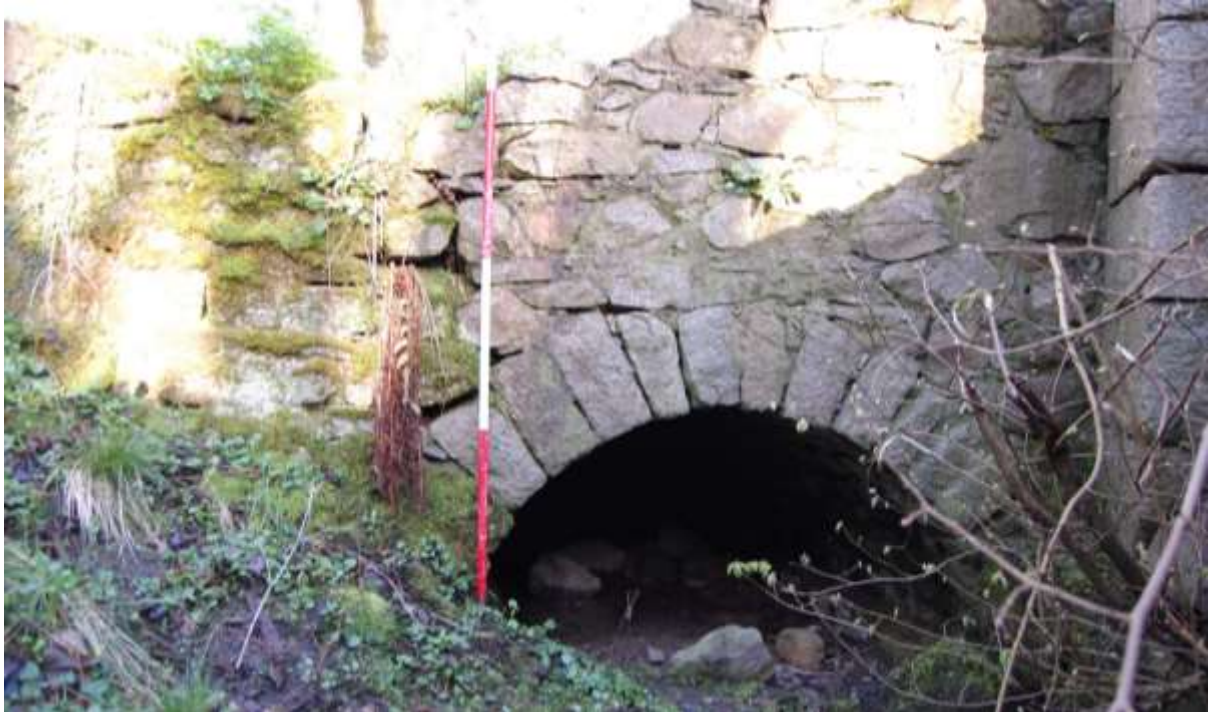
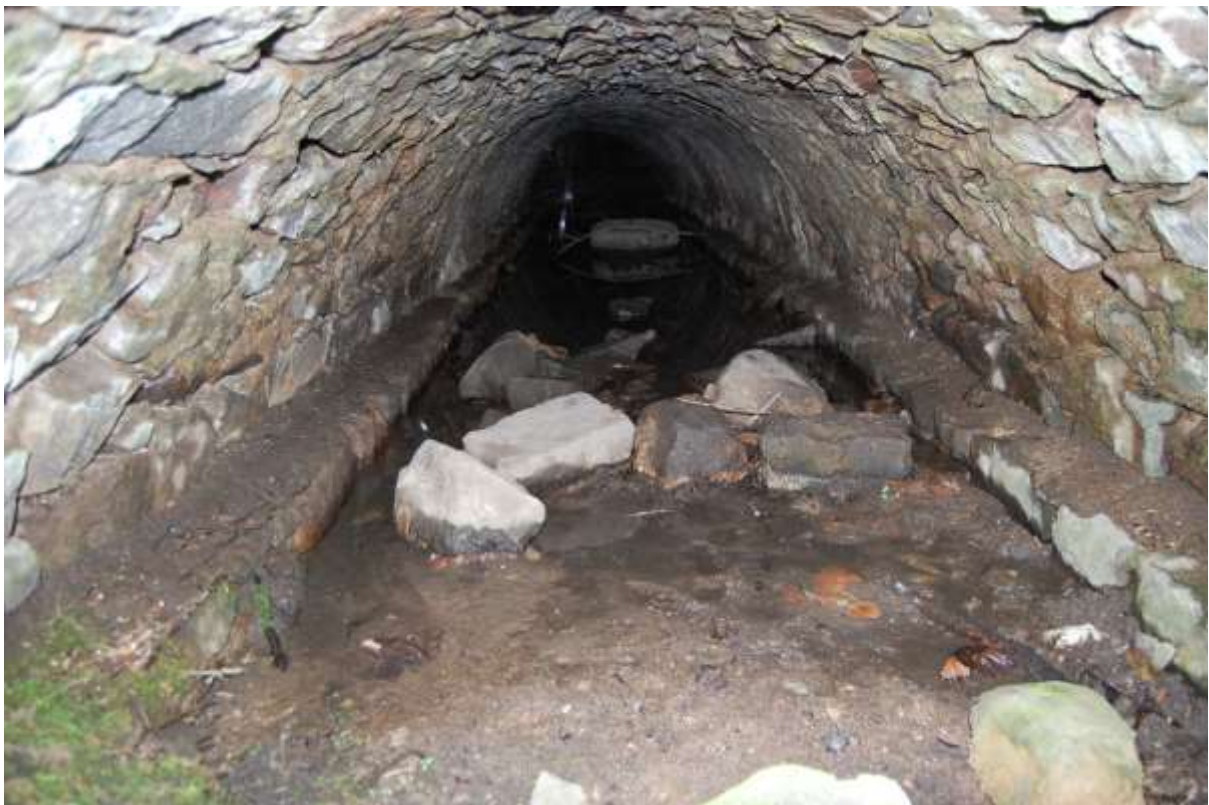
Structure 36 is the culvert through which an unidentified lade entered lade S13 and under culvert S33 and in to the river Don (Illus 102). The small culvert is stone vaulted (Illus 104) 1.8m diameter and set on a stone foundation (Illus 105).

Illus 104 Culvert S36 showing stone vaulting with bridge and culvert S33 (right); facing NW

Illus 105 Culvert S36 showing stone vaulting on stone foundation; facing NW

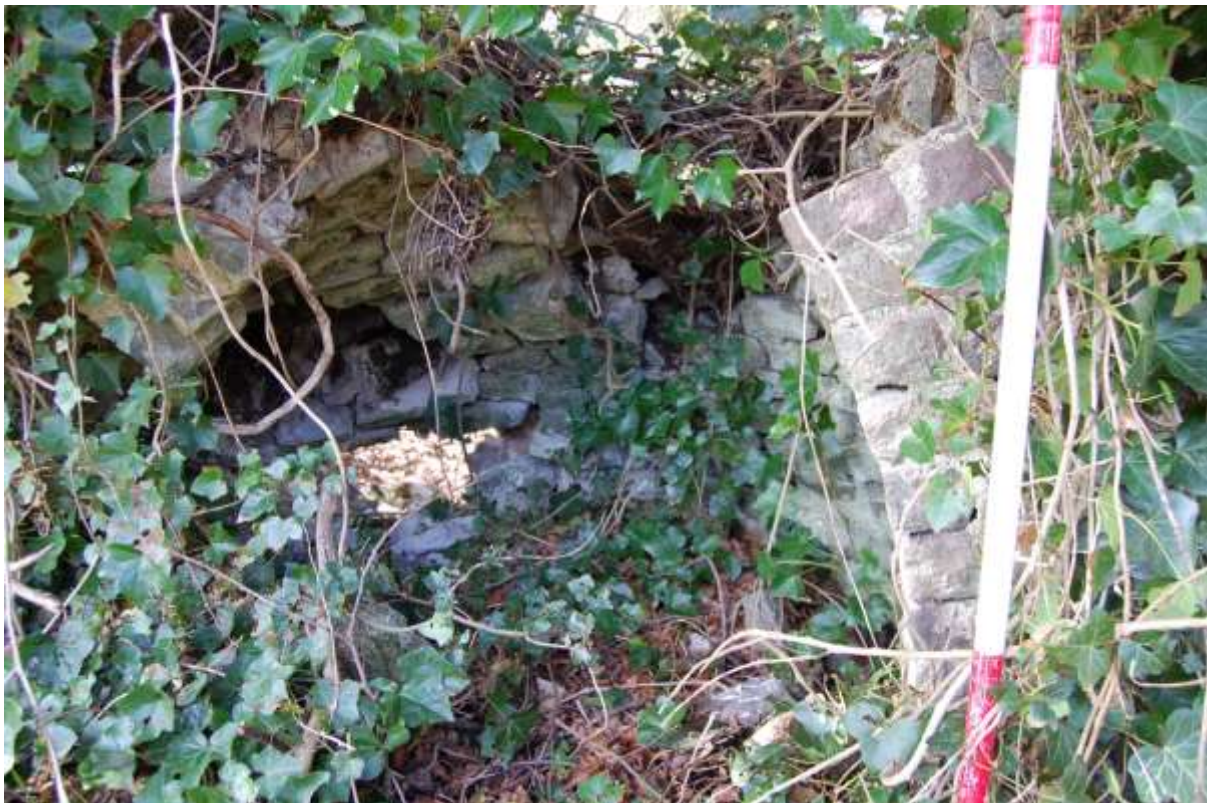
Structure 37 is a vaulted domed structure at the SW end of wall S21. It is almost completely obscured by a large tree growing on the top of the structure and it has also been burrowed by animals. The structure was originally semi-circular in shape with its opening to the east. It is constructed of heavily lime mortared granite fieldstones (Illus 108) with remains of a dressed stone opening (Illus 107). The maximum surviving height is c 2m and 2.7m internal diameter. It is marked as a 'seat' on the First (but not subsequent) OS Editions and would have provided shelter and a good view of the tree covered walkway around the west side of the walled garden.

Illus 107 Entrance to Structure 37; facing W

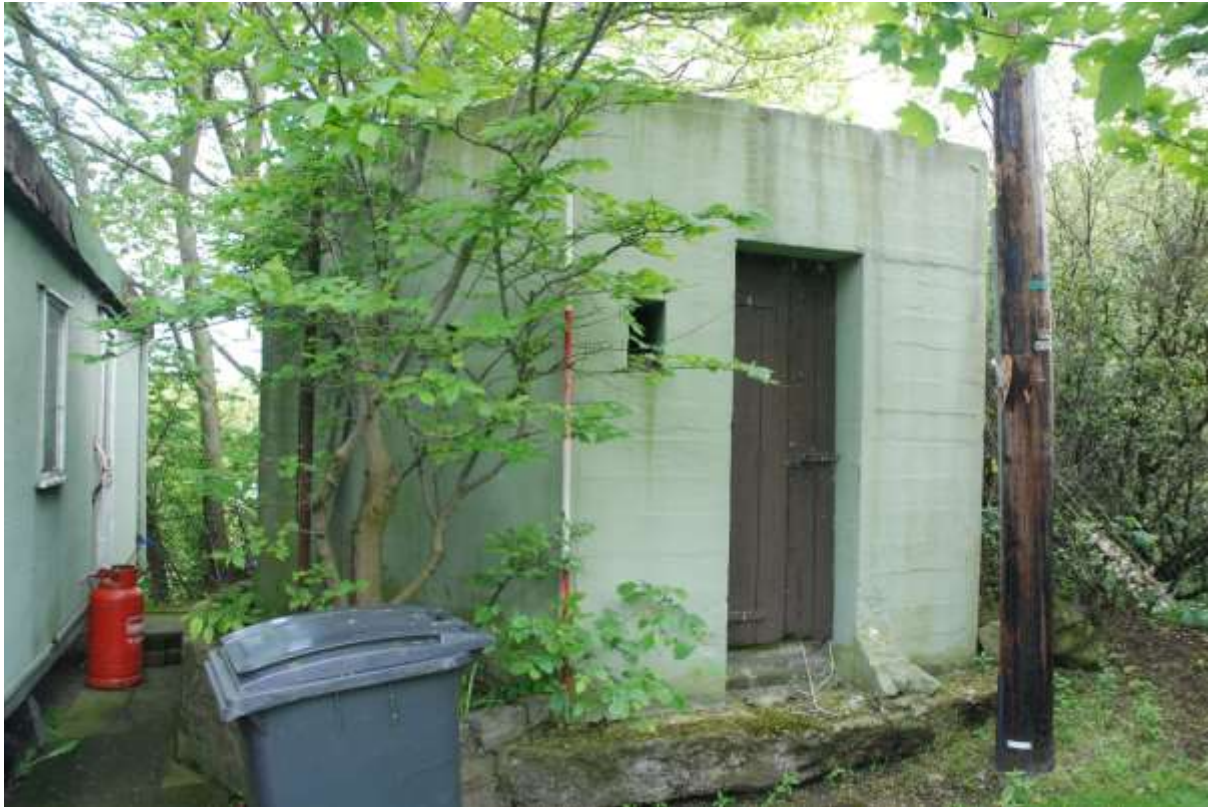
Illus 113 Pillbox Structure 41 south facing external wall showing central door, small aperture and 30cm thick concrete foundation

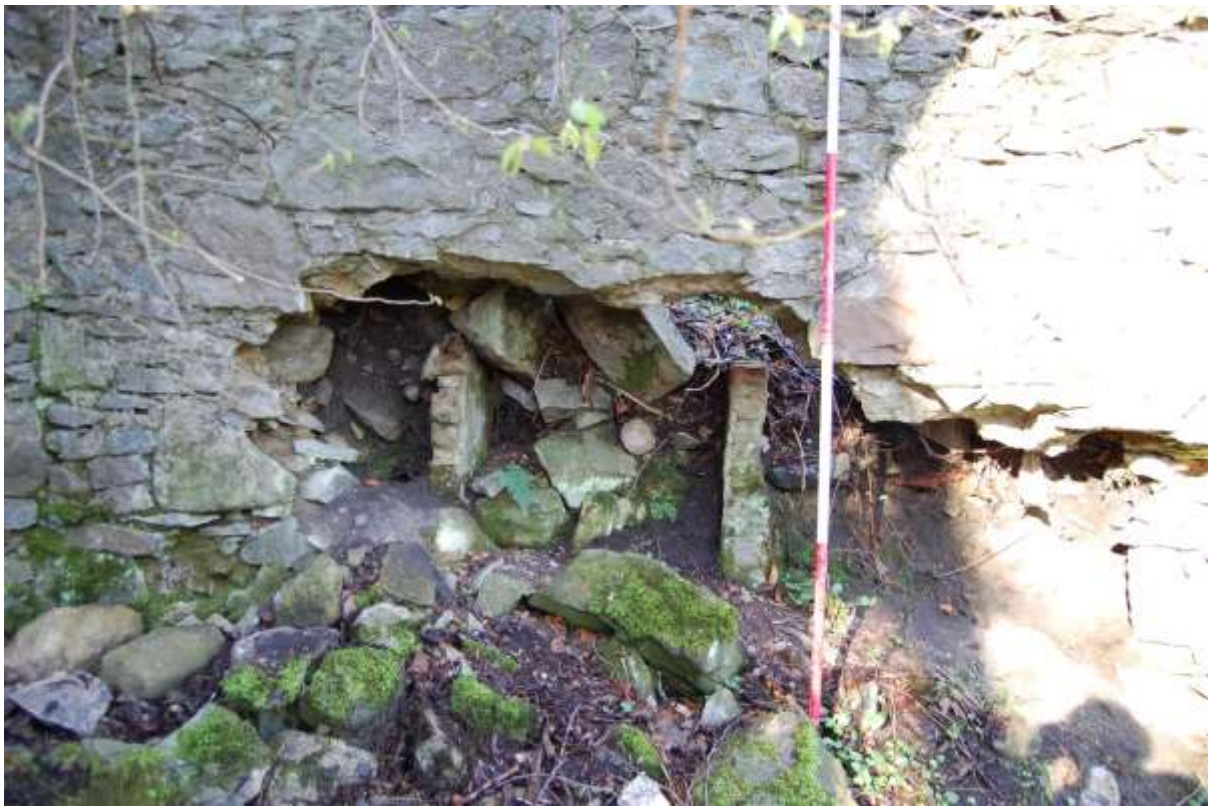
Two walls on the outside of enclosure S 11 can only be seen from the interior where the walls of the enclosure has collapsed (Illus 112). These cannot be seen from the exterior of the enclosure and it is uncertain what they are part of.

Illus 115 Two narrow brick walls on exterior of west wall of enclosure S11; facing W
